## BHANDARKHAL TANK LIONS

Report of the Institute of Conservation (IoC), University of Applied Arts Vienna

Bhandarkhal Tank Lion

May 2024

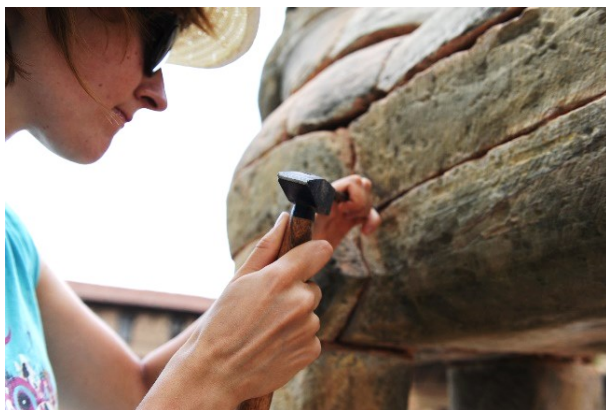
Fig. 3: Removal of former joints, 2011

- Removing damaged and unsatisfactory joint mortar until a depth of 3-4 cm
- Wet cleaning with brushes and water
- Biocide treatment (quaternary-ammonia-salts 2% in water), repeated 2-3 times
- Repointing of joints with mortar; locally available green pigment was added to adjust the colour (pigment was tempered in water and alcohol, fluid colour was then added to slaked lime before it was mixed with the brick dust); scratching-off of the joints to the surface level of the stone

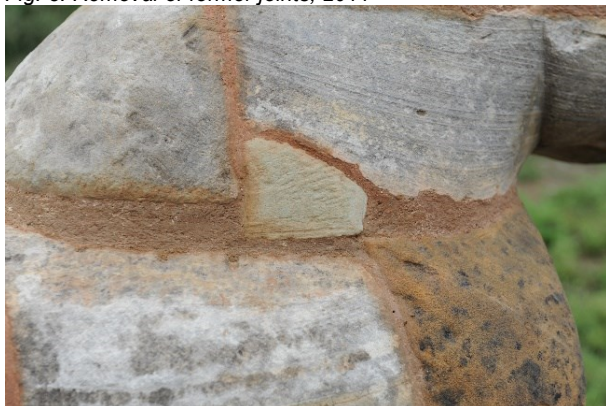
Fig. 5: Pointed joints while wet, 2011

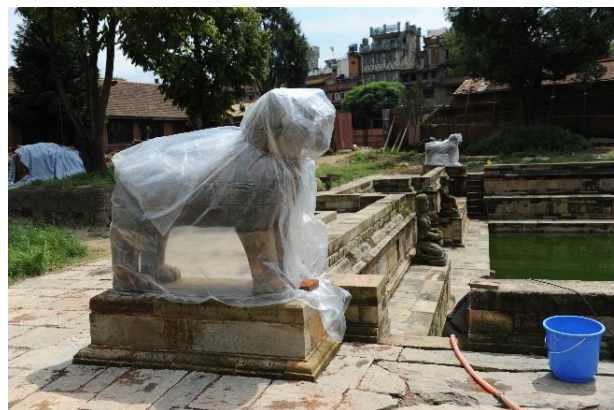
Fig. 4: Biocide treatment, 2011

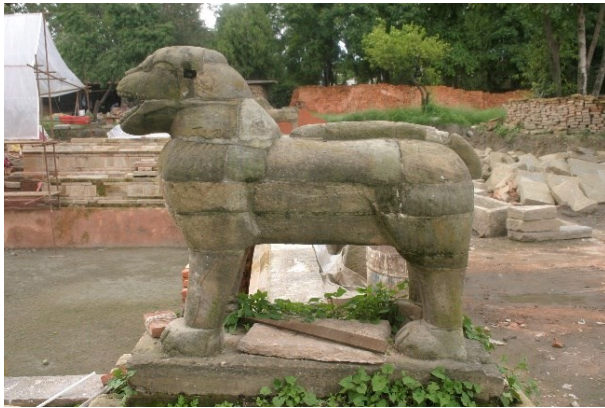
*Fig. 6: Lioness before the conservation, 2011*

- Pressure of higher plants deranged stone blocks
- Open and cracked joints

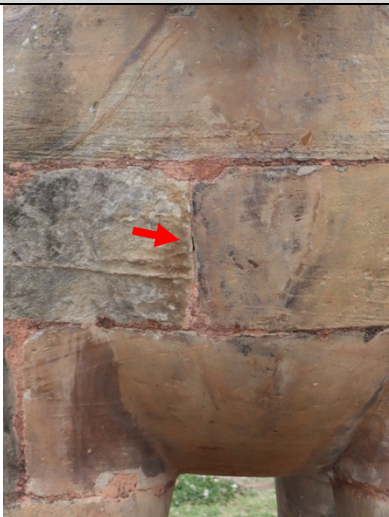
Only very thin joints are missing (Fig. 1).

Fig. 1: Thin joint section open.

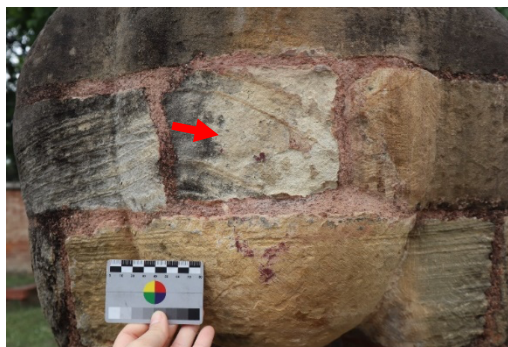
<input checked="" type="checkbox"/> Minor	Scaling at left front foot. Surface hardening on the underside of the lion which contributed to or was the reason for scaling; scaling may have also been caused by salt deterioration (Fig. 2).
--	---	--

<input checked="" type="checkbox"/> Salt Deterioration  <input type="checkbox"/> Not detected	<input checked="" type="checkbox"/> Efflorescence	<input type="checkbox"/> Major	
	<input type="checkbox"/> Not detected	<input type="checkbox"/> Medium	
		<input checked="" type="checkbox"/> Minor	Subflorescence on the underside of the lion caused minor scaling and powdering.

Fig. 2: Scaling/Sanding.

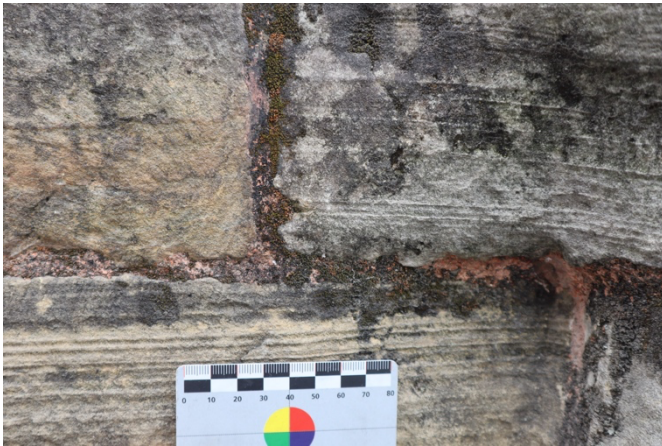
Fig. 3: Microbiological growth on the joints.

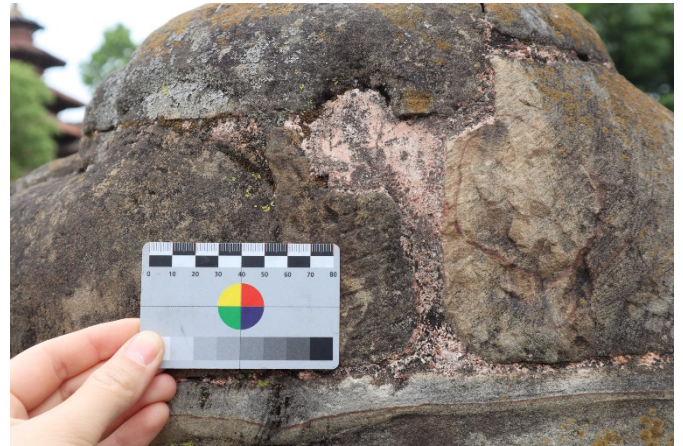
Fig. 4: Microbiological growth and lichen on the top part.
