## BHANDARKHAL PAVILION BASE

Report of the Institute of Conservation (IoC), University of Applied Arts Vienna

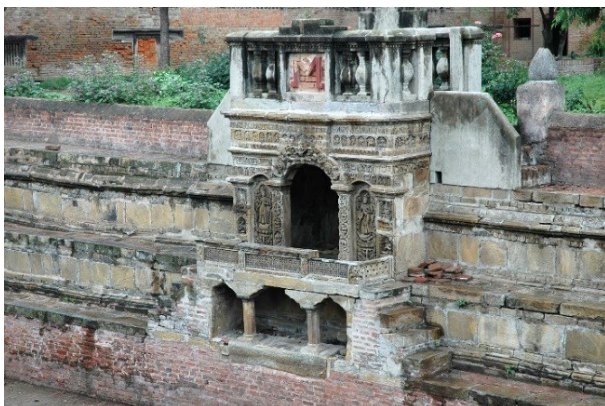
*Fig. 8: Former concrete balustrade 1956-2010*

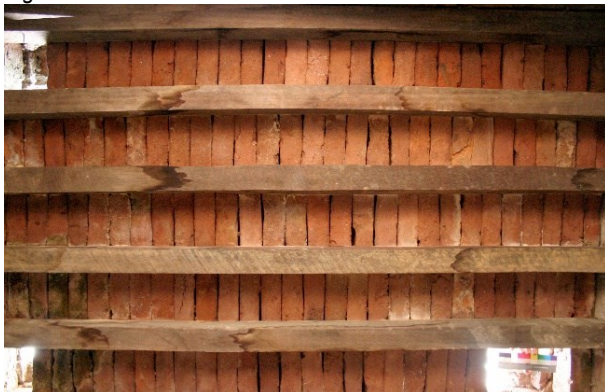
*Fig. 10: Former seating, loose bricks / wooden beams*

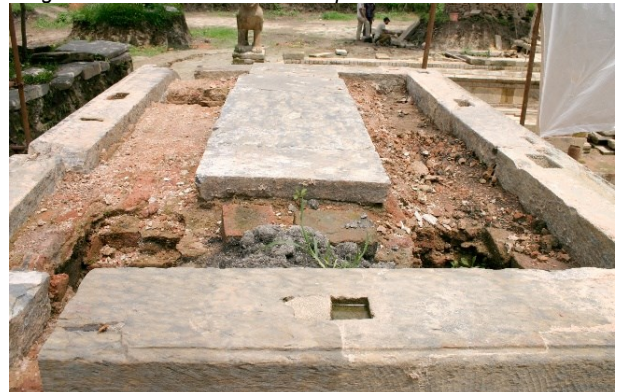
*Fig. 11: Mud on top of seating, calcitic schist capping/frame*

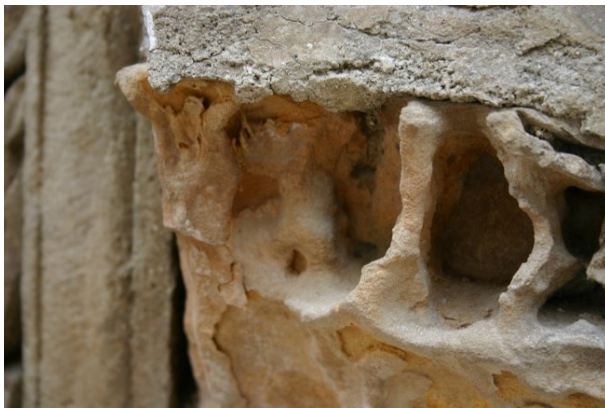
Fig. 12: Detail of extremely weathered carved stone and cement joint (upper part)

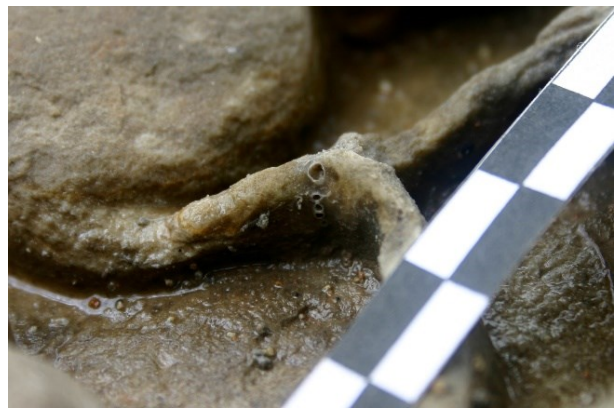
Fig. 13: Detail of surface coating

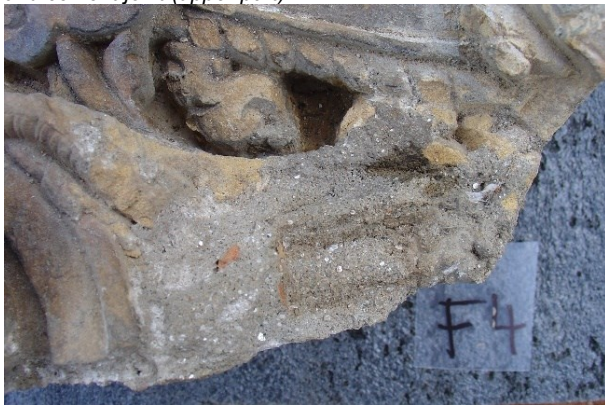
Fig. 14: Detail of thin cement coating on the surface

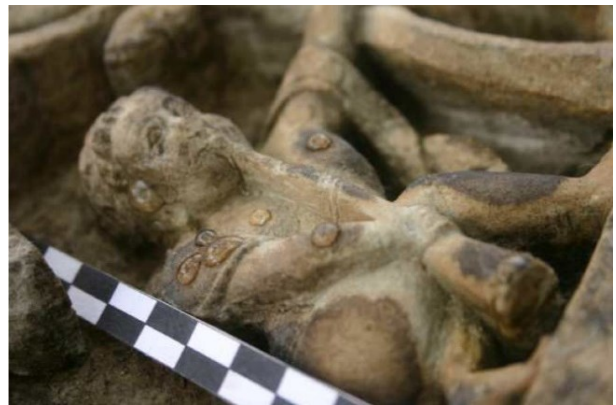
Fig. 15: Hydrophobic stone surface due to coating

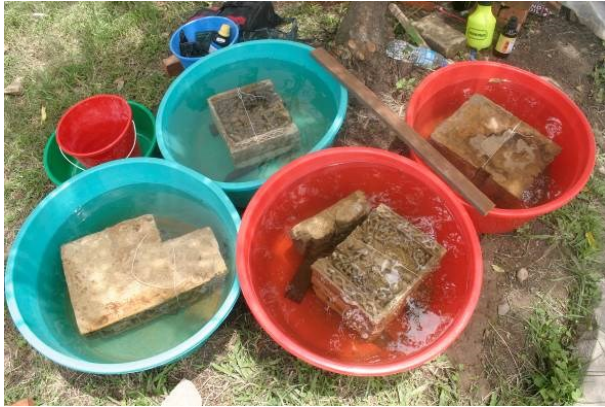
*Fig. 16: Desalination within water bath with rainwater*

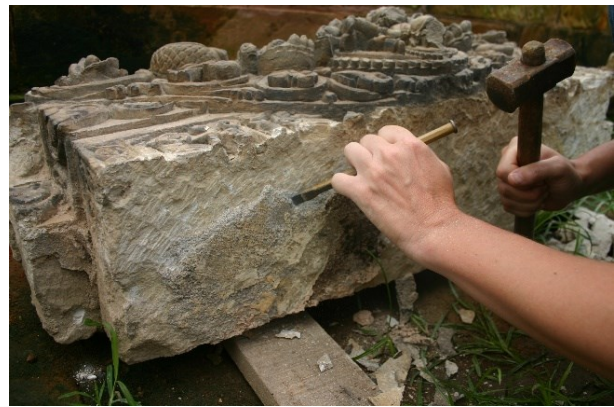
*Fig. 17: Removing former (cement) mortar*

- 2011
- Removing of damaged and unsatisfactory joint mortar until a depth of 3-4 cm
  - Mechanical removal of mortar remnants on stone surface with glass fibre pencil and scalpel

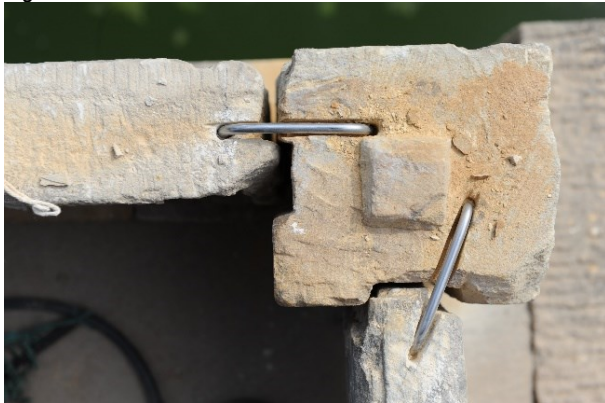
*Fig. 18: Inox clamps*

- Introducing six stone slides at the balcony to elevate the balustrade approx. 2 cm (together with the craftsmen of KVPT)
  - Introducing inox needles and clamps to fix the cornice stone blocks at the balcony balustrade

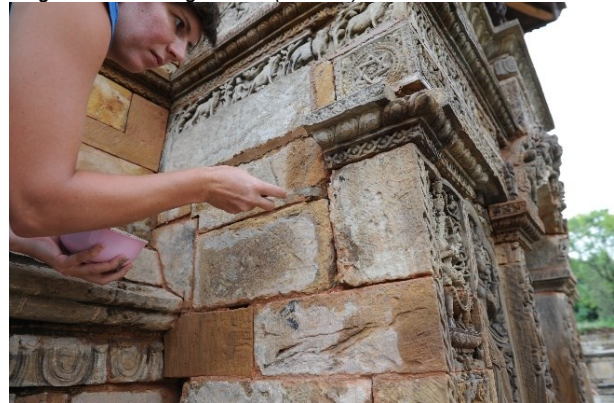
*Fig. 19: Pointing joints*

- Biocide treatment (quaternary-ammonia-salts 2% in water), repeated 2-3 times
  - Repointing of joints with joint mortar; locally available green pigment was added to adjust the colour (pigment was tempered in water and alcohol; fluid colour was added to slaked lime before mixing it with the brick dust); scratching-off the joints on surface level of the stone

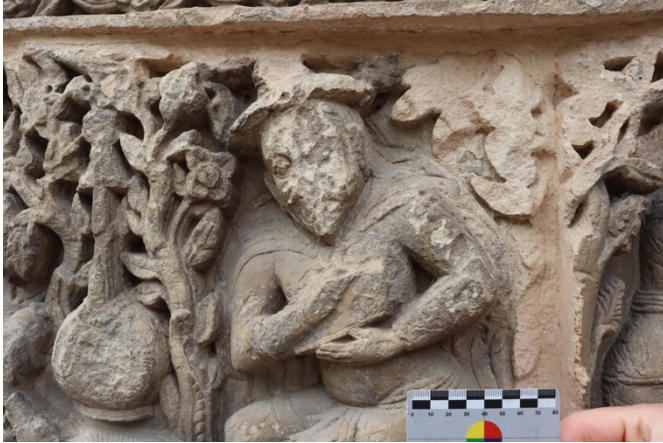
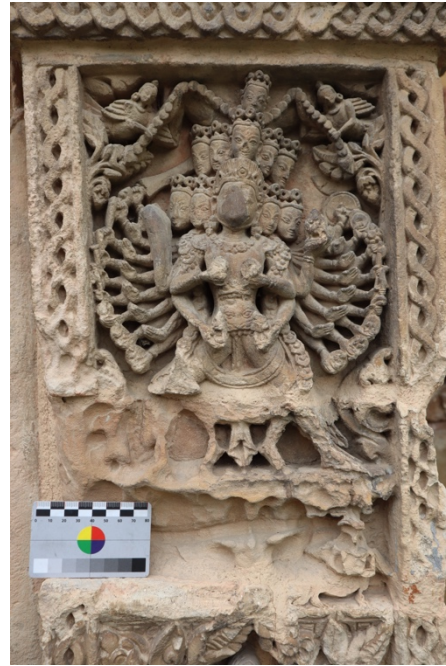
Surface erosion of already weathered surface

Mostly east and southside (Fig. 1, 2)

Fig. 1: Surface loss, erosion.

Fig. 2: Surface loss, erosion.

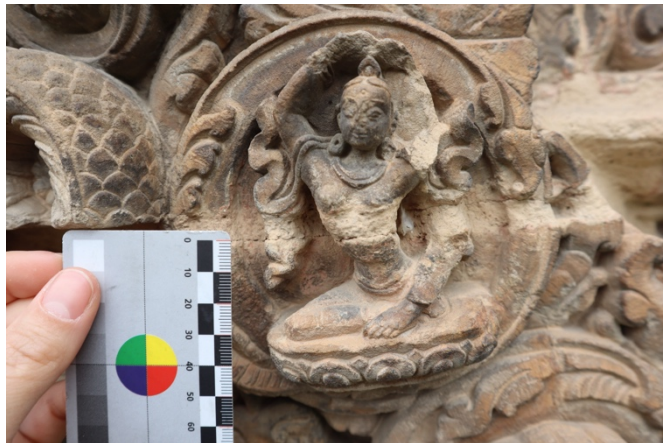
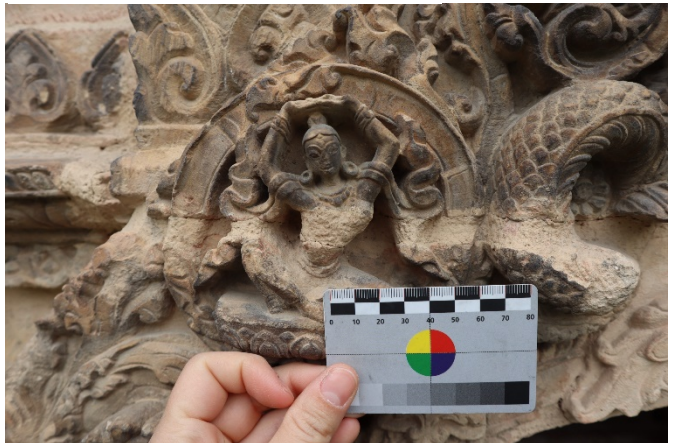
At the edges to the stone (Fig. 3, 4)

Fig. 3: Joints cracked along the edges to the stone.

Fig. 4: Joints cracked along the edges to the stone.

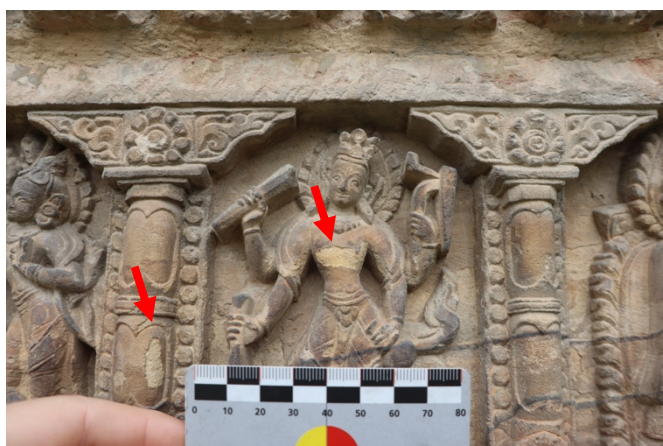
Minimal scaling is present at areas with remnants of surface coating (Fig. 5).

Fig. 5: Scaling on stone surface.

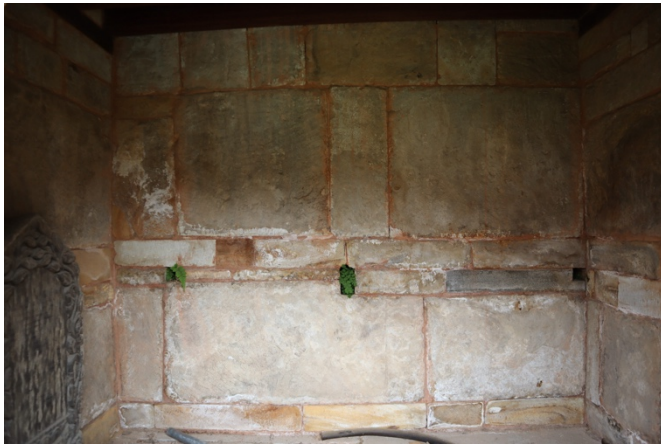
<input checked="" type="checkbox"/> Salt Deterioration  <input type="checkbox"/> Not detected	<input checked="" type="checkbox"/> Efflorescence   <input checked="" type="checkbox"/> Subflorescence	<input type="checkbox"/> Major <input type="checkbox"/> Medium <input checked="" type="checkbox"/> Minor Some joints and some stone blocks at ground level on the east- and west side show minor salt deterioration; also inside on the floor stones and up until ground level height (Fig. 6, 7). <hr/> <input type="checkbox"/> Major
---	---	--

Fig. 6: Salt efflorescence on the inside of the pavilion base.

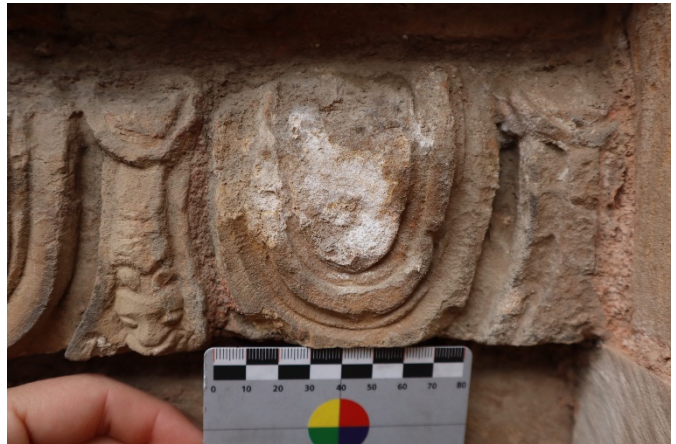
Fig. 7: Salt efflorescence causing material loss.

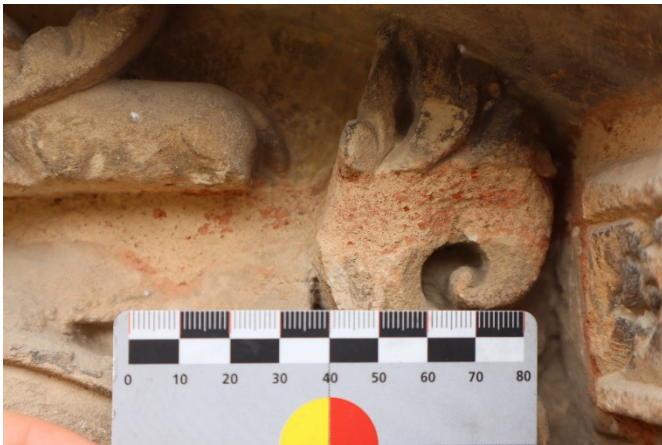
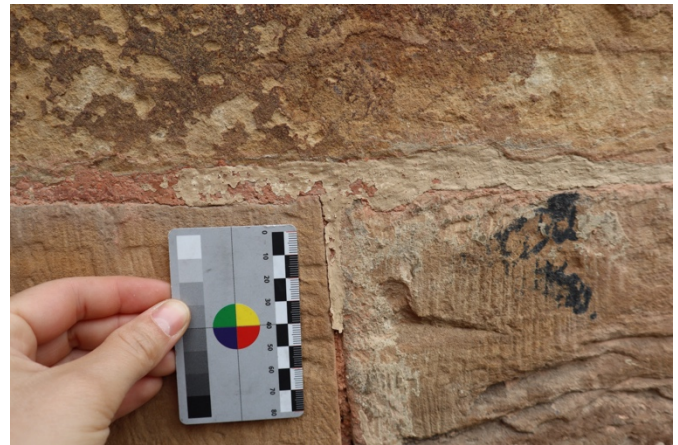
The joint mortar is in good condition with some cracks along the edges of the joints. Silicate paint retouching of the joints is powdering off in most areas (Fig. 8, 9).

Fig. 8: Powdering of joint retouching.

Fig. 9: Powdering of joint retouching revealing pinkish joint mortar.

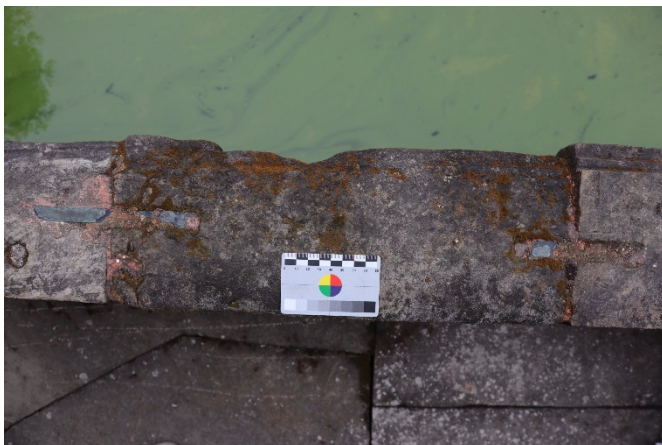
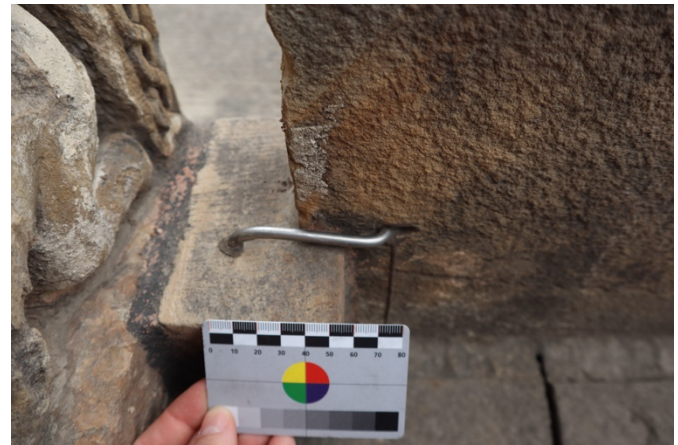
Inox pins and clamps at the balustrade are in good condition, although the mortar on top has mostly chipped off (Fig. 10, 11).

Fig. 10: Inox pins at the balustrade with chipped off mortar.

Fig. 11: Inox pin.
