BHIMSEN TEMPLE PINNACLES

Report of the Institute of Conservation (IoC), University of Applied Arts Vienna

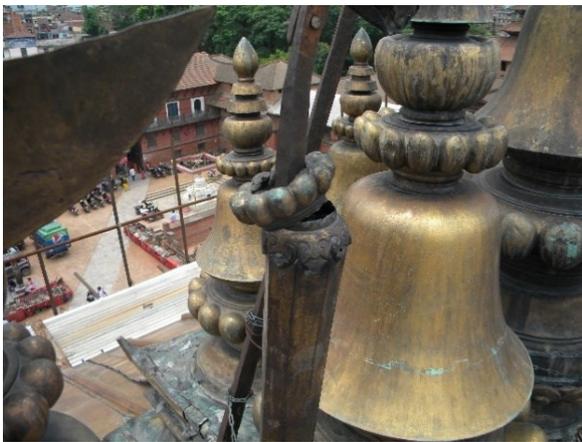
Fig. 7: Detail before dismantling

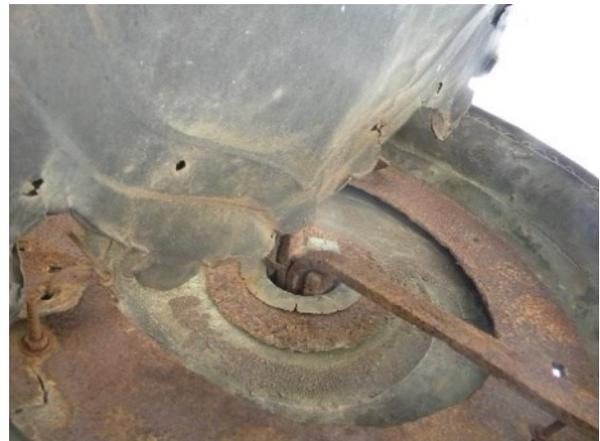
- Thick soiling layers
- Mechanical damage (scratches, bumps)
- Worn-out gilding
- Corroded surfaces due to direct exposure to weather and pollution, heavy corrosion on iron chains

Fig. 8: Corroded iron

- Dismantling of all metal components and disjoining / disassembling
- Dry cleaning with brushes
- Wet cleaning of metal parts with water and surfactant, rinsing off with drinking water and exposure to sun for drying; elements with compact soiling layers were placed in a water bath with surfactant over night
- Removing of copper corrosion with citric acid (complexing agent), elements were either placed in citric acid bath (1:10 citric acid and water) or treated with cotton-wool patches soaked in citric acid, immediate subsequent cleaning with drinking water and brushes
- Cleaning of iron parts with metal brushes to remove corrosion, afterwards a protective layer of pure transparent lead soap was applied

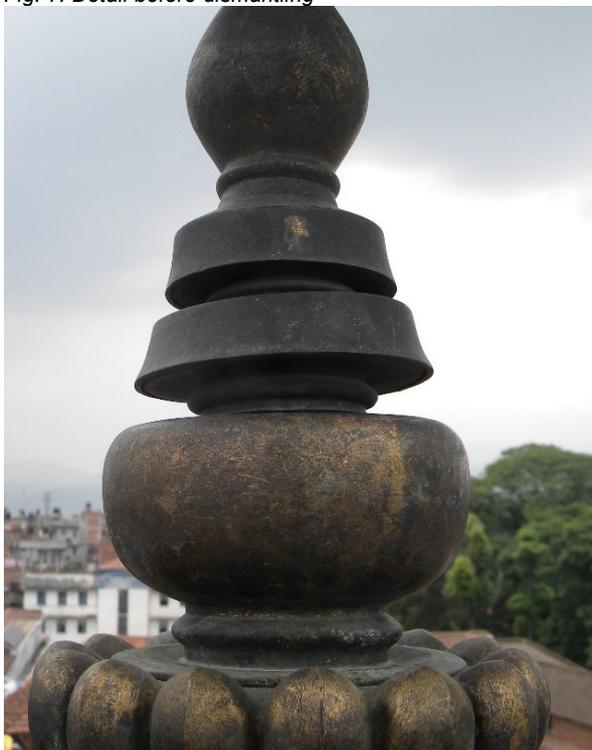
Fig. 9: Soiled surface

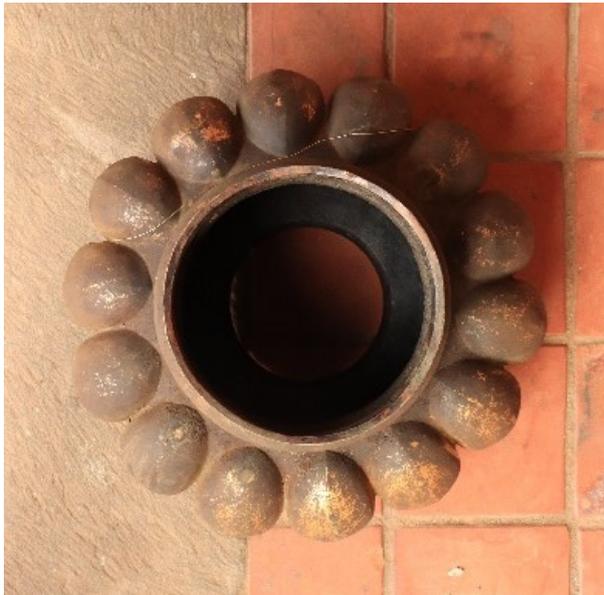
Fig. 15: Piece of pinnacle part before conservation

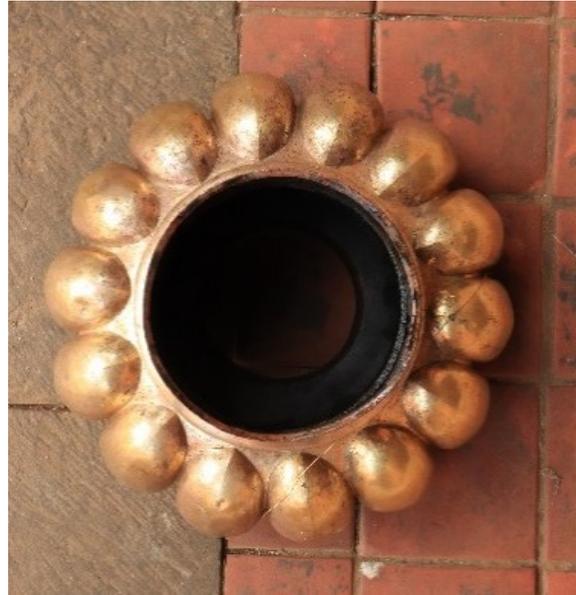
Fig. 16: Piece of pinnacle after conservation

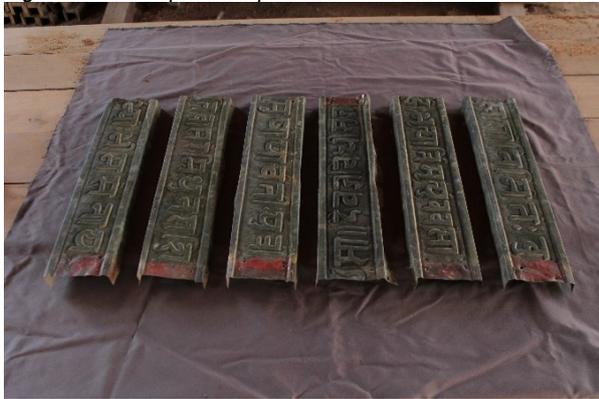
Fig. 17: Before conservation

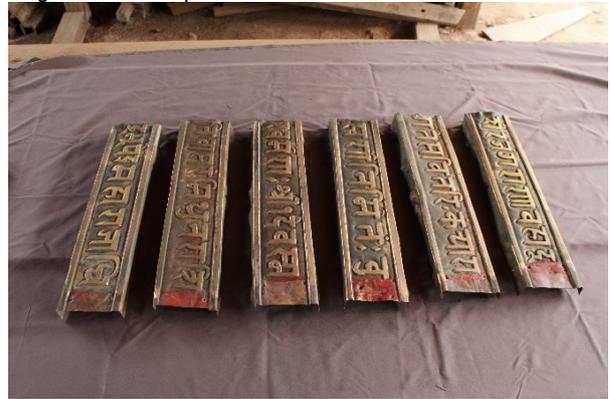
Fig. 18: After conservation

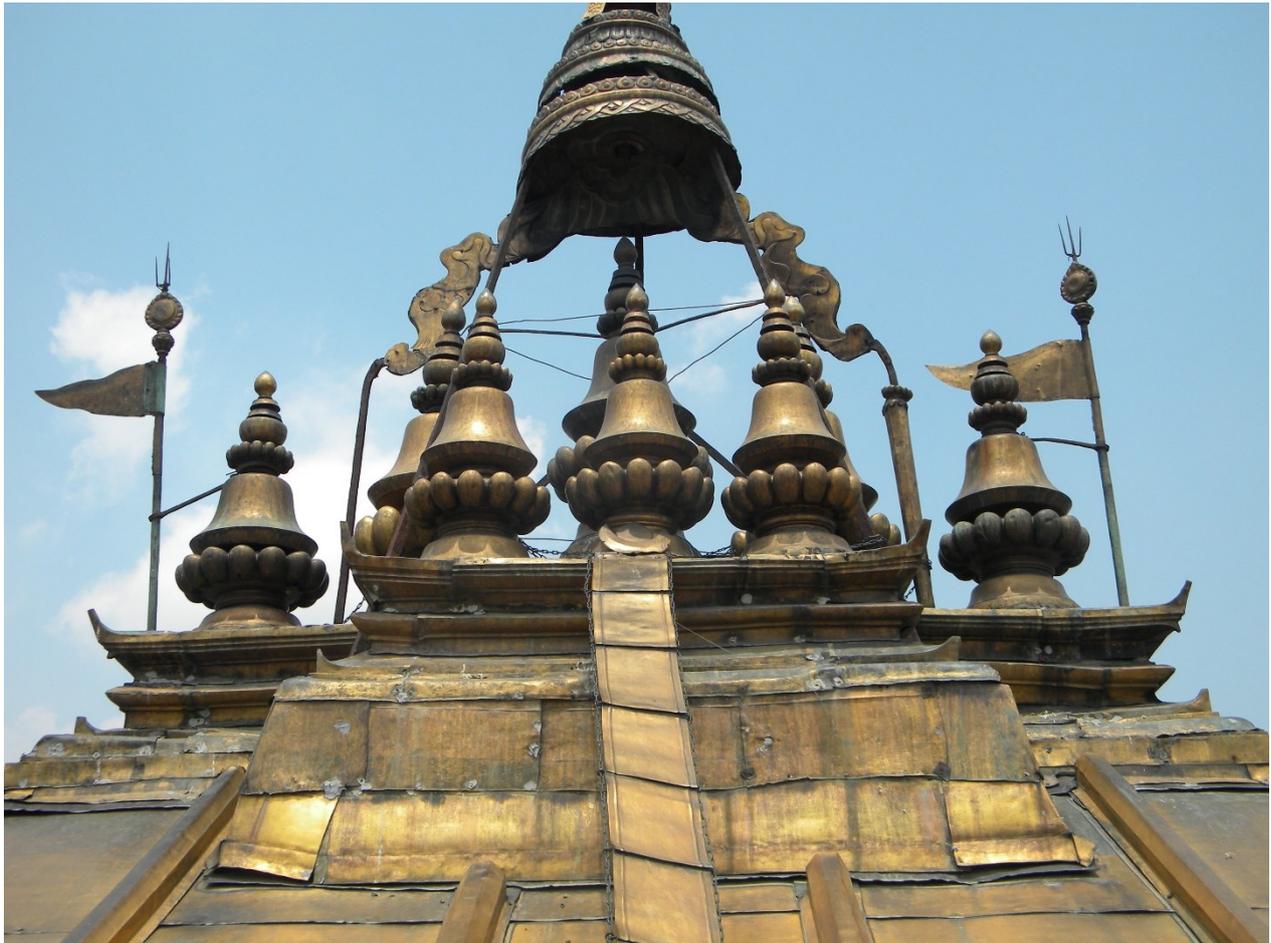
Fig. 20: Bhimsen Temple, pinnacles on top, before conservation, 2019

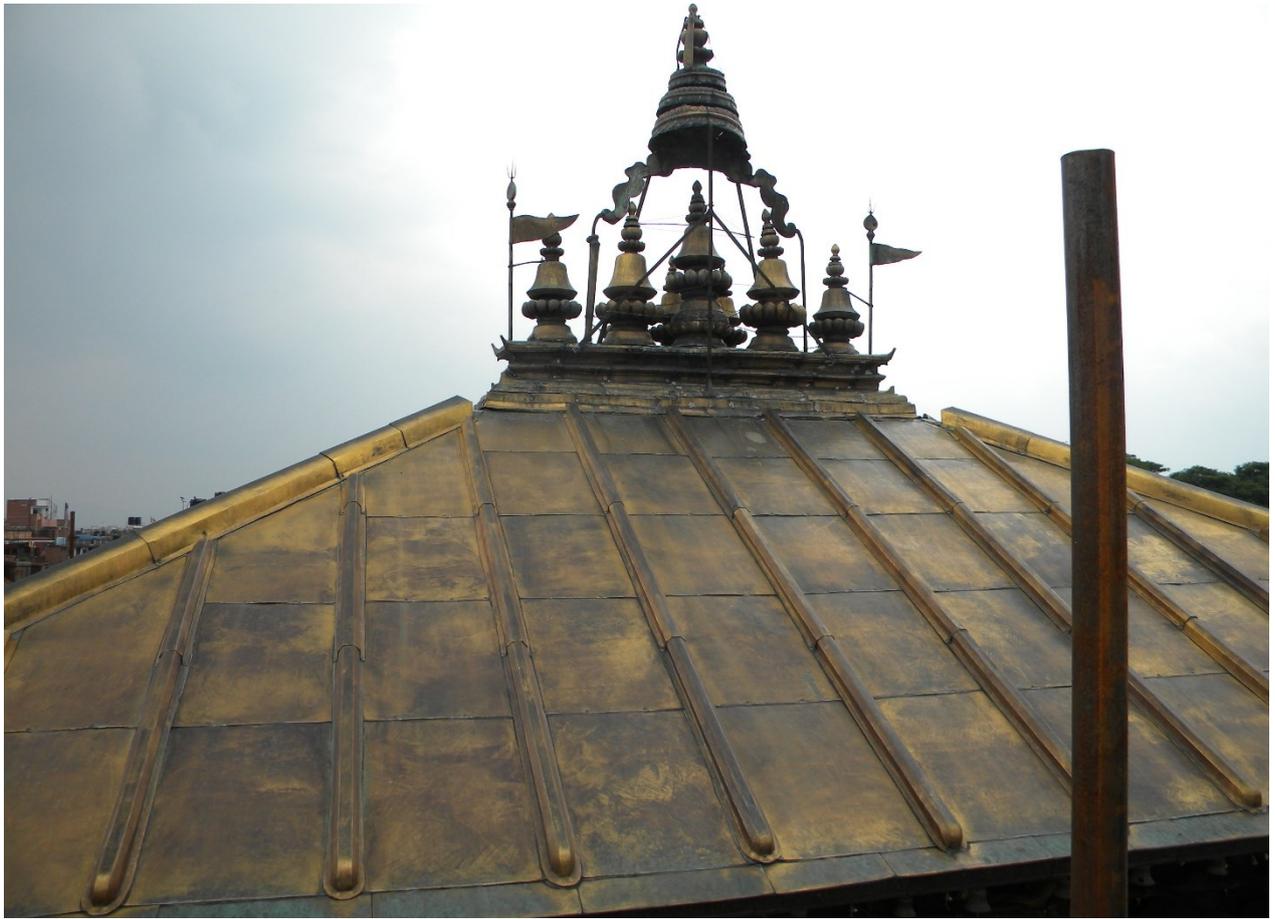
Fig. 21: Bhimsen Temple top roof, before conservation, 2019

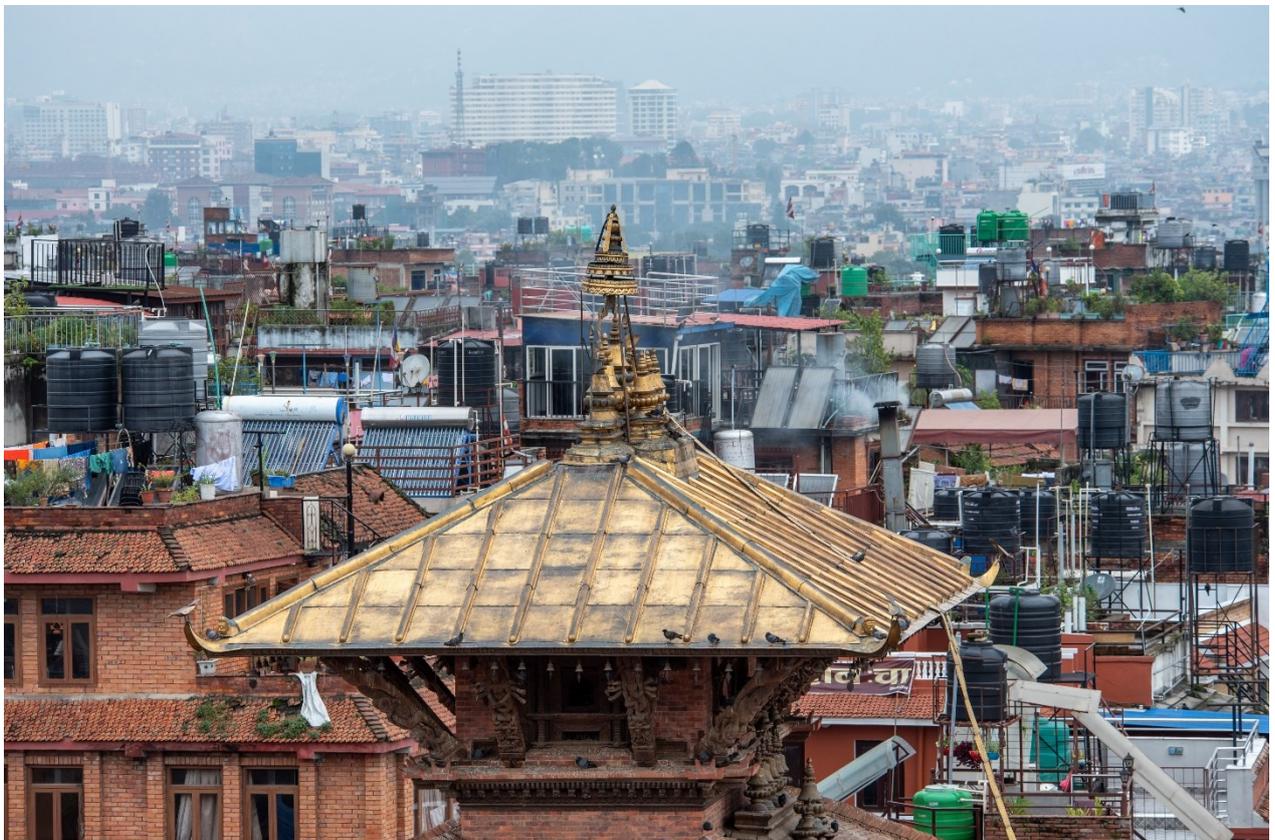
Fig. 22: Bhimsen Temple, top roof, after conservation, 2024 © Bikash Khadghi

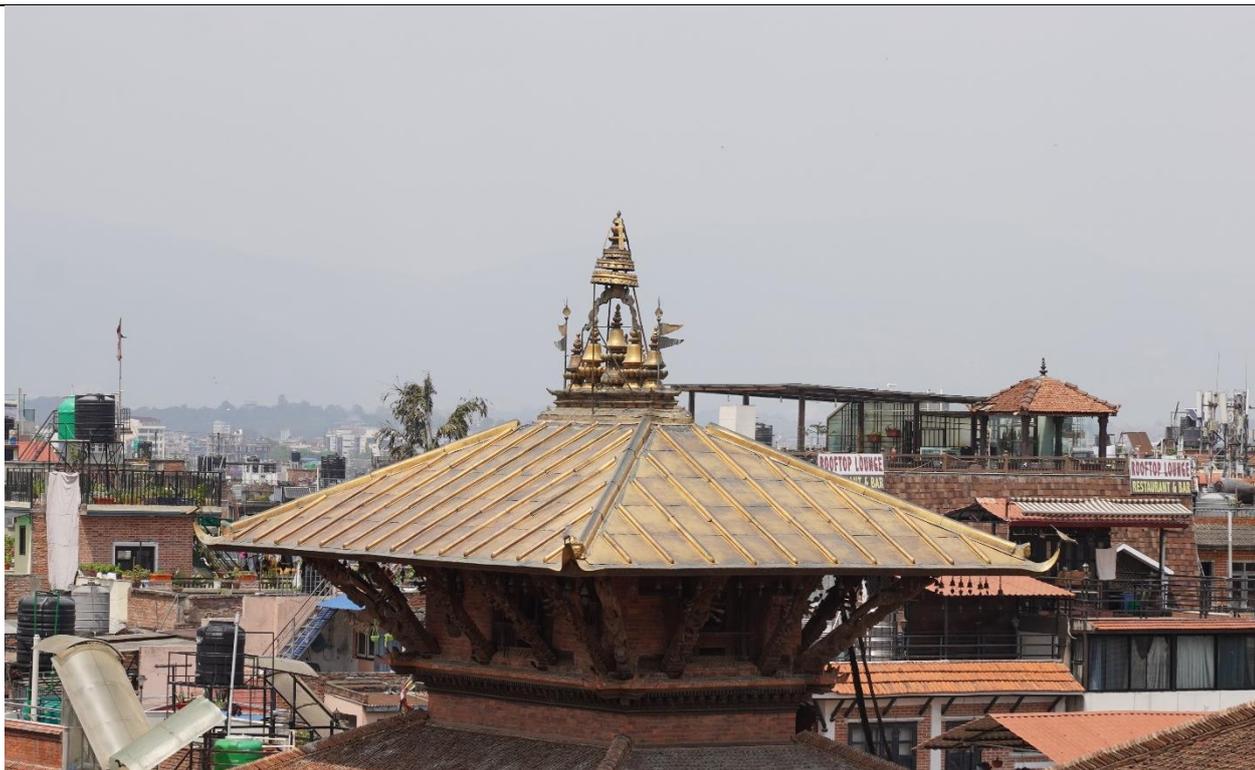
The IoC did not implement any technical measures (e.g. closing cracks) in 2019-2020. The surface treatments that were carried out have proved to be stable over time. The pinnacles show partial darkening, however the overall appearance blends in well with the surroundings. The pinnacles on the two lower levels were not cleaned, so that they have a dark appearance in comparison due to dust and dirt deposits.

Deposits (soiling and especially bird droppings) can be found on the surface and are a major cause of corrosive reactions. In this respect, maintenance is the key to the long-term preservation of the sculpture. Regular cleaning and removal of bird droppings must be considered by the local community as the most important factor in long-term conservation. Where citric acid is used to chemically reduce corrosion, it is essential that the surface is thoroughly rinsed after cleaning, as acidic residues accelerate corrosive reactions.

Fig. 2: Top roof of Bhimsen Temple in May 2024

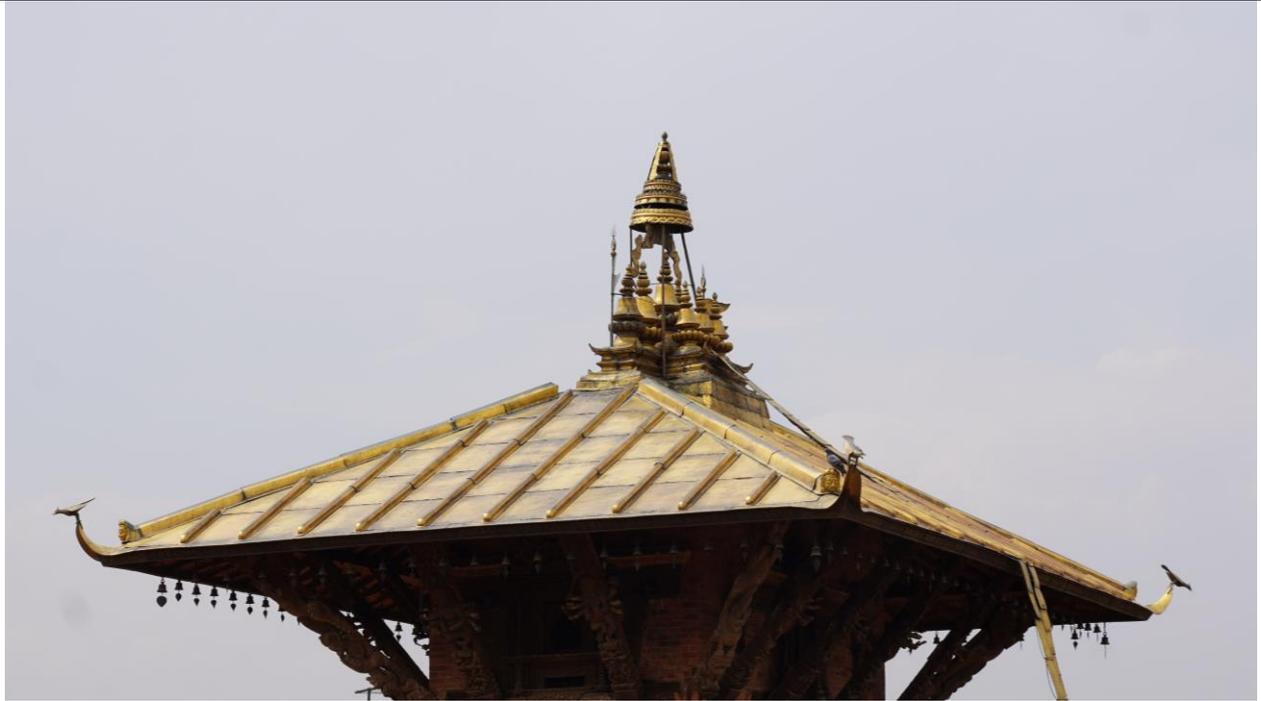
Fig. 3: Top roof of Bhimsen Temple in May 2024
