DEGUTALE TEMPLE – METAL ELEMENTS

Report of the Institute of Conservation (IoC), University of Applied Arts Vienna

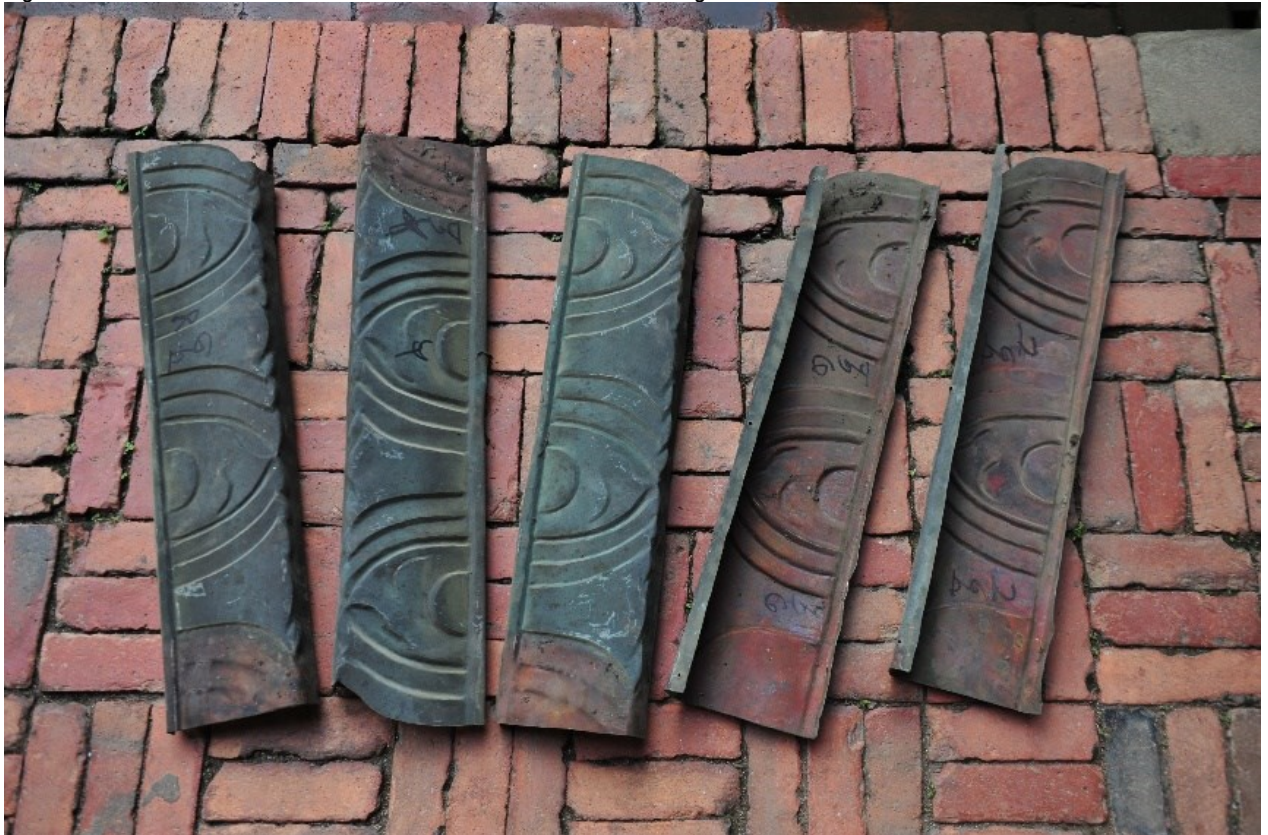
Fig. 6: Some copper sheets were already "restored"

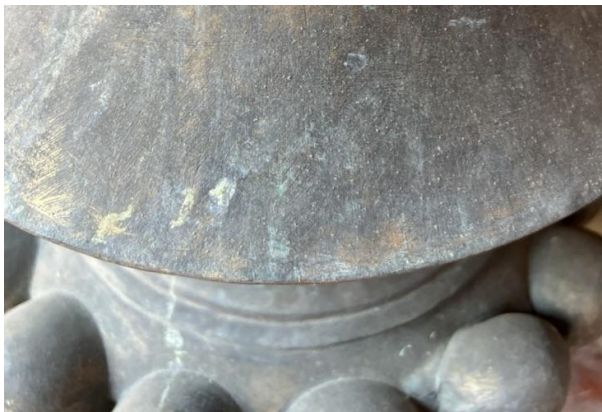
Fig. 7: Soiled and corroded surfaces

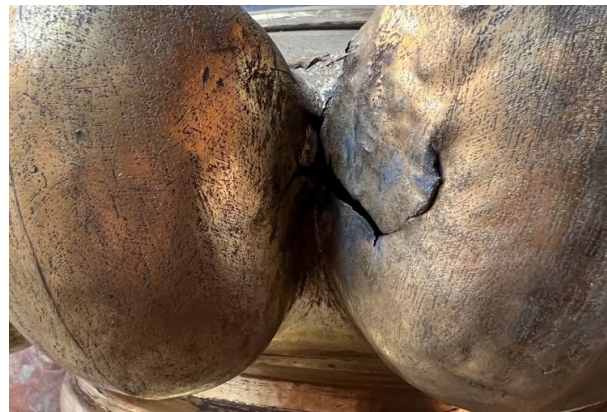
Fig. 8: Deformations and cracks

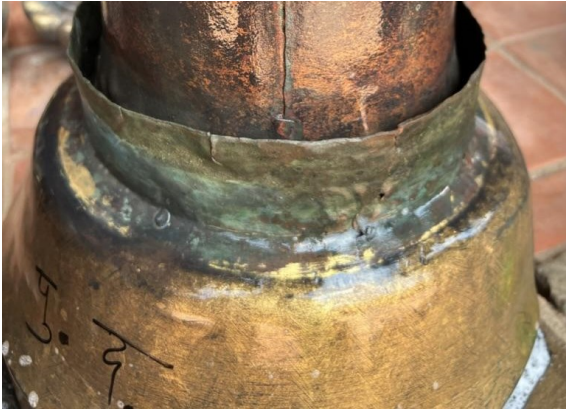
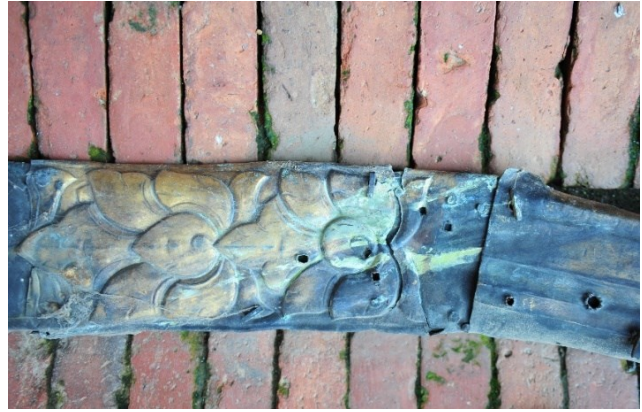
Fig. 9 and Fig. 10: Examples of corrosion: Dark brown copper oxide

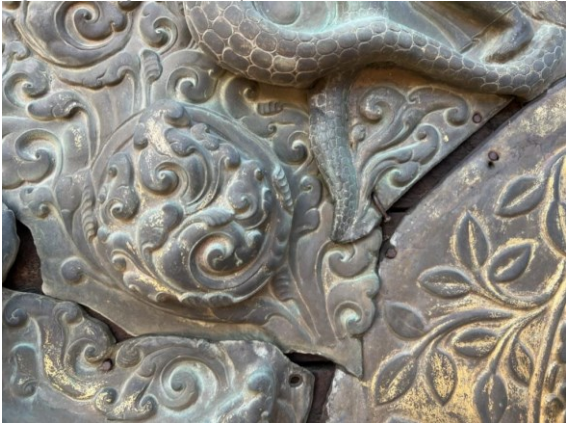
Fig. 11: Gilded surface lost in great parts

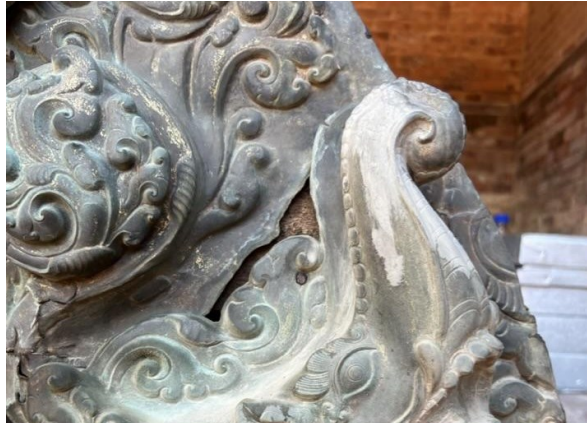
Fig. 12: Surface covered with dirt

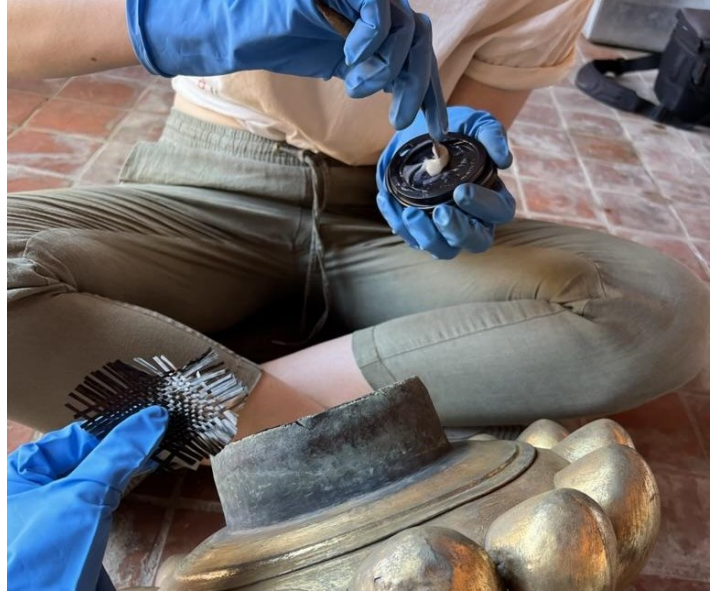
Fig. 14: Preparing the resin for closing the hole

- Dry cleaning with rough brushes in different sizes
- Wet cleaning with water, surfactant and different brushes and sponges
- Reducing copper corrosion on the fire gilded surface with citric acid and rough brushes
- Holes were closed with epoxy resin and carbon-fibre
- Polishing the surface with cotton towels
- Regilding of areas with bare copper with gold leaves using oil size (Mixture)

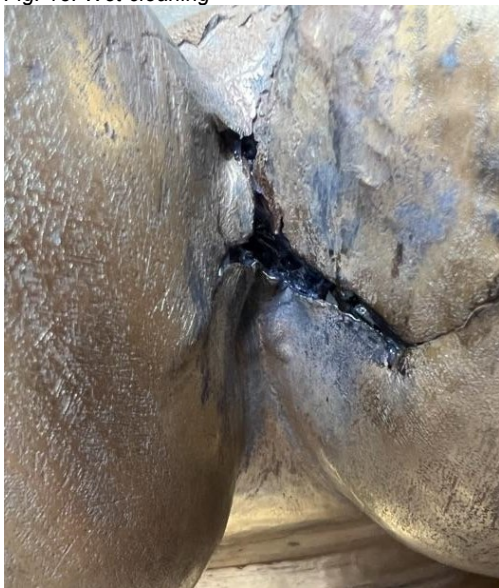
Fig. 15: Hole with backing made out of carbon fibre

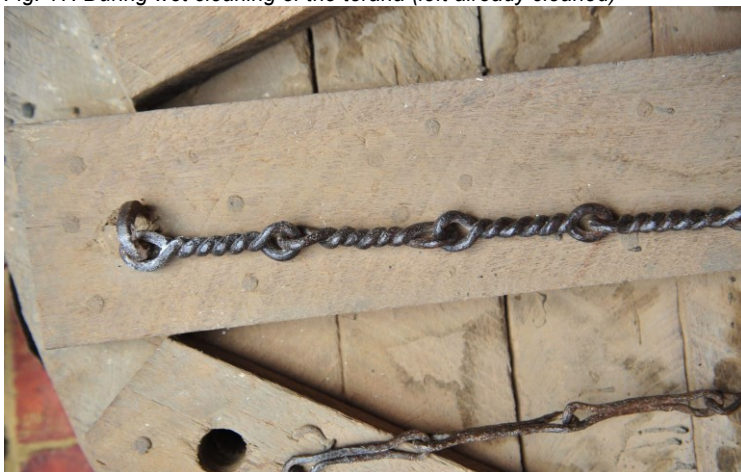
Fig. 19: Iron chains after conservation

- Dry cleaning with rough brushes of different sizes
- Wet cleaning of metal parts with water, different brushes and sponges
- Reducing of copper corrosion on the fire gilded surface with citric acid (3% in water) and rough brushes
- Reducing of rust on iron chains with micromotor (iron brushes)
- Polishing of the surface with micromotor (brass brushes, nylon brushes)
- Coating of iron chains with a layer of microcrystalline wax

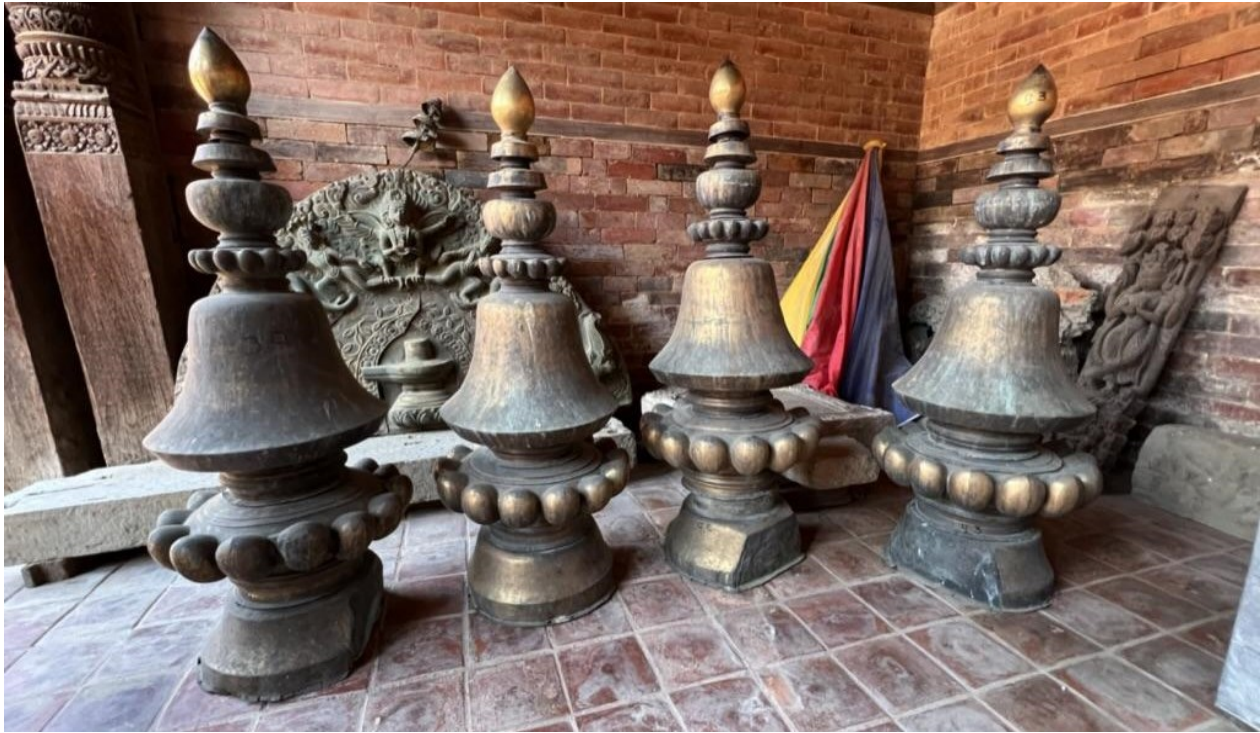
- heavy corrosion on exposed copper parts due to environmental pollutants (particularly in conjunction with rainwater)
- selective corrosion on areas with damaged fire gilding (e.g., microcracks, unburnished parts of the porous fire-gilded surface) that are directly exposed to rain, whereas surfaces on the undersides of the parts are often fully intact
- mechanical damage: deformations and holes in some parts
- surfaces covered with dust, grime and bird droppings

Fig. 20: Pinnacles before conservation

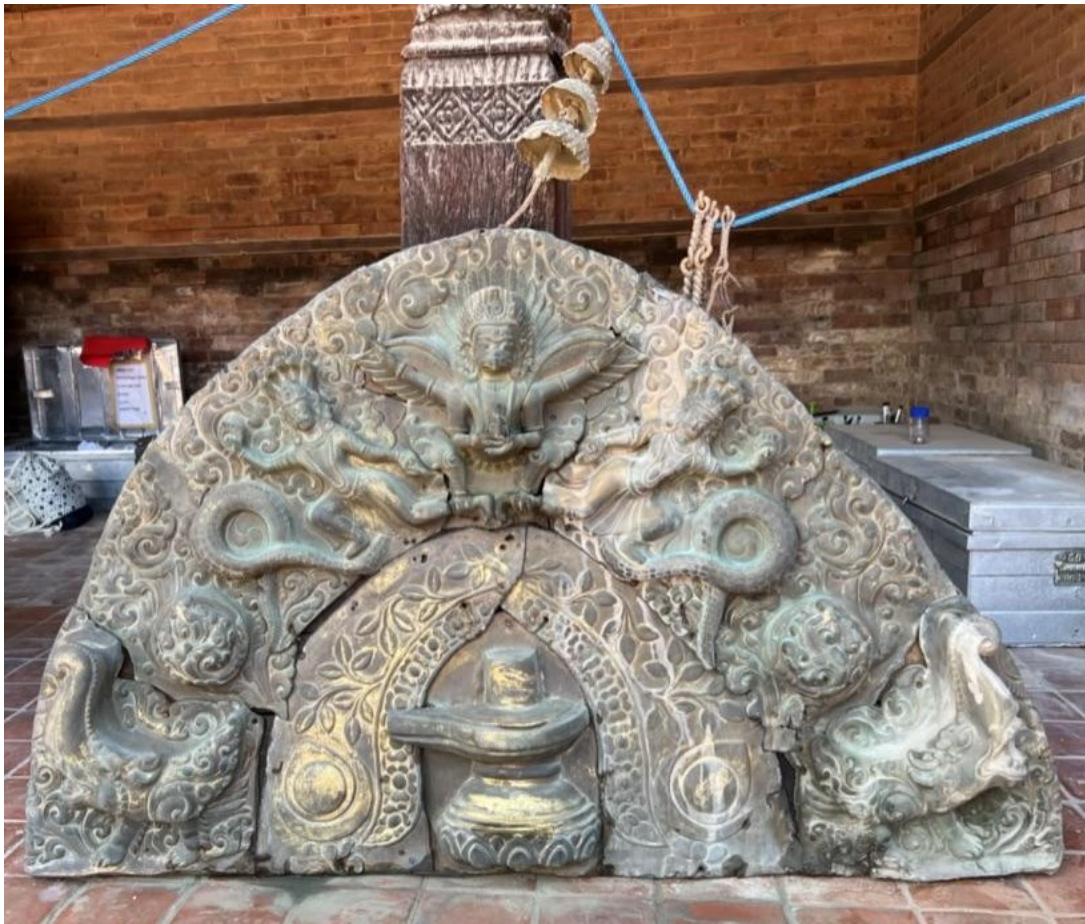
- bright green corrosion products mainly accumulated in crevices and overall dark brown copper oxide on copper surfaces, corrosion due to reaction of the surface with environmental pollutants
- iron chains on the backside rusted, due to high humidity
- gilded surface mostly weathered off, only few areas with fully intact gilding left
- slight mechanical damage such as deformation
- surface covered with accumulation of dirt and dust as well as bird droppings

Fig. 22: Torana before conservation

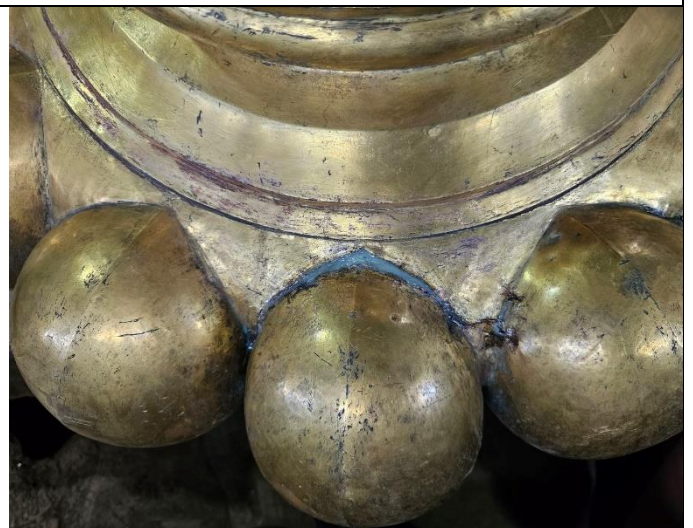
Fig. 4: Large crack in the pinnacle glued with epoxy resin and a fitted copper sheet, 2023

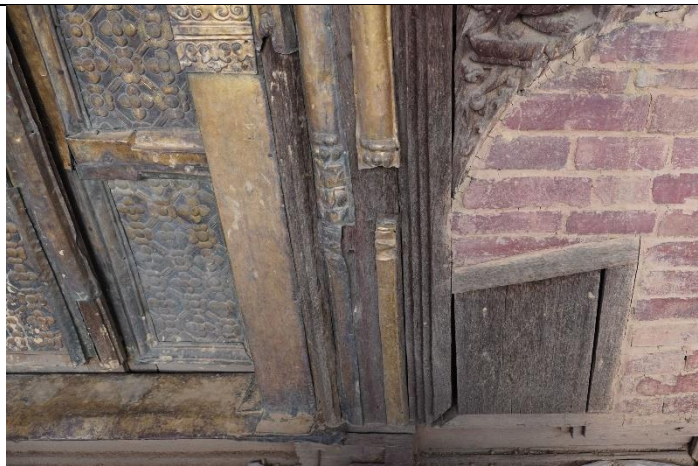
<input type="checkbox"/> Broken / - into several Pieces	<input type="checkbox"/> Many <input type="checkbox"/> Some <input type="checkbox"/> Few	
Comment:		
<input checked="" type="checkbox"/> Loose / Missing Parts	<input type="checkbox"/> Many <input checked="" type="checkbox"/> Some <input checked="" type="checkbox"/> Few	<u>Torana:</u> - around 20 nails are missing - top piece (tiny pinnacle on top of the umbrella) is missing <u>Door:</u> - lower area and base copper sheets are missing - sheets on the side and middle areas on the frame left and right of the door are missing too <u>Window:</u> - 2 cracks

Fig. 3: Missing elements in the lower area of the door, May 2024

The implement technical measures (e.g. reshaping of deformations, replication of missing parts, replacement of loose elements, riveting of copper sheet patches to close cracks, replacing missing nails with brass rods) is still to be carried out by local coppersmiths.

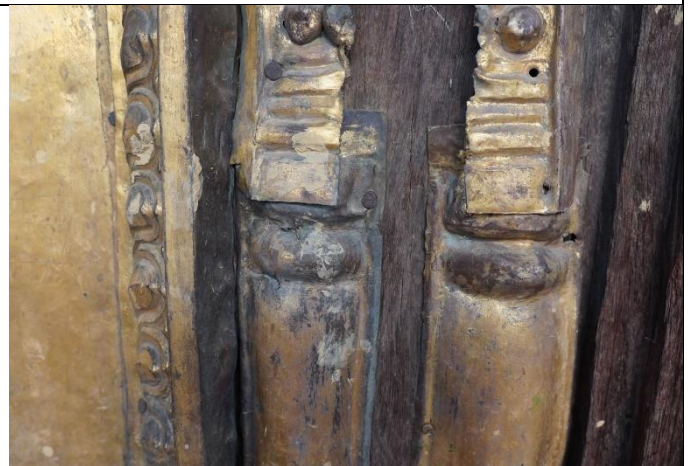
Fig. 4: Missing nails and iron nails for fixing the copper sheets to the door, May 2024

Deposits (soiling, bird droppings) that accumulate on the surface over time are a major cause of corrosive reactions. In this respect, maintenance is the key to the long-term preservation of the Degutaleju metal elements. Regular cleaning and removal of bird droppings must be considered by the local community as the most important factor in long-term conservation. Where citric acid is used to chemically reduce corrosion, it is essential that the surface is thoroughly rinsed after cleaning, as acidic residues accelerate corrosive reactions. It is recommended that the copper sheet metal elements of the door are dismantled for reshaping and cleaning. All iron nails should be replaced with brass or copper nails. Some abraded areas should be retouched with oil gilding.

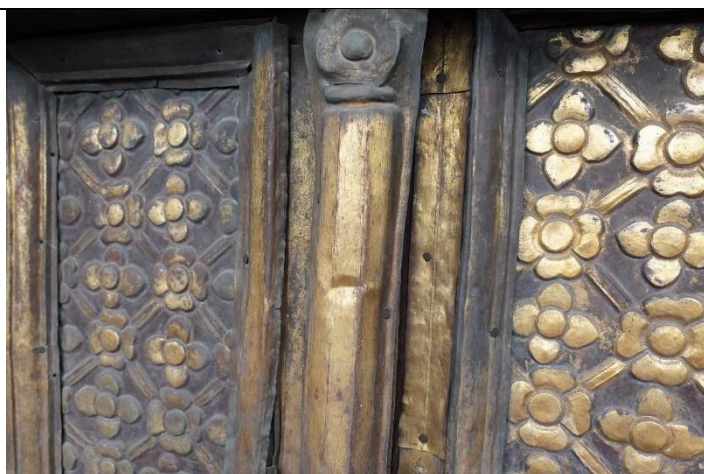
Comment: all cracks have been glued with epoxy resin and carbon fibre last year		
<input checked="" type="checkbox"/> Deformation / Dents	<input type="checkbox"/> Major <input type="checkbox"/> Medium <input checked="" type="checkbox"/> Minor	<u>Torana:</u> - umbrella on top - right Makara's snout - along the right upper edge <u>Door:</u> - some d., especially in the centre of the door on the baffle plate and on the step plate <u>Window:</u> - some minor deformations

Fig. 5: Deformation on the baffle plate in the centre of the door, May 2024

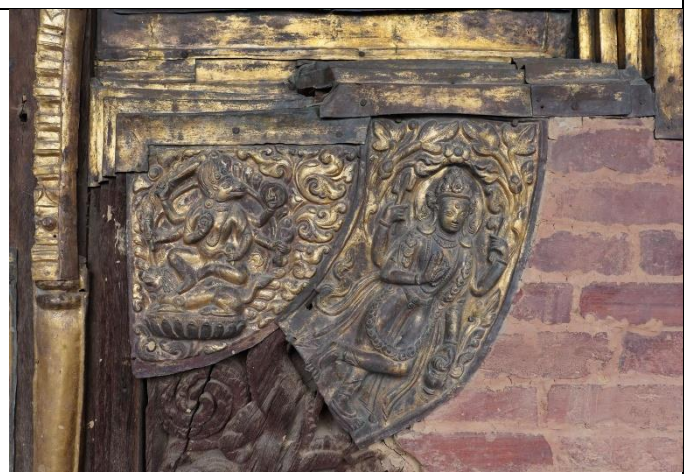
- whole surface shows some abraded areas with w.o.g., especially on the upper frame with the three deities, the four deities on the side and the centre baffle plate of the door
Window:
- secondary paint on top of the gilded copper sheet

Fig. 6: Abraded areas / worn out gilding on the copper sheet repousse on the sides of the door, May 2024

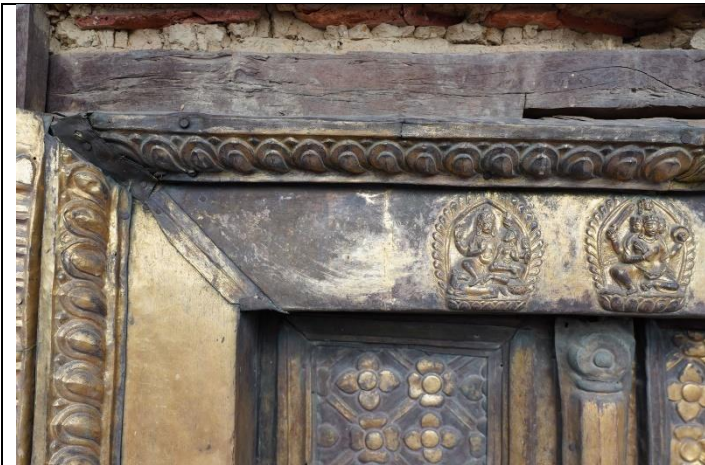
Fig. 7: Abraded areas / worn out gilding on the upper frame of the door, May 2024

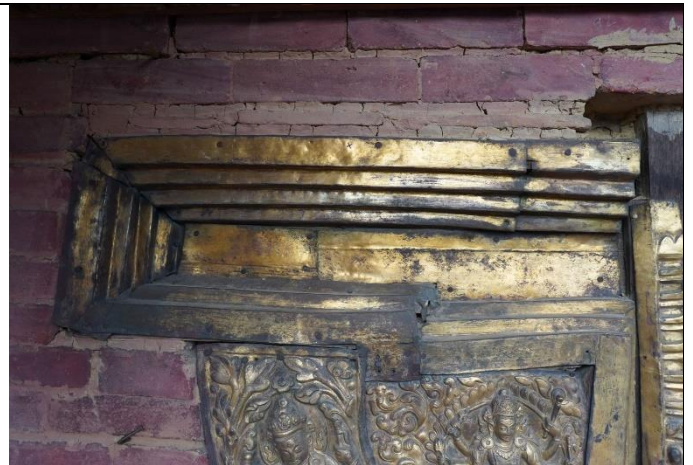
Fig. 8: Abraded areas / worn out gilding on the copper sheet repousse on the sides of the door, May 2024

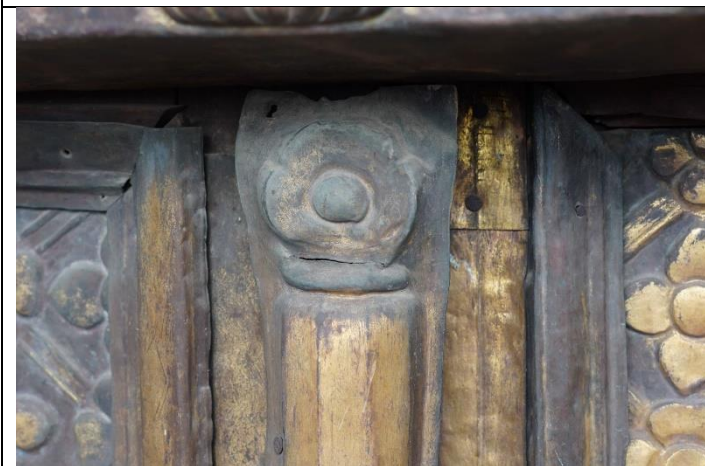
- darkening of w.o.g. areas
- green corrosion especially on the lower area of the door

Fig. 9: Partial green corrosion on some door elements, May 2024

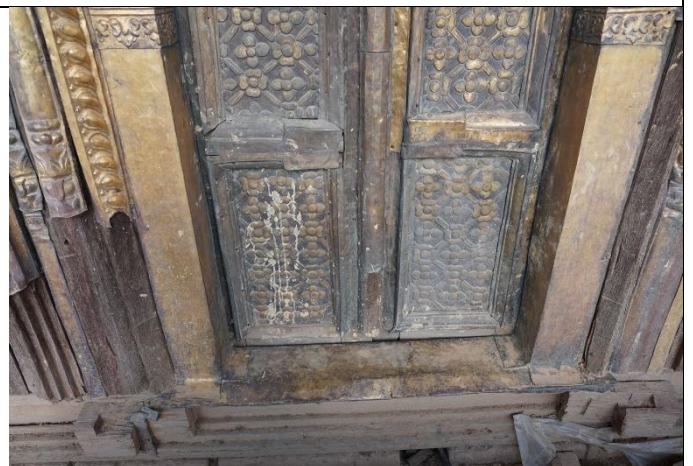
- dirt accumulation due to the construction work, especially in the lower areas

The surface treatments carried out by the IoC on some elements in 2022 and 2023 are generally in good condition, but much dust has accumulated on the surface due to the surrounding construction work and missing dust covers. It is expected that the gilded surface, which has been cleaned with citric acid, will darken over time, particularly in areas of worn gilding.

Fig. 10: Door covered in dust from construction work, May 2024

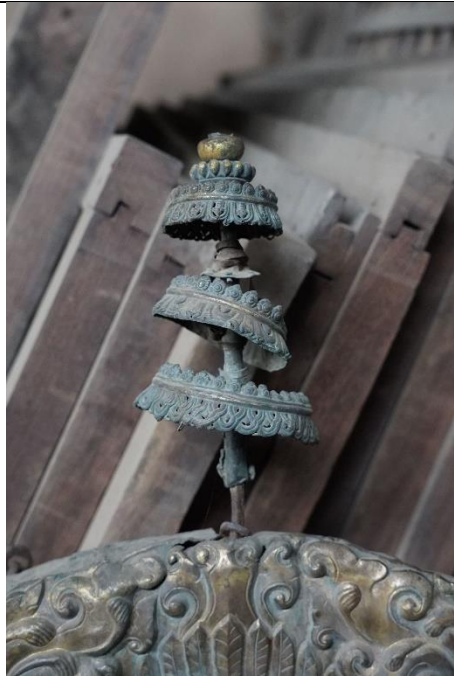
Fig. 13: Missing small pinnacle on top of the umbrella and deformations, May 2024

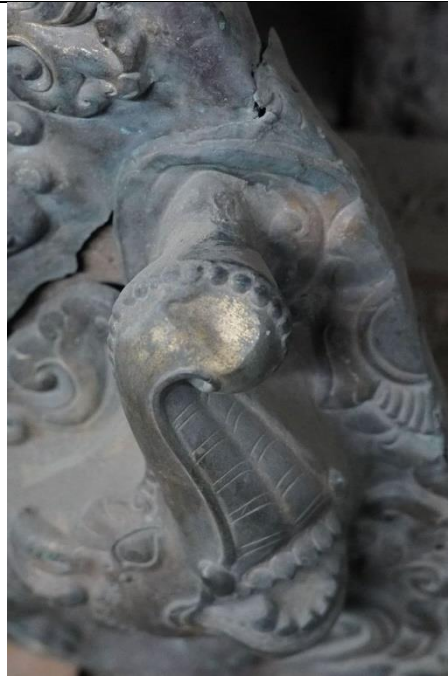
Fig. 14: Deformation on the Makara's snout, May 2024

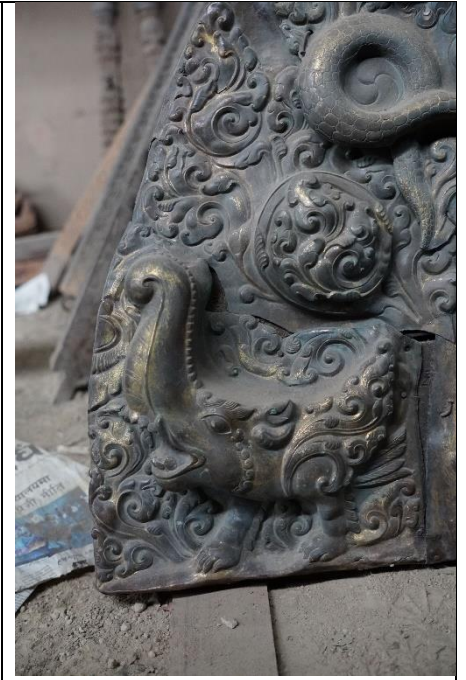
Comment: reshaped last year by local craftsmen		
<input checked="" type="checkbox"/> Abrasion / Worn out Gilding	<input type="checkbox"/> Major <input type="checkbox"/> Medium <input checked="" type="checkbox"/> Minor	<u>Torana:</u> - most gilding worn out → around 70-80% <u>Door:</u>

Fig. 15: Darkening due to worn out gilding over the entire surface, May 2024

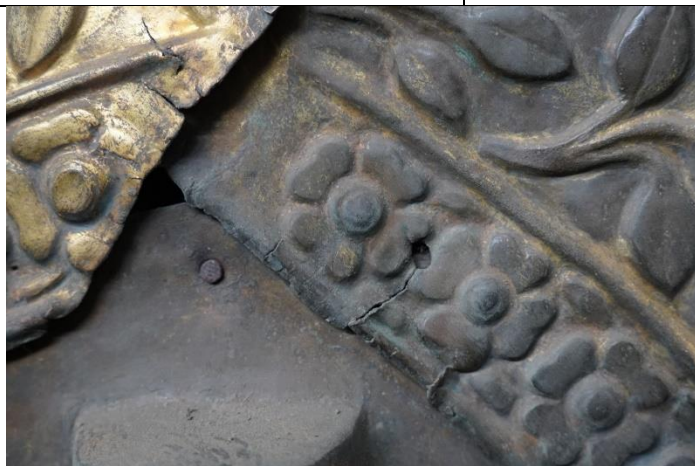
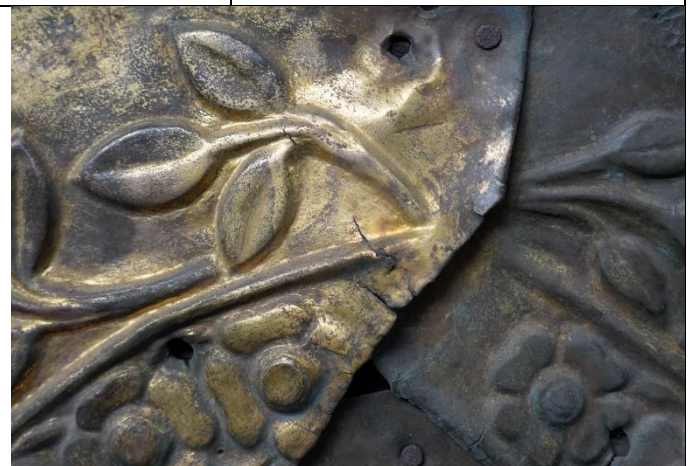
Comment:		
<input checked="" type="checkbox"/> Cracks / Holes	<input type="checkbox"/> Many <input checked="" type="checkbox"/> Some <input checked="" type="checkbox"/> Few	<u>Torana:</u> - around 25 cracks <u>Door:</u> - Some small cracks all over the copper sheets <u>Window:</u> - 2 cracks

Fig. 16: Cracks in the Torana's copper sheet repousse, May 2024

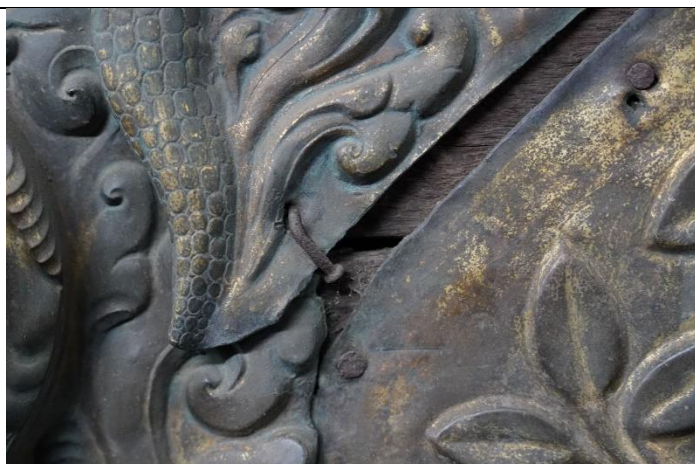
- darkening in w.o.g. areas
- slight green corrosion in indentations
- iron nails corroding

Fig. 18: Iron nails for fixing the copper sheets to the torana, May 2024

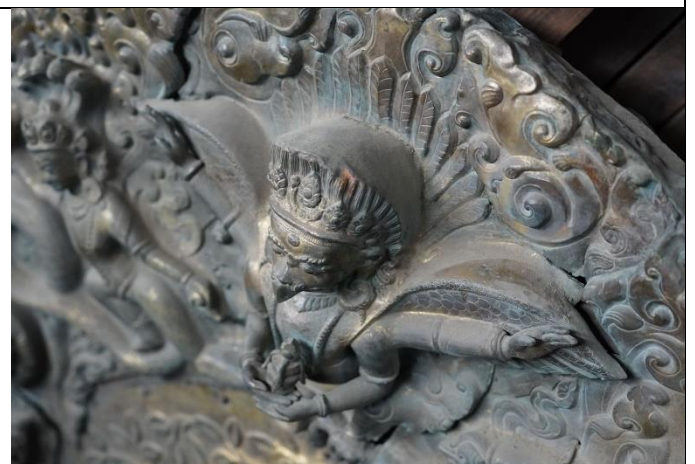
Fig. 19: Dust, abraded areas and tika residues on the torana, May 2024

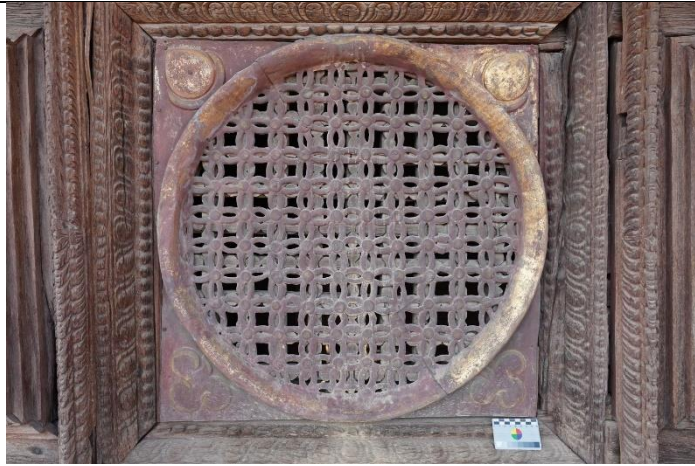
Fig. 20: Condition of the window after partial removal of the secondary paint on the fire-gilded surface, May 2024

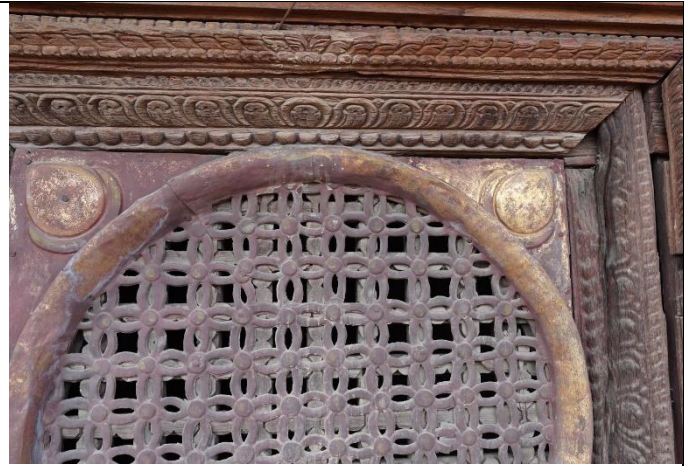
Fig. 21: Window covered in dust from construction work, May 2024

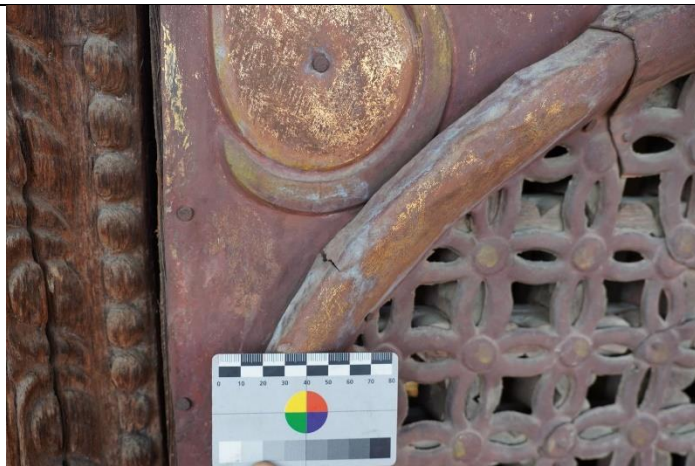
Fig. 22: Crack in the copper sheet repousse of the window, May 2024

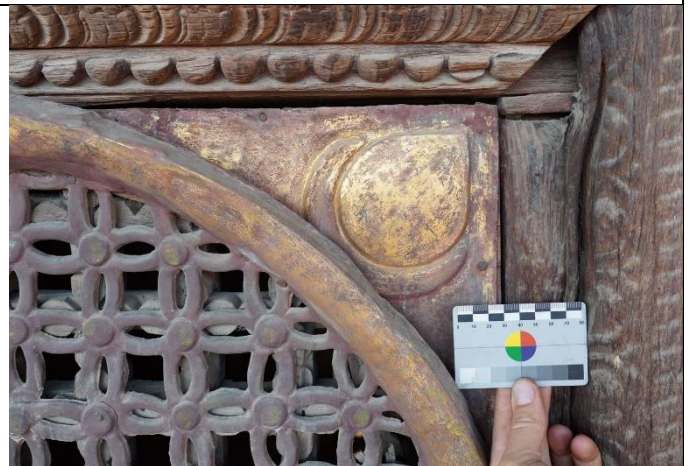
Fig. 23: Detail of the gilding beneath the secondary red painting, May 2024
