GARUDA PILLAR

Report of the Institute of Conservation (IoC), University of Applied Arts Vienna

GENERAL INFORMATION

Condition Assessment

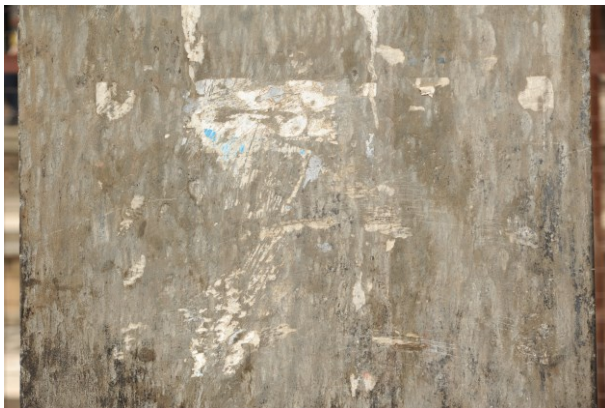
- Soiling (loose deposits of dust and dirt, pigeons' droppings), particularly at the lower area of the pillar also wax stains, Tikka paste, and different kind of paper labels
- Graffiti and scratches in the lower areas
- Partial thin black crust on stone surface
- Open joints
- Small cracks
- Biological colonization at joints (moss)

Fig. 8: Applied labels at the lower area of column

- Dry cleaning (mechanical removal of loose deposits with brushes and spatulas)
- Combination of chemical-mechanical cleaning with detergent-solution in water by using brushes and non-woven web
- Filling of cracks with mortar based on natural hydraulic lime and sand
- Pointing of joints with a mortar based on natural hydraulic lime and different sands, mortar was applied above level and scratched off to the stone level after pre-curing
- Retouching of joint mortar in aqua sporca technique using dust particles and fine sand grains in water with 5% acrylic resin (Primal)

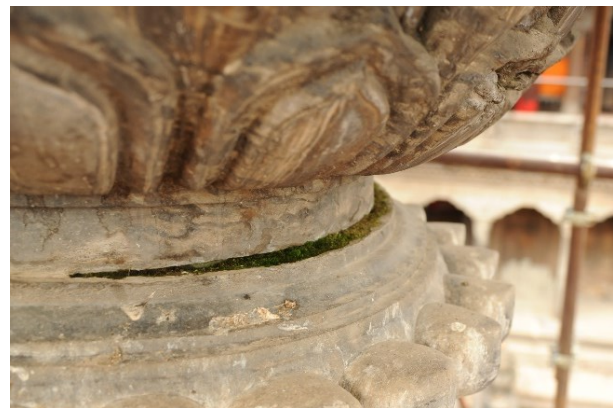
Fig. 9: Moss growth within joint

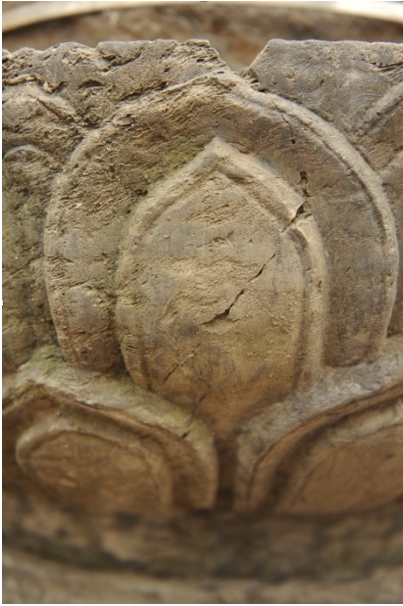
Fig. 10: Small crack

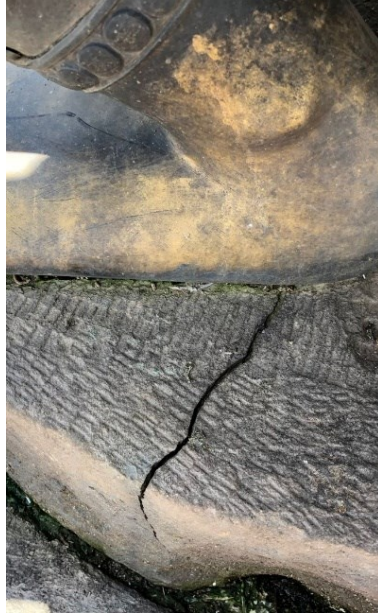
Fig. 11: Crack at the plinth

Fig. 22: Filling of crack in plinth with mortar

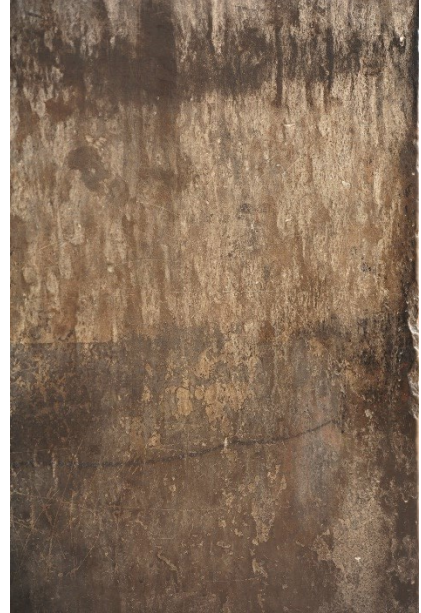
Fig. 12: Partial black crust on stone

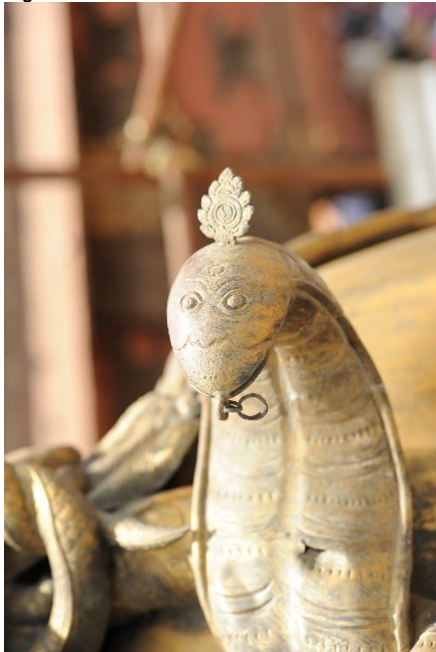
Fig. 13: Detail of metal part with hole

- Dry cleaned
- Wet cleaning by using detergent solution and brushes
- Mechanical removal of corrosion products on metal ring and sculpture
- Closing of cracks and holes in metal surface with epoxy resin (Akepox)
- Tightening and fixing the existing metal ring

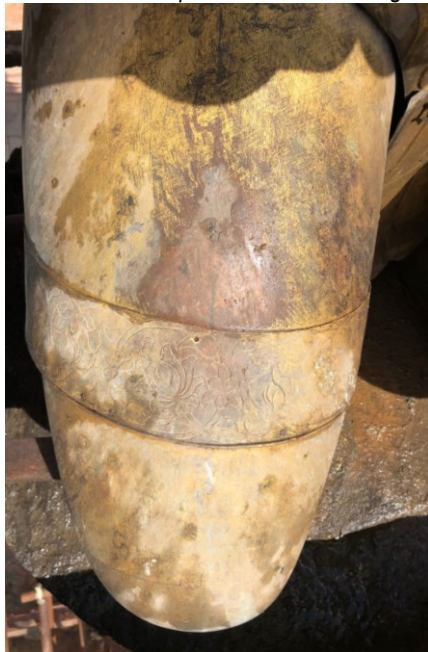
Fig. 14: Partly lost gilding

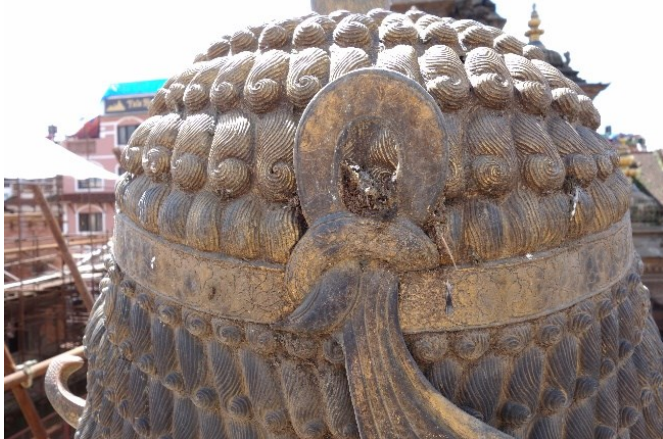
Fig. 15: Soiling on the head of Garuda

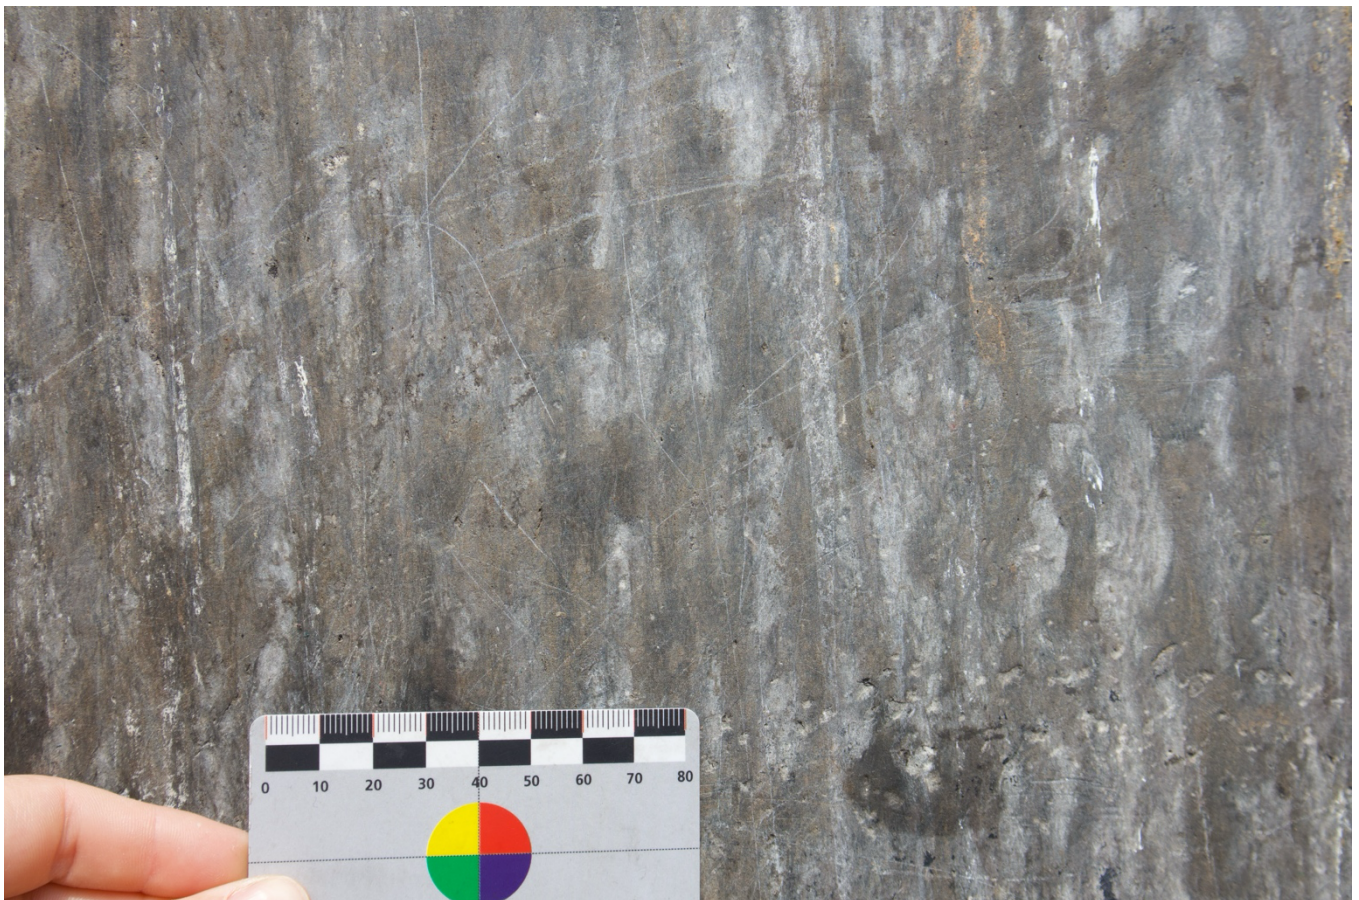
<input checked="" type="checkbox"/> Mechanical Damage <input type="checkbox"/> Not detected	<input type="checkbox"/> Abrasion	<input type="checkbox"/> Major	_____
		<input type="checkbox"/> Medium	_____
		<input type="checkbox"/> Minor	_____
	<input checked="" type="checkbox"/> Other	<input type="checkbox"/> Major	_____
		<input checked="" type="checkbox"/> Medium	Fine scratches were found on all sides of the shaft of the pillar, from bottom to top (Fig. 1)
		<input type="checkbox"/> Minor	_____

Dark crusts on the stone, specifically under the lotus seat in the shape of drips (“Rinnsuren”) (Fig. 3).
Iron belt shows corrosion, but no rust stains are visible on the floor (Fig. 3)
Fine scratchings on the surface due to abrasive cleaning?
Pillar acts as perch for pigeons

Fig. 1: Scratches on the stone surface.

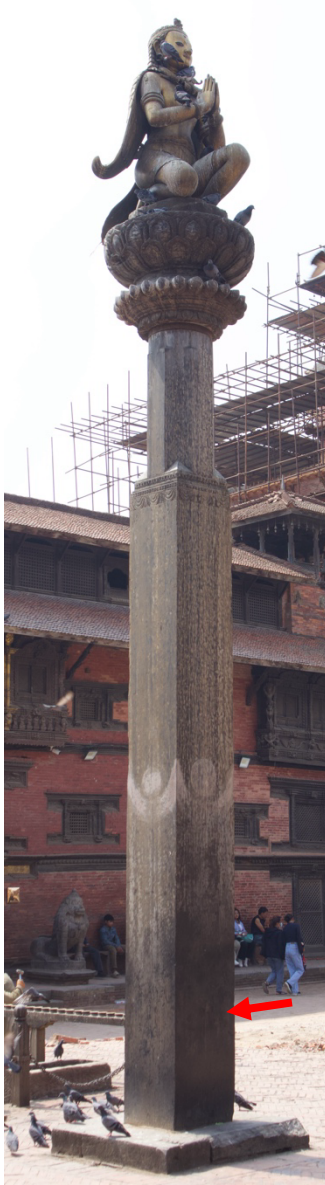
<input checked="" type="checkbox"/> Light	Mostly in lower areas of the pillar, particularly human-caused soiling such as oil and greasy substances (Fig. 2)
Comment:		
<input checked="" type="checkbox"/> Other	Comment: Vertical crack running through the lower shaft on the south side

Fig. 2: Darkened area due to oil and other greasy substances.

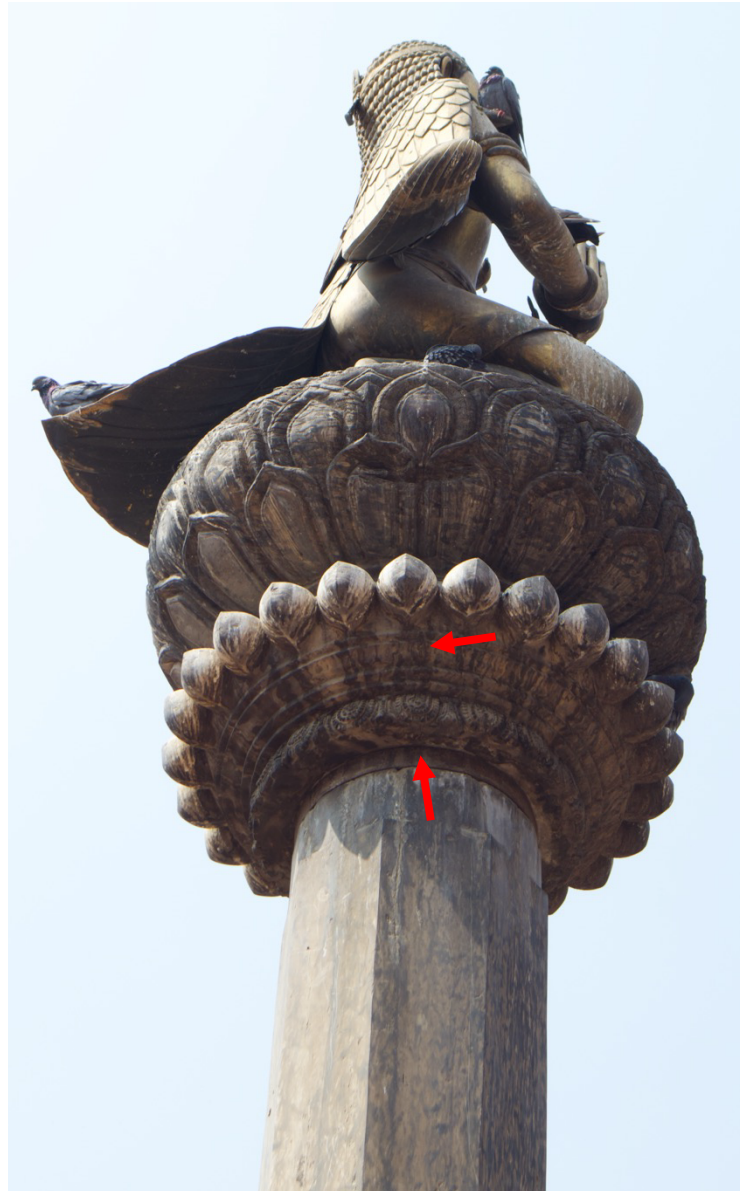
Fig. 3: Dark grey drips under the lotus seat, and rusted iron rim.

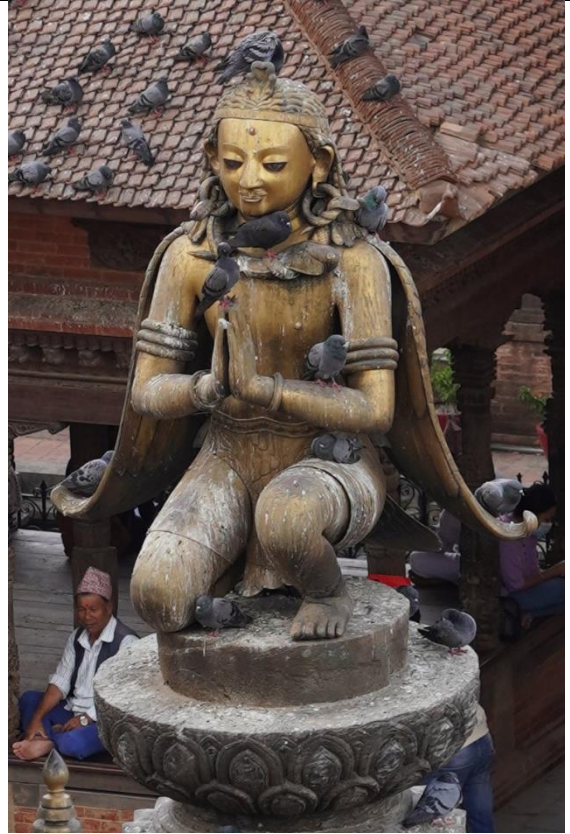
Comment:			
<input checked="" type="checkbox"/> Abrasion / Worn out Gilding	<input type="checkbox"/> Major <input type="checkbox"/> Medium <input checked="" type="checkbox"/> Minor	- Especially on upper thighs and left knee - Also on lower arms, lower thighs, jewellery, crown decoration, hind end of the three wings (especially on tail feather), middle fingertips (black copper visible)

Comment:			
<input checked="" type="checkbox"/> Corrosion	<input type="checkbox"/> Major <input type="checkbox"/> Medium <input checked="" type="checkbox"/> Minor	- Darkening especially on tail feather and legs - Also on chest, arms, shoulders (gutter-shaped) and jewellery - Green corrosion not visible from afar

Comment:			
<input checked="" type="checkbox"/> Soiling	<input checked="" type="checkbox"/> Dust	<input checked="" type="checkbox"/> Heavy <input type="checkbox"/> Medium <input type="checkbox"/> Light	- Matt appearance of the whole surface due to dust layers
	<input checked="" type="checkbox"/> Dirt	<input checked="" type="checkbox"/> Heavy <input type="checkbox"/> Medium <input type="checkbox"/> Light	- Heavy soiling due to numerous bird droppings (especially on upper thighs, but also on arms, right bangle, chest, snake, head and wings)

The surface treatments have proven to be stable over time. The appearance of the sculpture is very matt due to heavy dirt deposits. Countless birds sit on the object every day. As a result, the surface also shows worn gilding and therefore extensive darkening in exposed areas (e.g. upper thighs, hind end of the wings). Deposits (soiling and especially bird droppings) are also a major cause of corrosive reactions. In this respect, maintenance is the key to the long-term preservation of the sculpture. Regular cleaning and removal of bird droppings must be considered by the local community as the most important factor in long-term conservation. Where citric acid is used to chemically reduce corrosion, it is essential that the surface is thoroughly rinsed after cleaning, as acidic residues accelerate corrosive reactions.

Fig. 2: Garuda sculpture, front, in May 2024

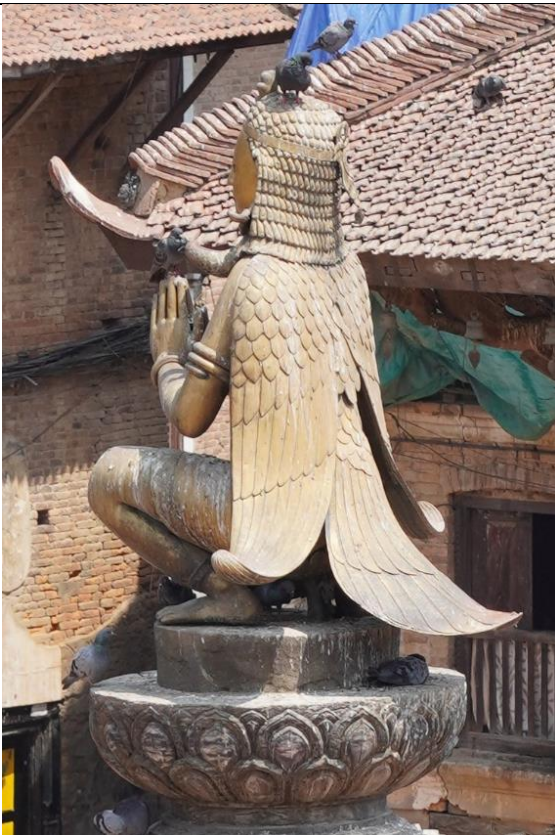
Fig. 3: Garuda sculpture, side view, in May 2024

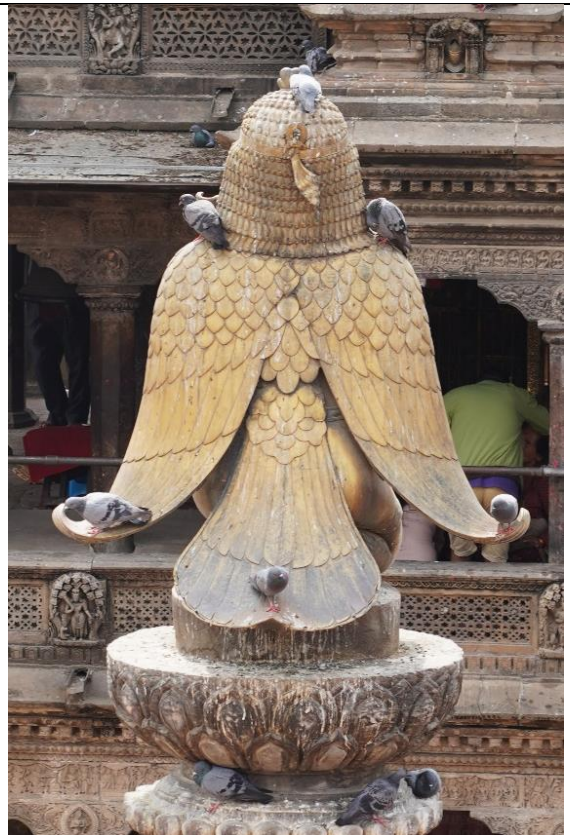
Fig. 4: Garuda sculpture, back, in May 2024
