GOLDEN DOOR AND WINDOW, PATAN MUSEUM

Report of the Institute of Conservation (IoC), University of Applied Arts Vienna

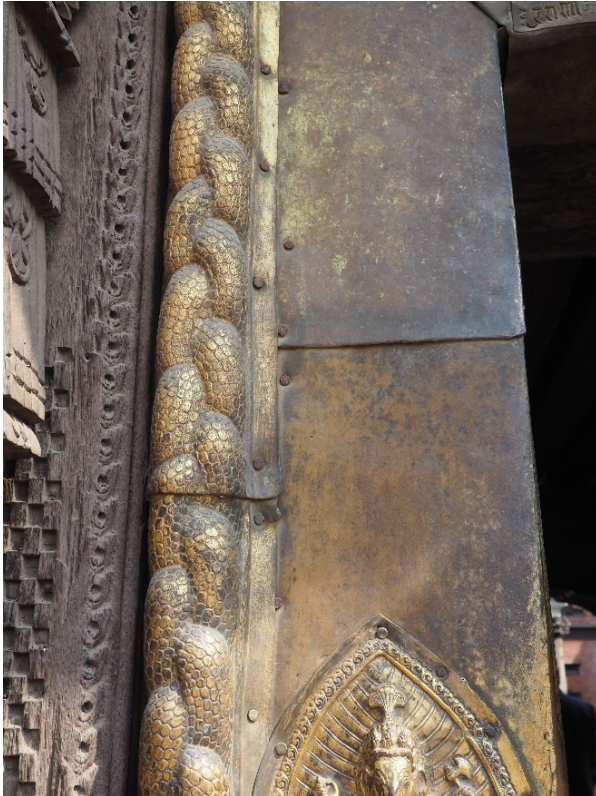
Fig. 6: Worn gilding

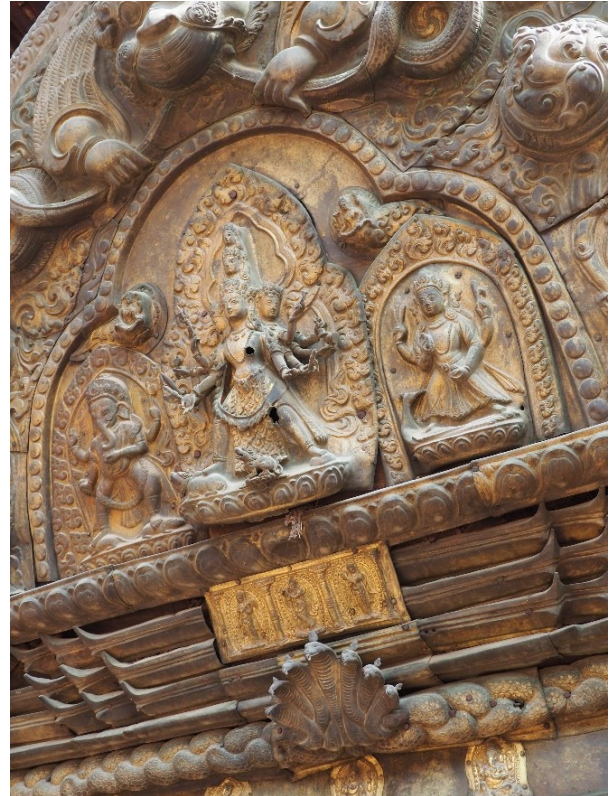
Fig. 7: Holes in the torana

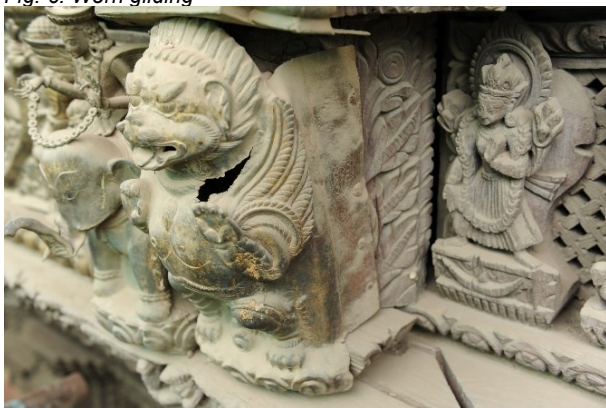
Fig. 8: Holes and corrosion on metal elements of Window

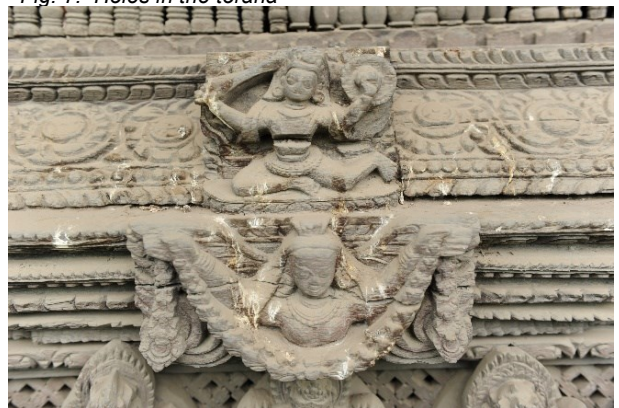
Fig. 9: Soiling on wooden carvings of Window

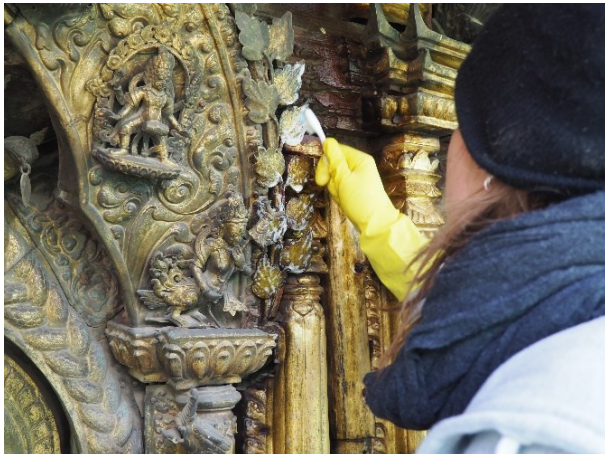
Fig. 10: Wet cleaning of Golden Window

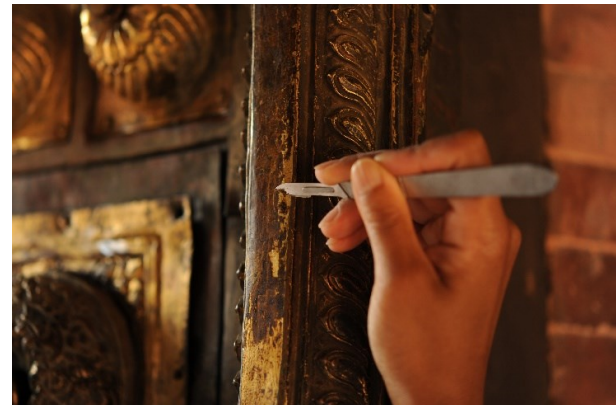
Fig. 13: Mechanical removal of corrosion

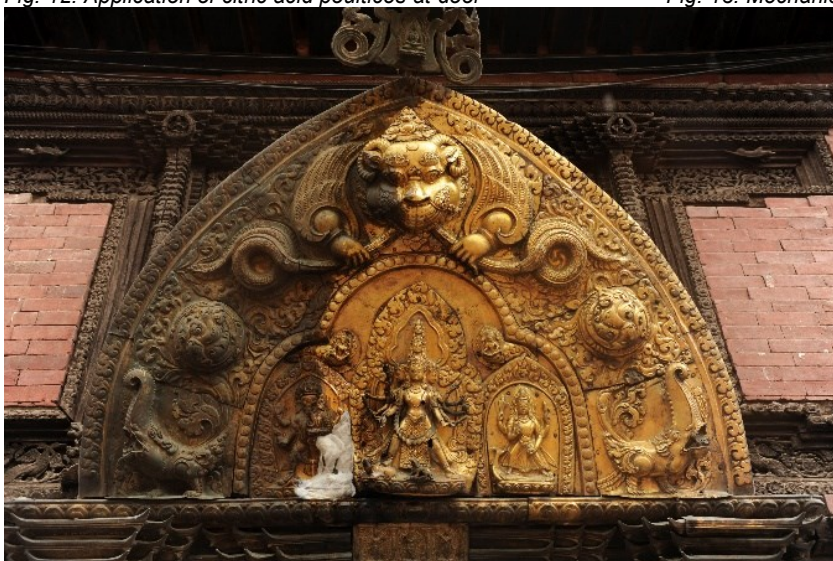
Fig. 14: Torana during cleaning

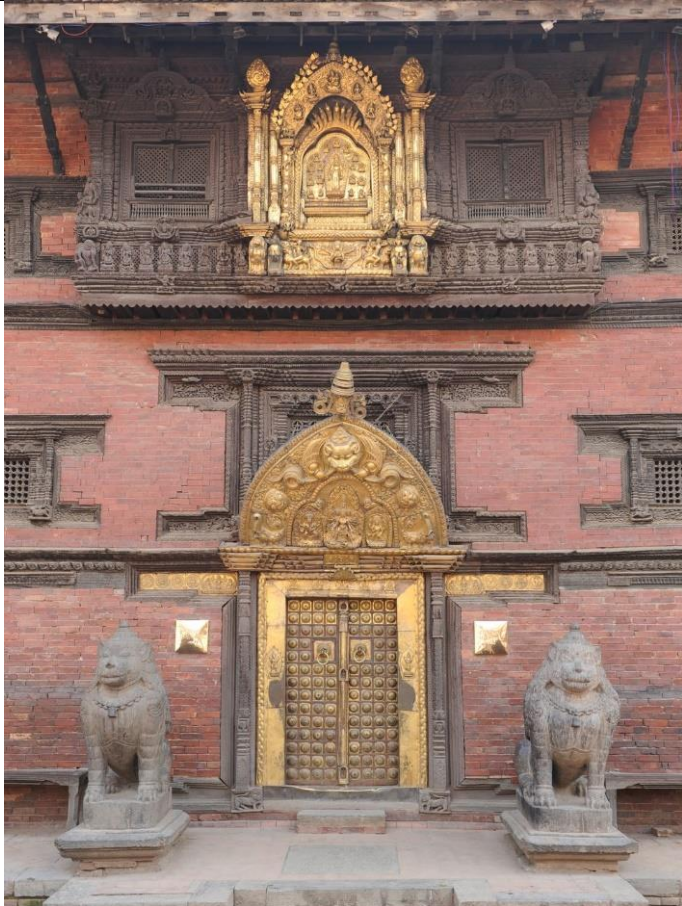
Fig. 1: Golden Door, Torana and Window after conservation, 2019

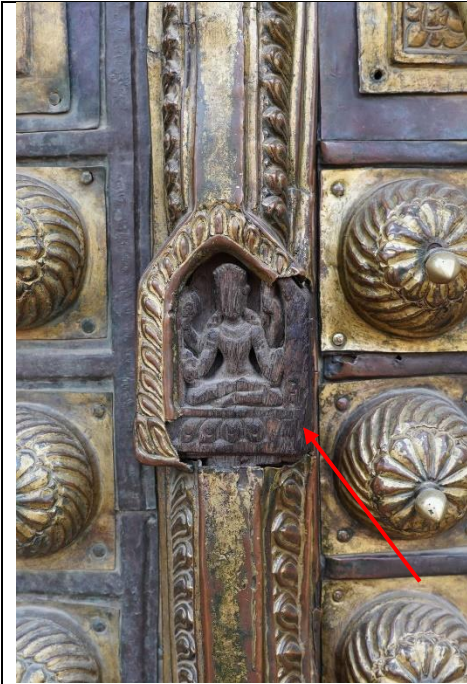
Fig. 11: Missing chased ornament (red arrow) on the middle part of the baffle plate

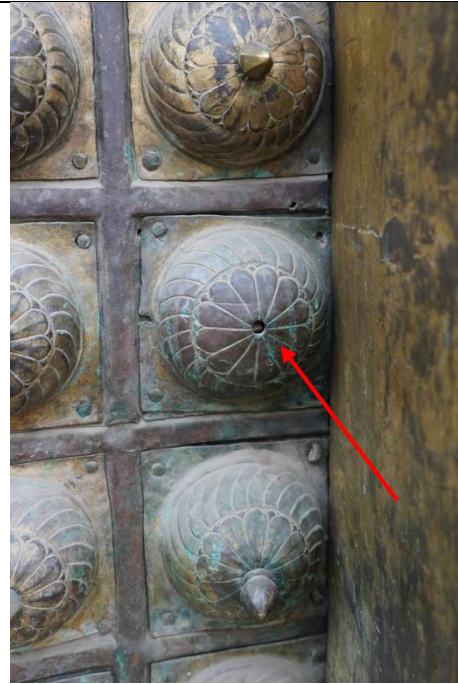
Fig. 12: Missing knob screw (red arrow) and green corrosion on the right door wing

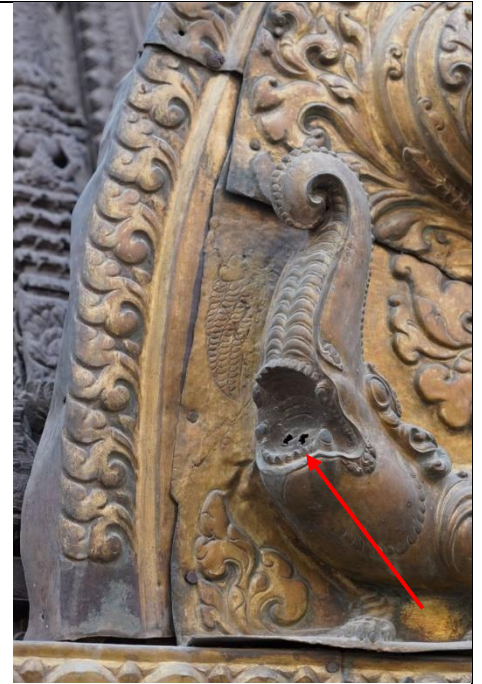
Fig. 13: Missing water spout (red arrow) on left Makara on Torana

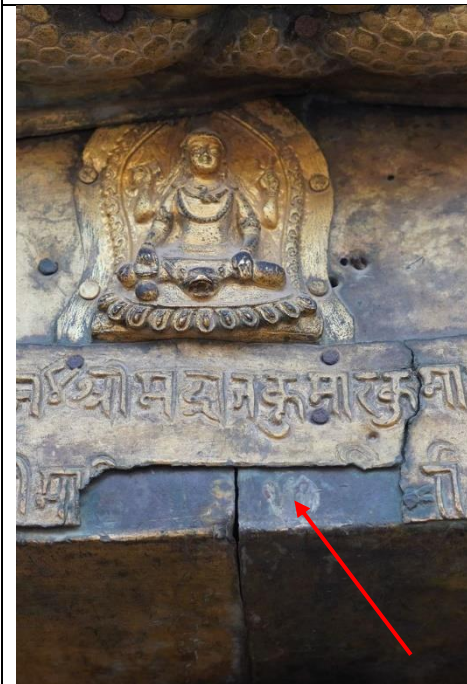
Fig. 14: Missing inscription (red arrow) and nails as well as cracks on the upper door wing

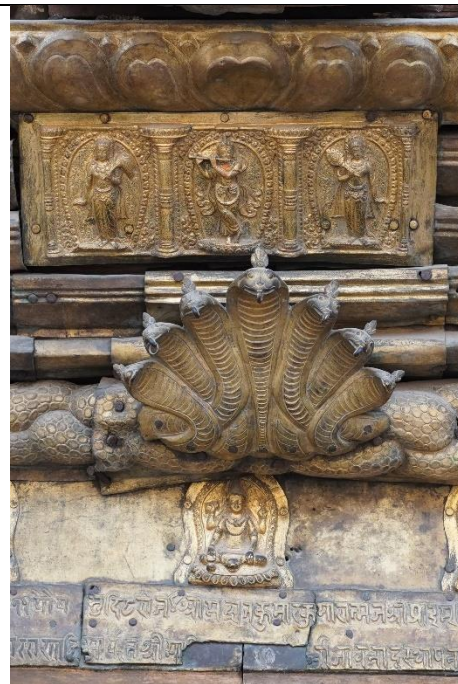
Fig. 15: Missing decoration-elements (*naga* mouths)

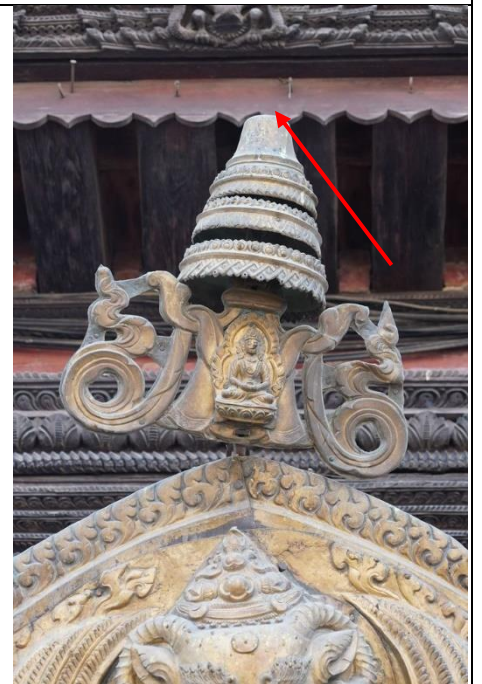
Fig. 16: 5 Missing tip on umbrella above Torana, darkening and corrosion due to soiling and bird droppings

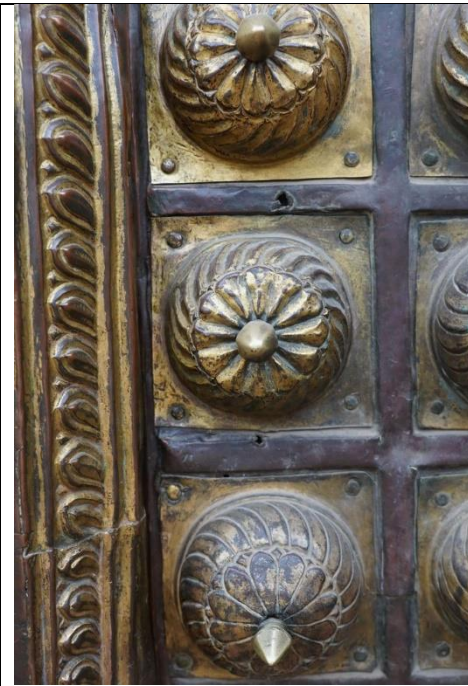
Fig. 17: Missing nails on the left doorwing

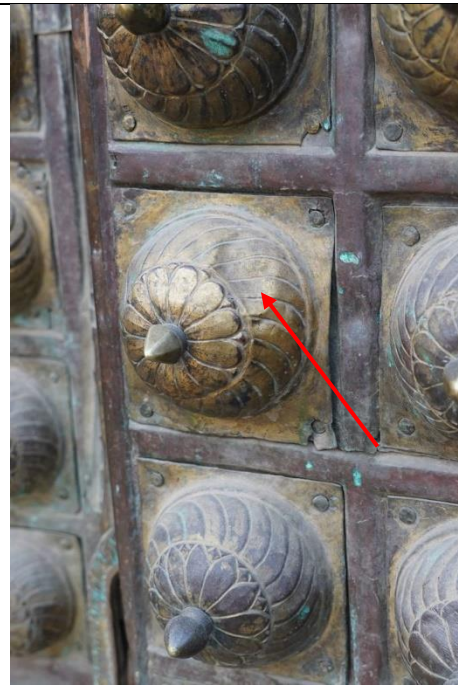
Fig. 18: Deformation (red arrow) on a knob on the right doorwing

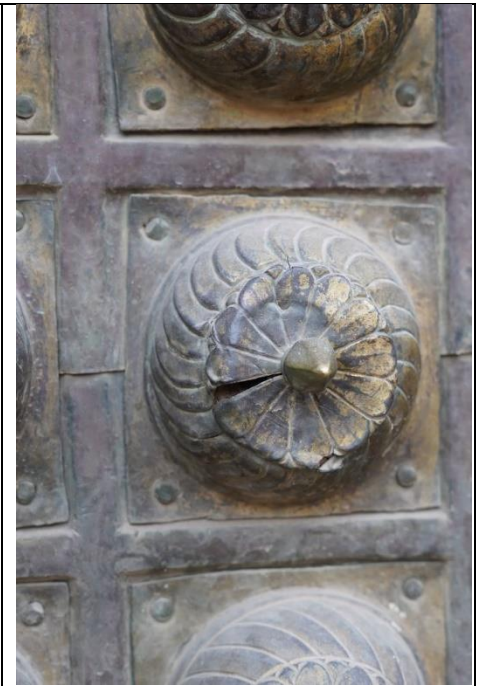
Fig. 19: Deformation and cracks on a knob

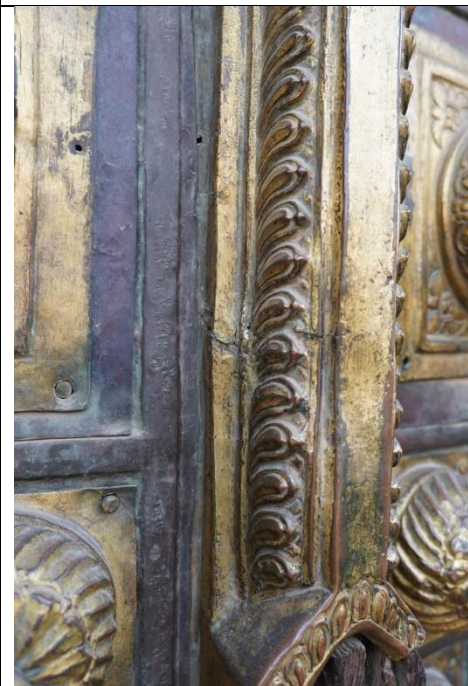
Fig. 20: Deformations and cracks on upper part of the baffle plate

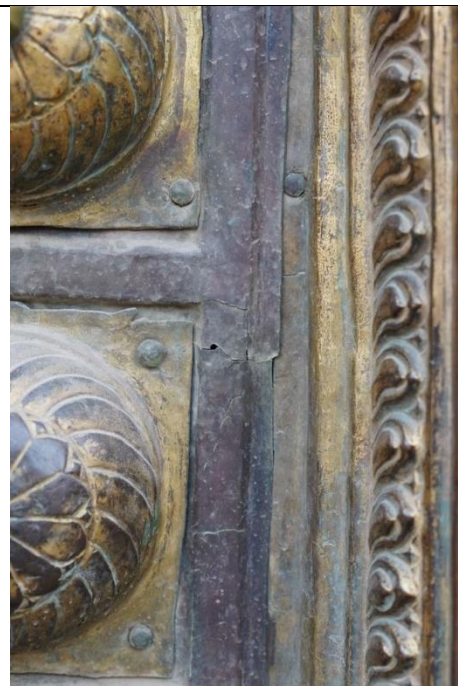
Fig. 21: Cracks on the right doorwing

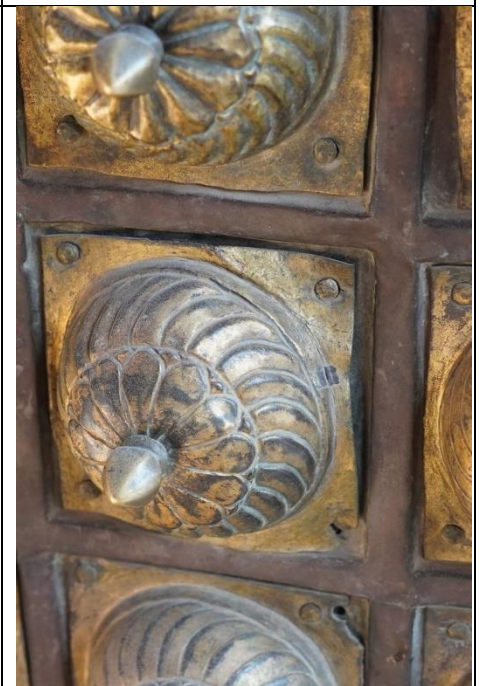
Fig. 22: Deformation and missing nails

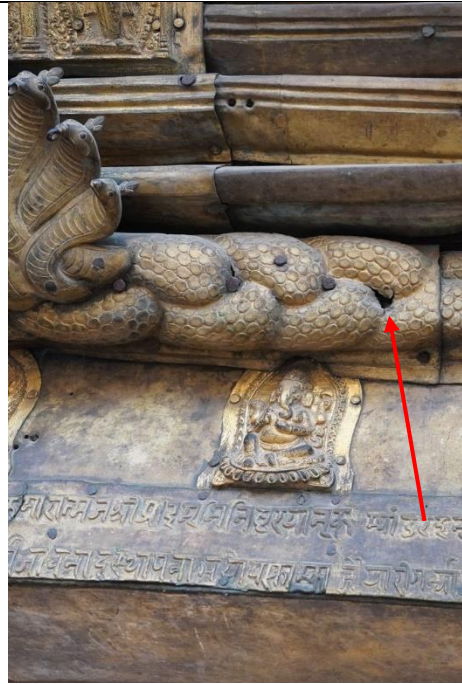
Fig. 23: Hole (red arrow) on the snake ornament, missing nail holes and secondary iron nails

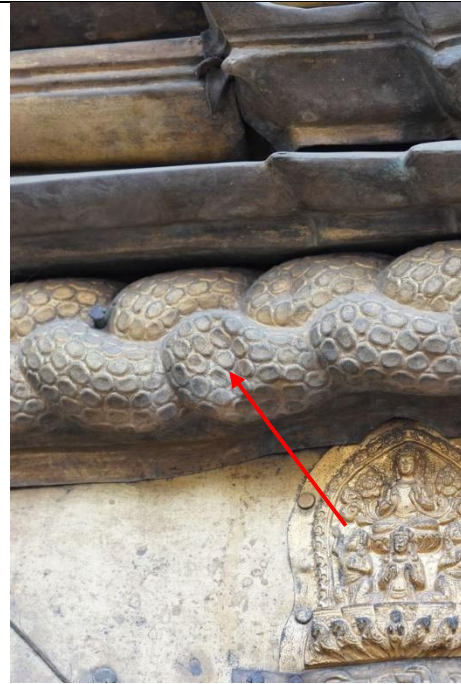
Fig. 24: Dent on a snake ornament between the doorframe and the kulam

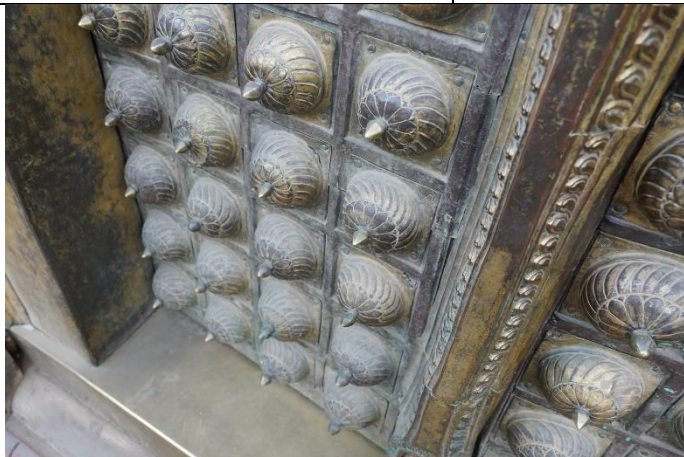
Fig. 26: Soiling and corrosion in the lower area of the doors

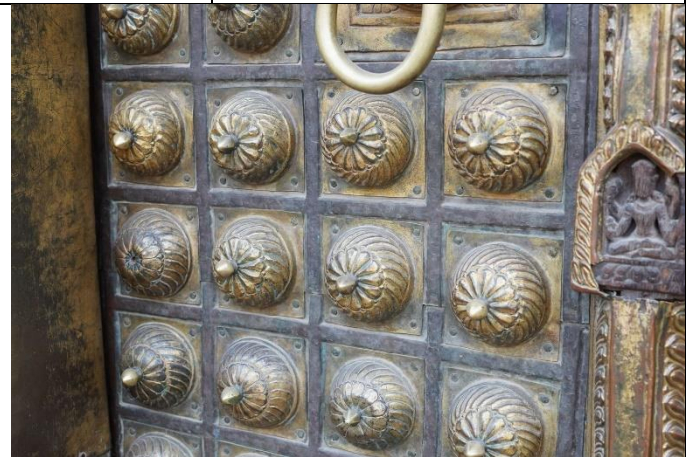
Fig. 27: Less soiling and corrosion in the middle area of the doors

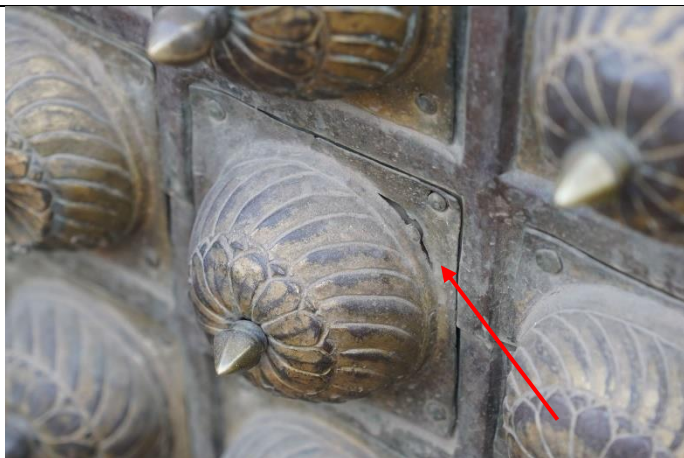
Fig. 28: Large crack (red arrow) on a doorknob

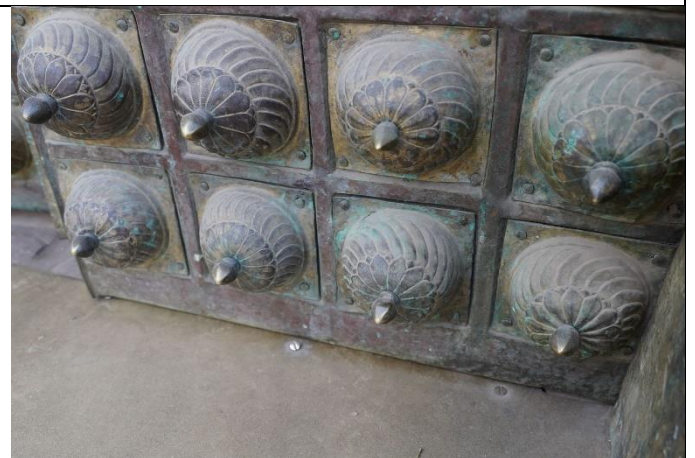
Fig. 29: Green corrosion on lower area of the right doorwing

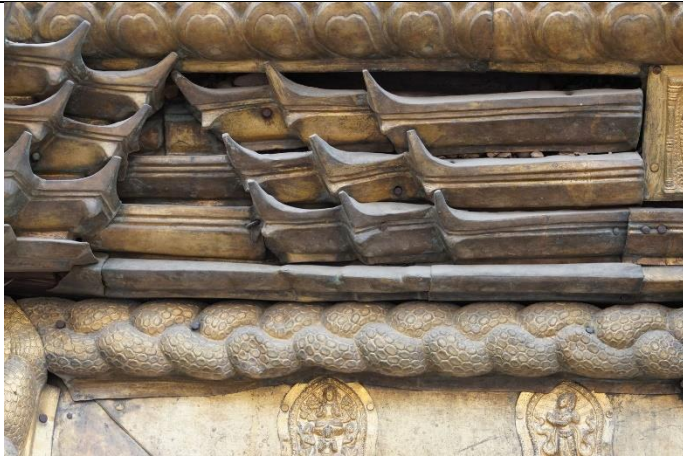
Fig. 30: Darkening and slight green corrosion on the *kulām* and iron corrosion on secondary nails

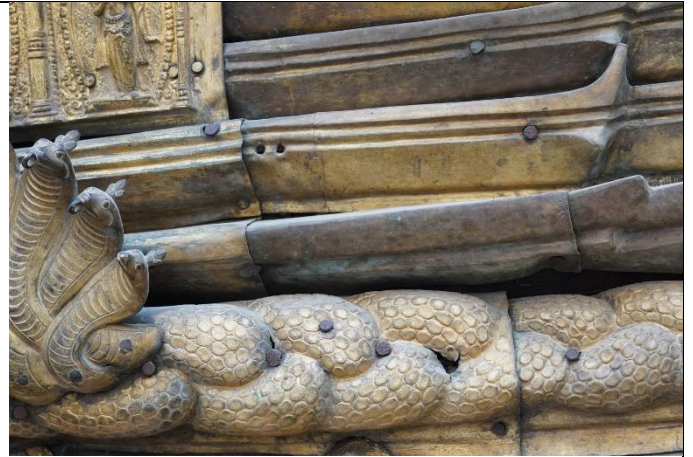
Fig. 31: Corroding iron nails on snake ornament and *kulām*

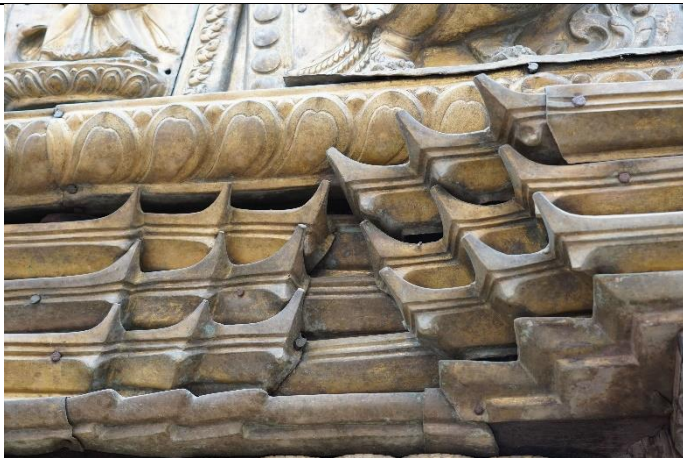
Fig. 32: Slight green corrosion on the *kulām*

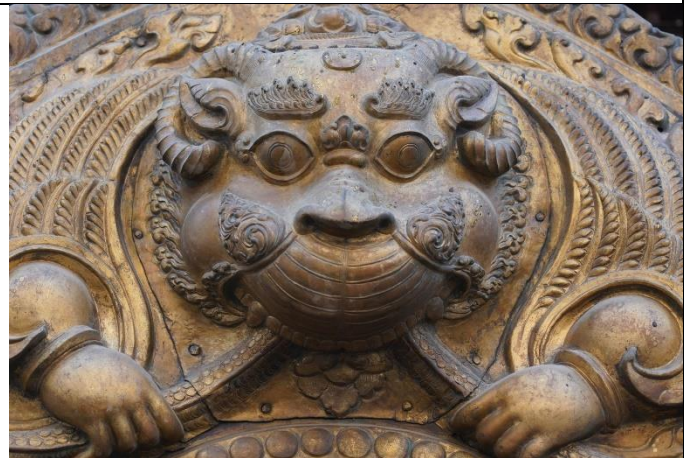
Fig. 33: Soiling and darkening on the upper area of the Torana

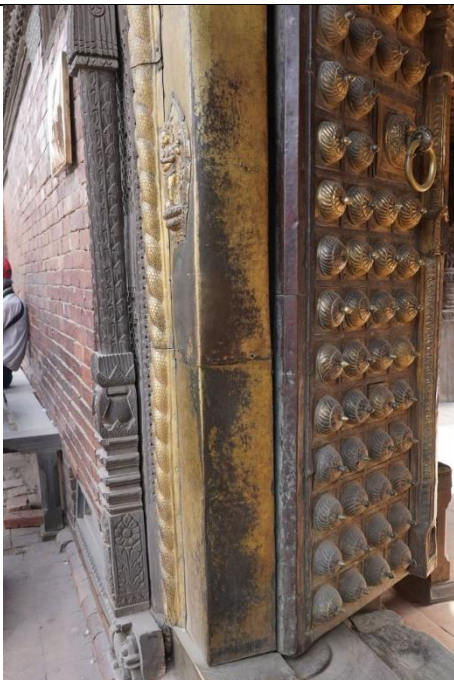
Fig. 34: Abrasion/Worn out Gilding on the left door frame

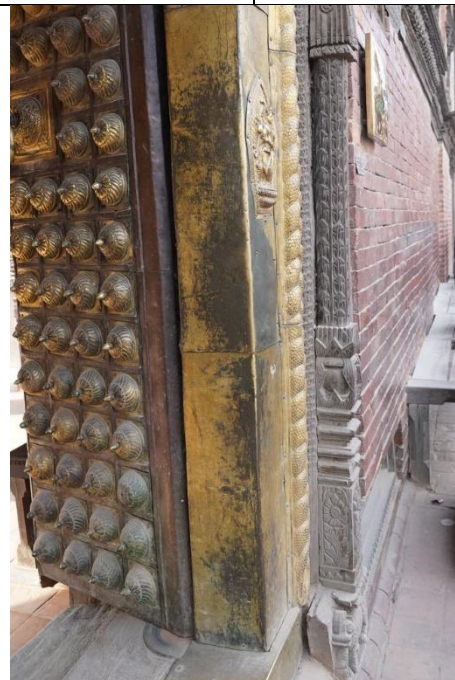
Fig. 35: Abrasion/Worn out Gilding on the right door frame

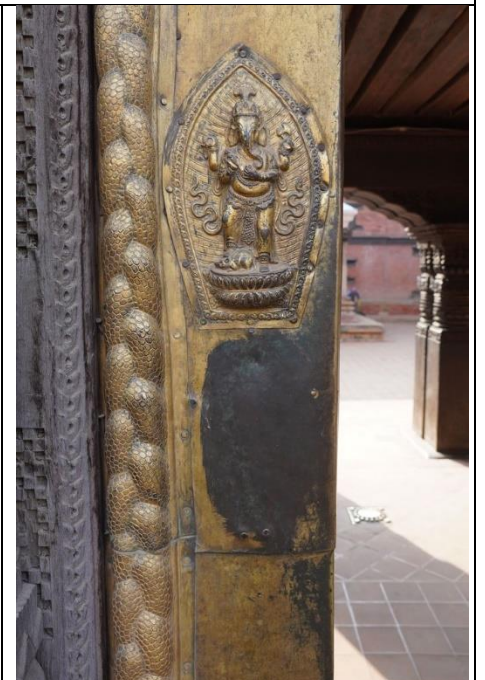
Fig. 36: Abrasion/Worn out Gilding on the left door frame

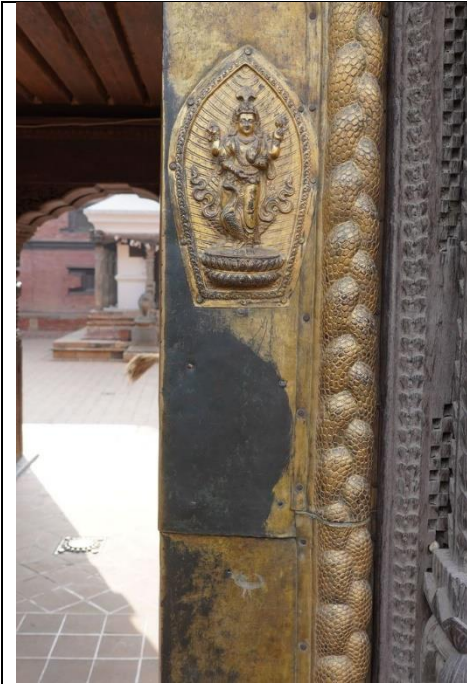
Fig. 37: Abrasion/Worn out Gilding on the right door frame

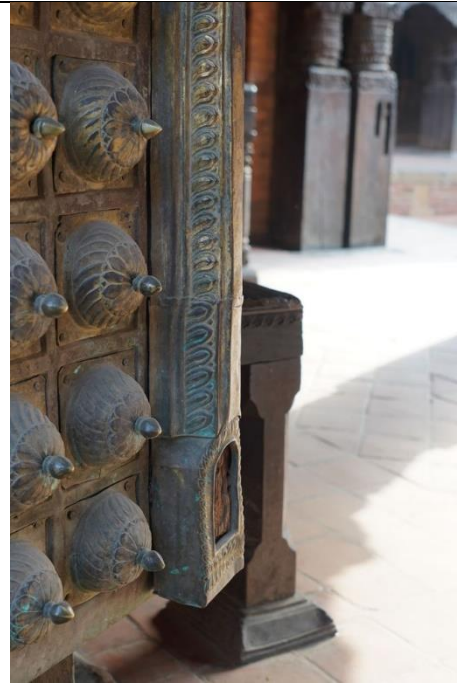
Fig. 38: Green corrosion on the lower area of the baffle plate

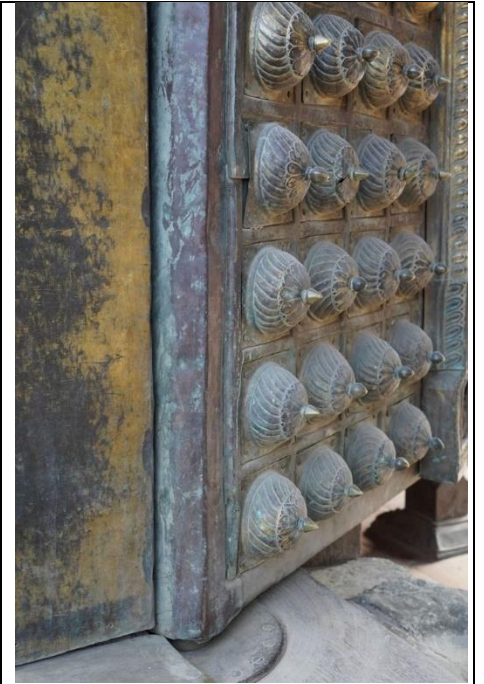
Fig. 39: Soiling, abrasion, darkening and green corrosion on the lower area of the left door
