GOLDEN DOORWAY ENSEMBLE

Report of the Institute of Conservation (IoC), University of Applied Arts Vienna

EVALUATION	
Date of Evaluation May 2024	Evaluation done by Meral Hietz, Katharina Mendl

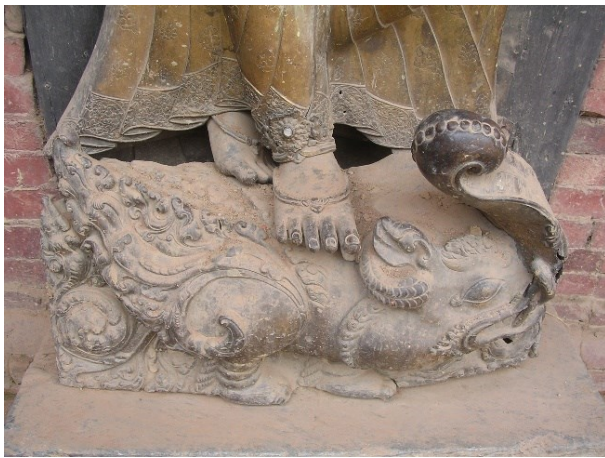
Fig. 13: Thick layer of soiling, 2011

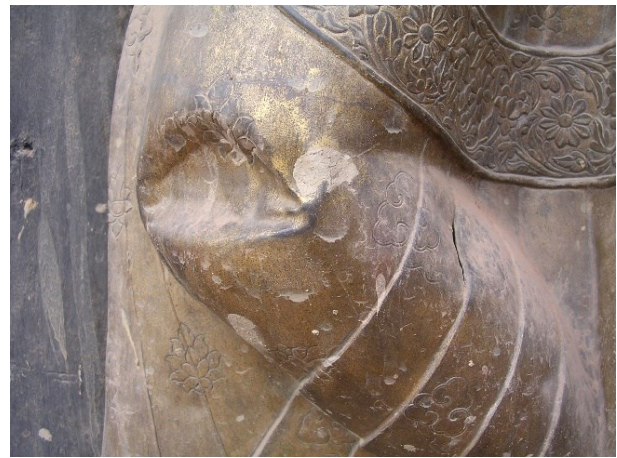
Fig. 14: Deformations and soiled surface, 2011

- Reshaping of deformations by hammering with rubber or skin-hammer/wooden ones (done by local artisans)
 - Cracks either underlaid with copper strips and fixed with copper rivets (Ganga's left leg, Makara's head) or closed with brass solder (crook of Yamuna's arm, Makara's head)

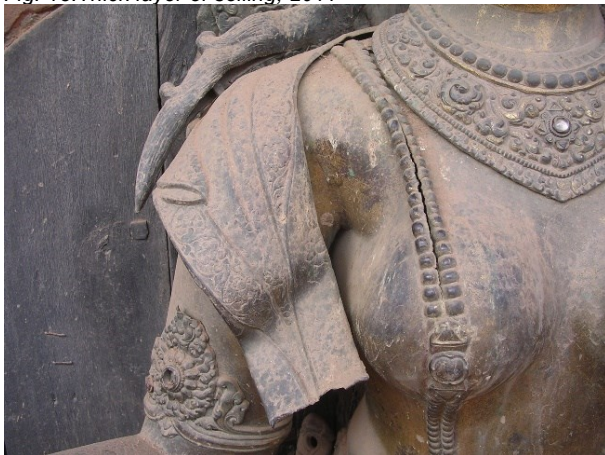
Fig. 15: Heavily soiled and missing parts, 2011

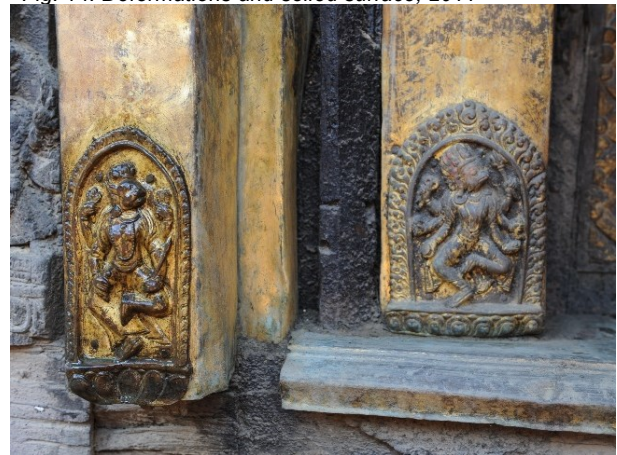
Fig. 16: Greasy remnants of worshipping, 2012

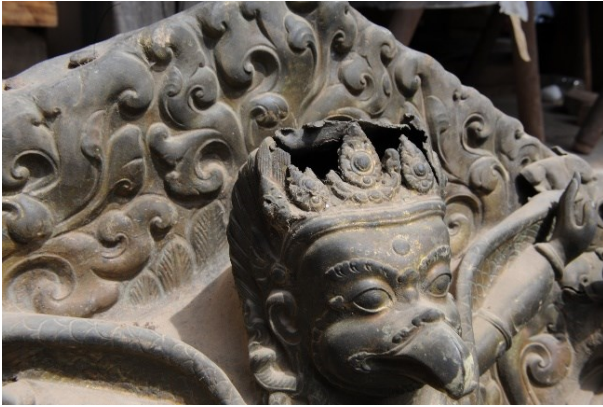
Fig. 17: Deformations and broken parts, 2012

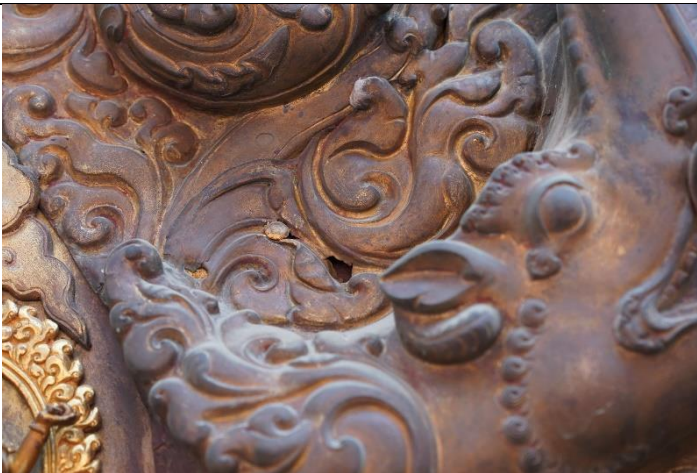
- Missing parts on the two of the three small flame frames
- one missing nail on left doorframe and seven missing nails on the left door wing

Fig. 13: Missing nail above the Makara

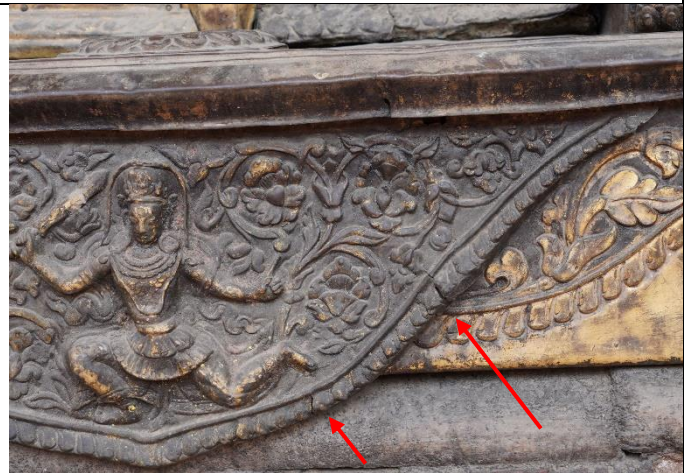
- 8 cracks (c.) on the lower area of the door frame (with figure of Durga)
- 6 c. upper part of the right column (roof elements), 10 c. on the left pillar
- one large c. on the right door wing and 7 c. + 5 small c. in the lower area, 1 c. on the right door blade, 1 c. on the baffle plate of the door
- 2. c. on the roof element of the door

Fig. 14: Cracks close to the Durga figure

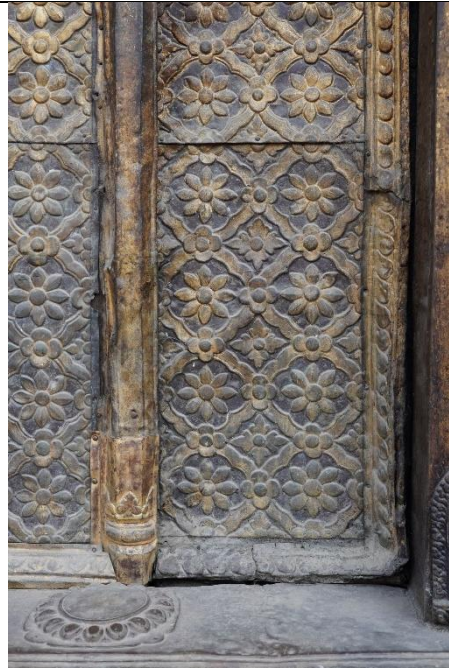
Fig. 15: Cracks and deformations on the right lower door wing and baffle plate

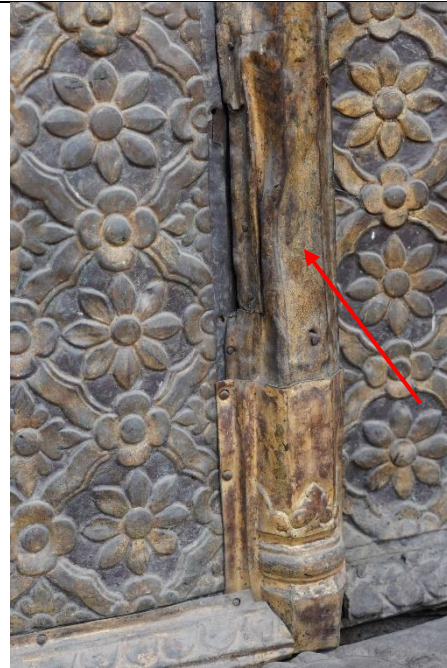
Fig. 16: Cracks and deformations on the baffle plate

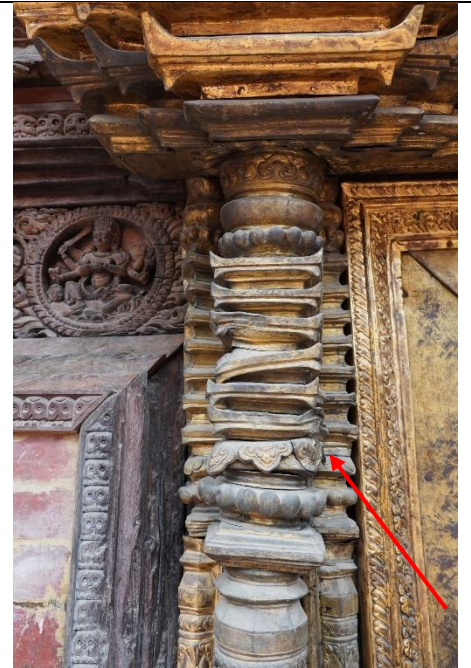
Fig. 17: deformations on the left pillar

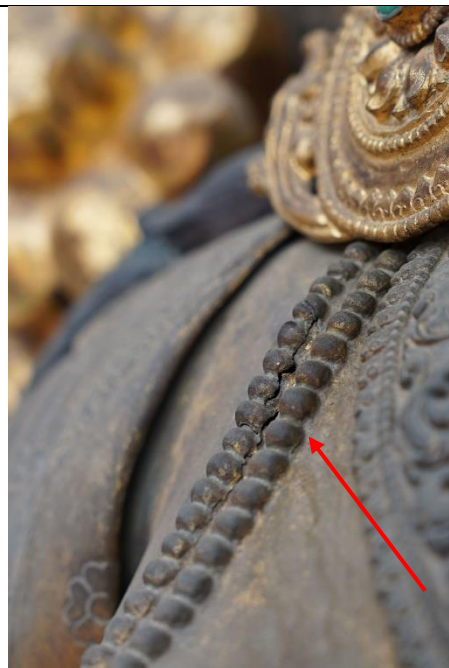
Fig. 18: Cracks on the necklace of Ganga

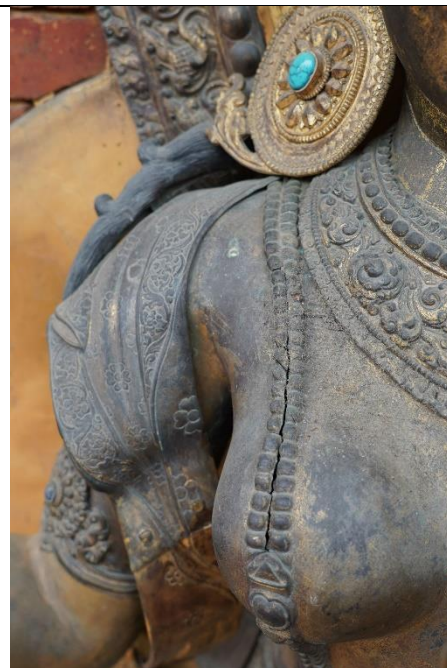
- Probably only old cracks (on the left hind leg of the turtle, left front leg of turtle, right upper side of the necklace with "pearls", small c. on the upper frame and lower right leg)

Fig. 19: Cracks on the necklace of Yamuna

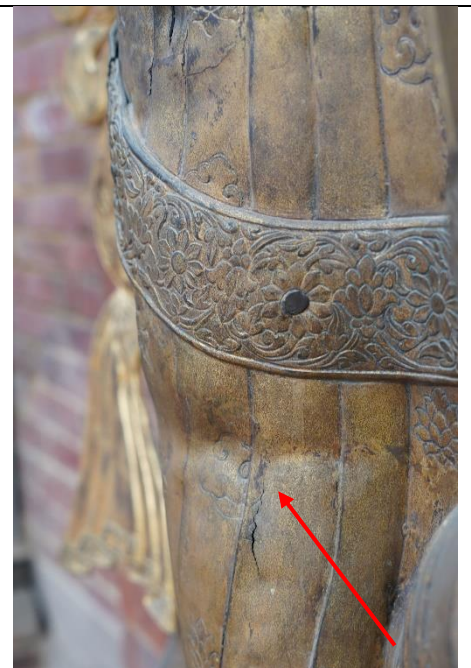
Fig. 20: 5 Cracks and deformations on the right leg of Ganga

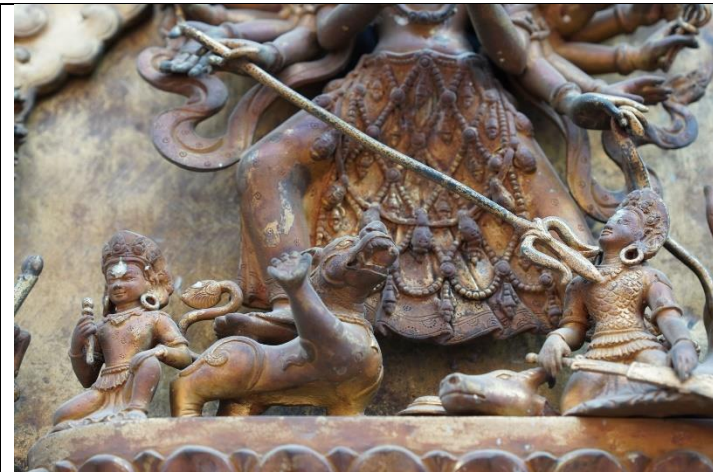
Fig. 21: Darkening of areas with thin gold layer on the Torana

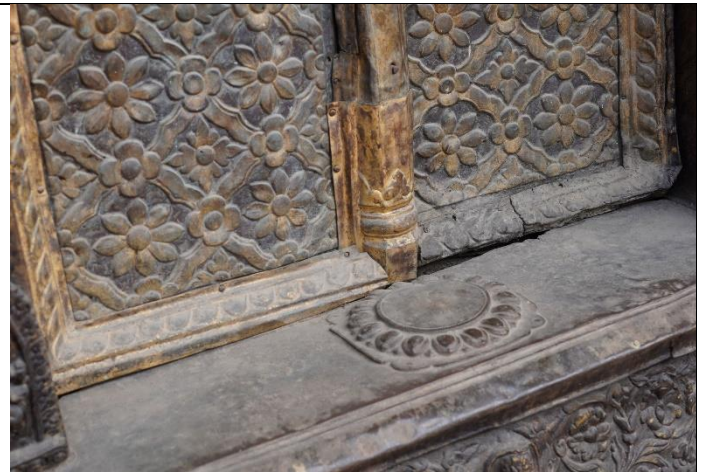
Fig. 22: Soiling and abraded, darkened surface in the lower door area

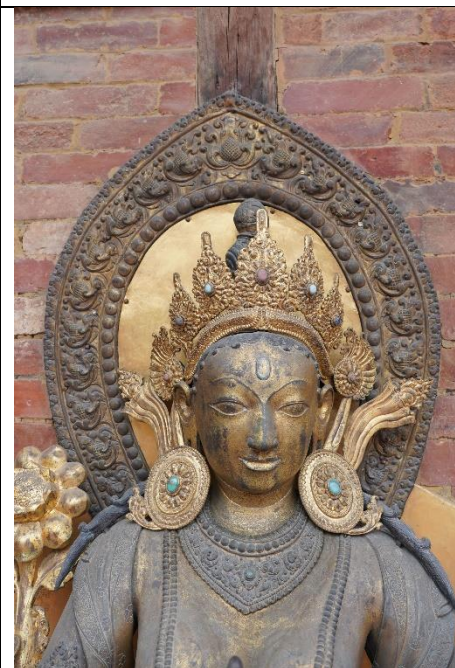
Fig. 23: Abraded and darkened areas on Ganga

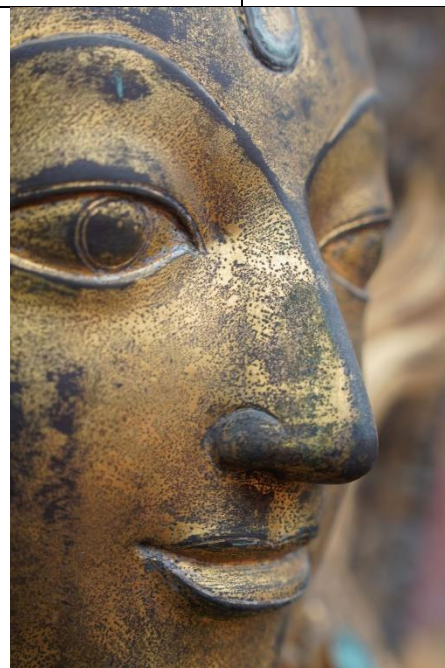
Fig. 24: Worn of gilding and dots of green corrosion on Ganga's face

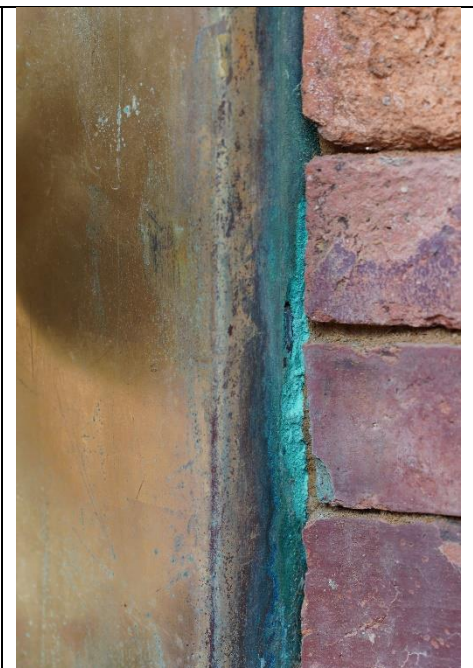
- Green corrosion (partially on the whole surface, on the face more than on the Ganga and left wrist, but mainly on the leaf gilded areas: particularly pronounced on the underside of the forearm, flower, and to a lesser extent on the scarf, top, insignia
- strong green corrosion on the connection to the wall and on the outer edge)
- General darkening of areas with thin gold layer

Fig. 25: Strong green corrosion on the edges of the back plate of Yamuna

Deposits (soiling, bird droppings, ritual substances) can be found on the surface and are a major cause of corrosive reactions. In this respect, maintenance is the key to the long-term preservation of the Golden Doorway Ensemble. Regular cleaning and removal of bird droppings must be considered by the local community as the most important factor in long-term conservation. Where citric acid is used to chemically reduce corrosion, it is essential that the surface is thoroughly rinsed after cleaning, as acidic residues accelerate corrosive reactions.

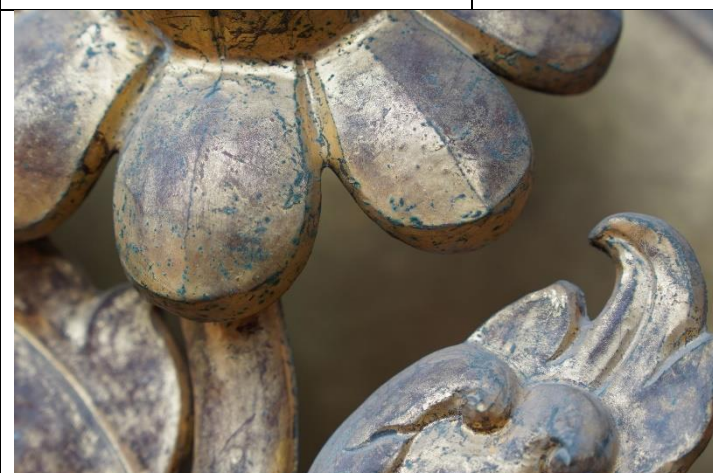
Fig. 26: Green corrosion dots on the Yamuna ornaments

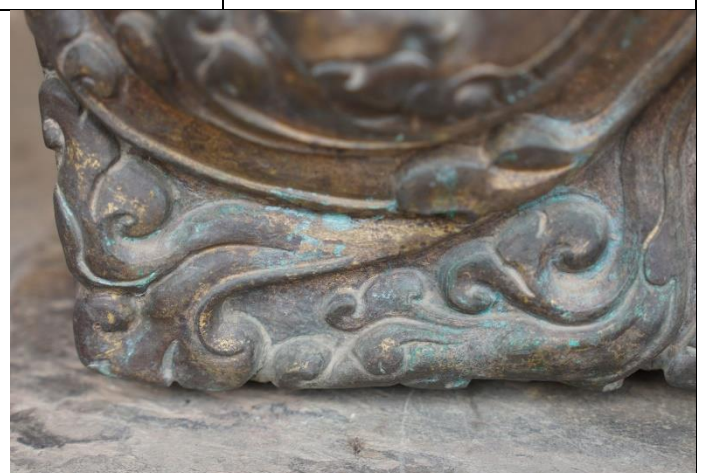
Fig. 27: Partial green corrosion on the Makara of Ganga

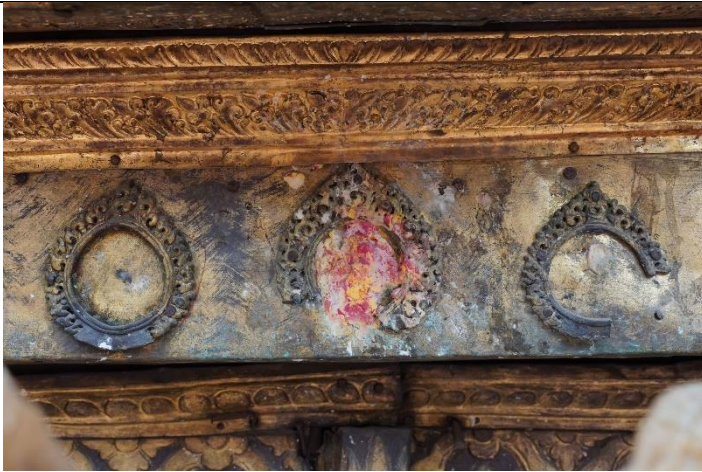
- Some bird droppings, ritual substances and pigments on door frame head and central deity Durga on roof element

Fig. 28: Worn of gilding and ritual substances on the upper door frame

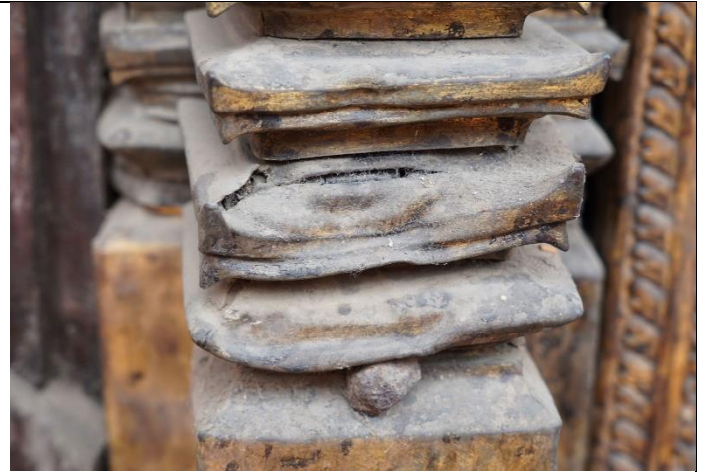
Fig. 29: Deformations and dust accumulations on the left pillar

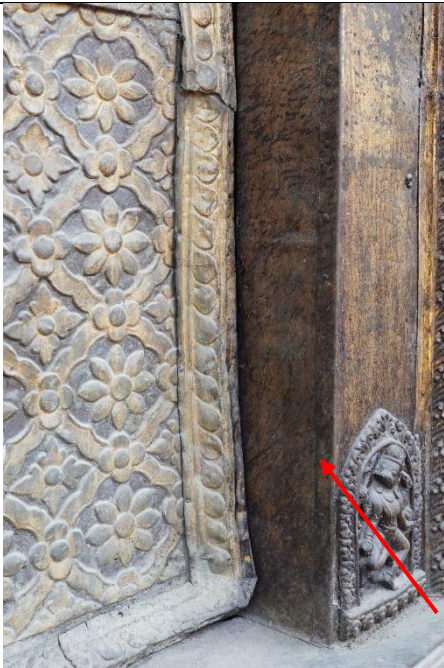
- Particularly on the lower sides of the door frame and the lower area of the column

Fig. 30: Blood stains on the door frame

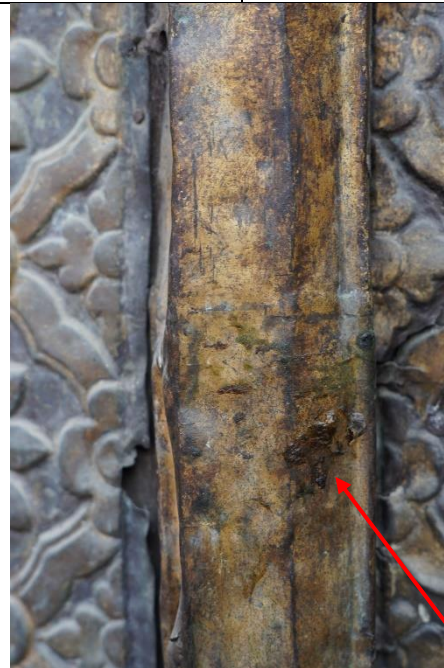
Fig. 31: Soiling on the baffle plate

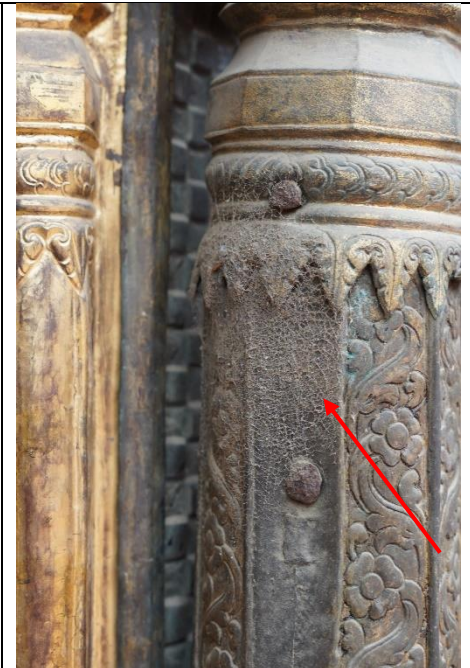
Fig. 32: Spider webs and dust on the pillar

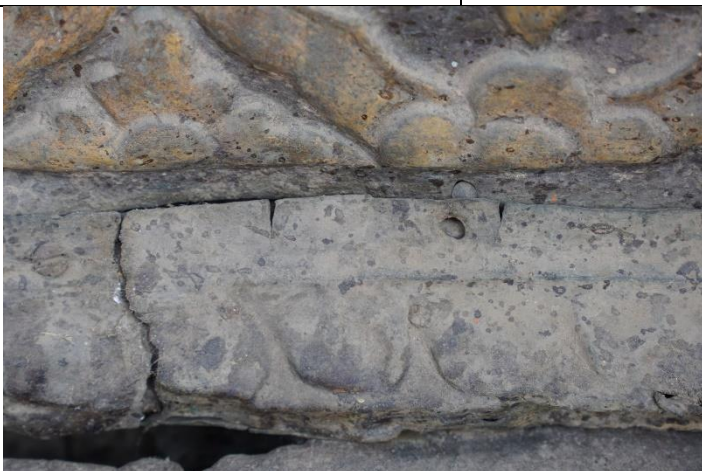
Fig. 33: Dust accumulations and blood stains on the lower door area

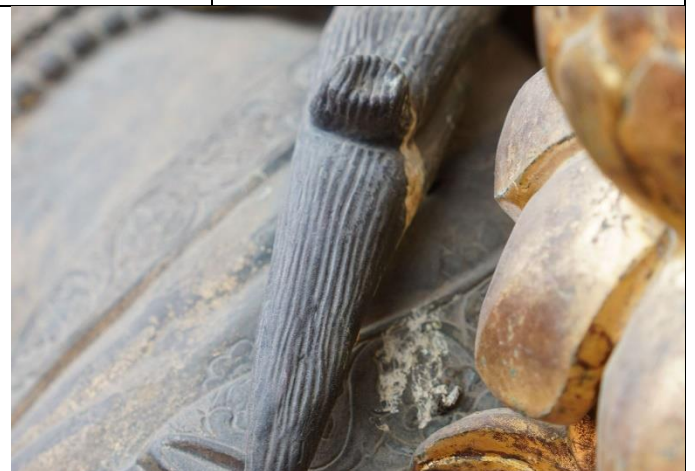
- Few bird droppings,
- Tika pigment paste on forehead

Fig. 34: Bird droppings on the Yamuna statue
