## HARISHANKARA TEMPLE – BASE AND SCULPTURE

Report of the Institute of Conservation (IoC), University of Applied Arts Vienna

## Data Sheet

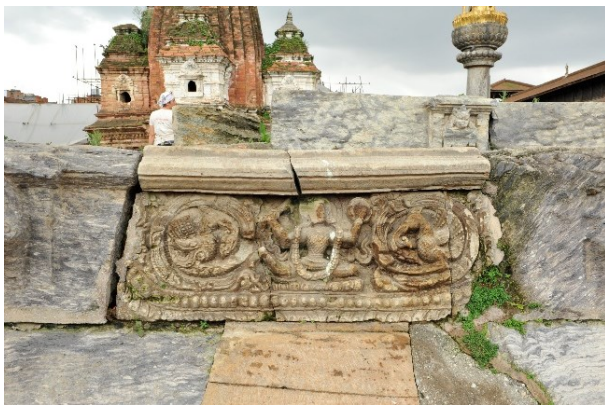
- Some stone blocks show fractures; cracks in the form of fissures on all stone blocks
- Building collapsed towards the South – therefore, stone blocks at this side suffered most (fractures, broken parts, and chipping)

Fig. 14: Totally cracked figurative block, 2017

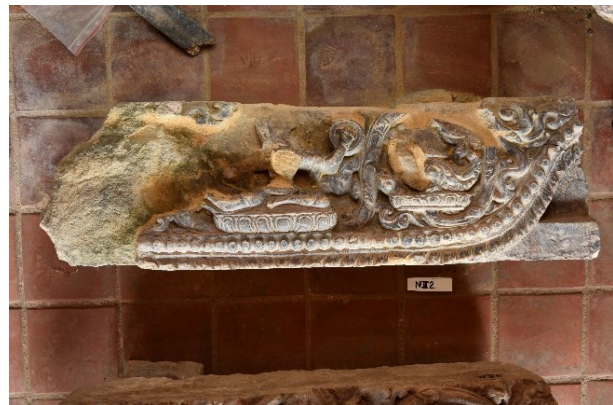
Fig. 15: Cracked and fragmented sandstone, 2017

- Biocide treatment (QUATS, 2% in water, one application); subsequent cleaning with water
- Backfilling of cracks with acrylic resin (Paraloid B72, first 10% in Acetone for deep penetration, second 30% in Acetone for filling)
- Gluing and pinning of broken blocks with epoxy resin (Akepox 2010) and carbon fibre rods
- Micro-pointing of breakage joints and splitting areas with mortar based on natural hydraulic lime (depending on the stone colour either yellow or dark sand was chosen)

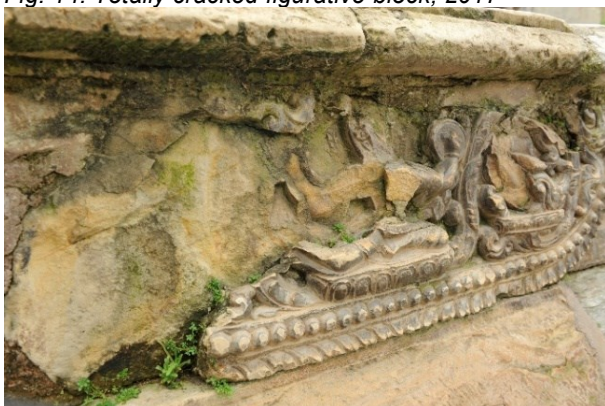
- Blocks made of sandstone show sanding, microbiological growth and growth of higher plants (joints); homogeneous dark crust (few mm) covers surfaces of sandstone blocks

Fig. 16: Sanding, microbiological colonization, 2017

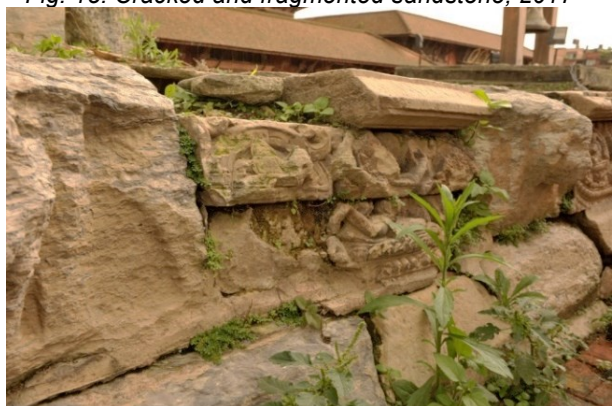
Fig. 17: Growth of higher plants within the joints, 2017

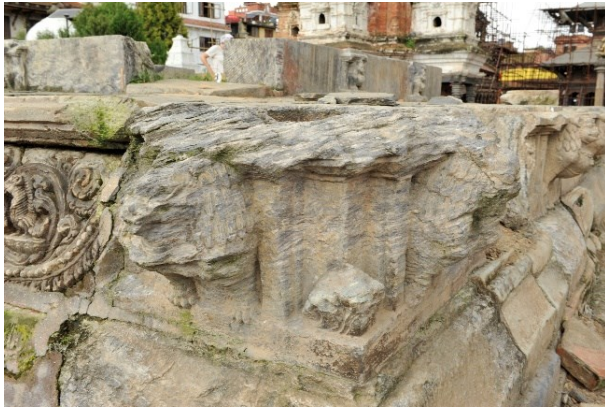
- Losses and missing parts (also on carved surfaces)
- Heavy soiling and deposits on all surfaces
- Blocks made of schist show splitting (vertically oriented lamination) and delamination

*Fig. 18: Weathered cornerstone, delamination, 2017*

- One broken base cornerstone glued with epoxy resin (Akepox 2010) and pinned with stainless steel reinforcements
- One heavily damaged base cornerstone equipped with stone indent; core was removed and indent inserted
- Broken threshold block (south) was glued with epoxy resin (Akepox 2010) and pinned with two stainless steel reinforcements (diameter 1.6 cm, length 60 cm)

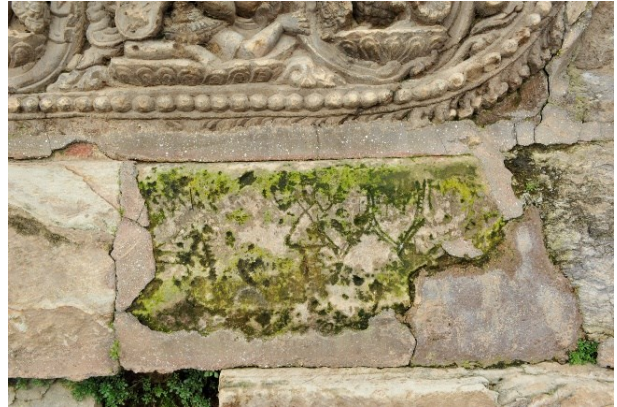
*Fig. 19: Insufficient cement joints incl. algae, 2017*

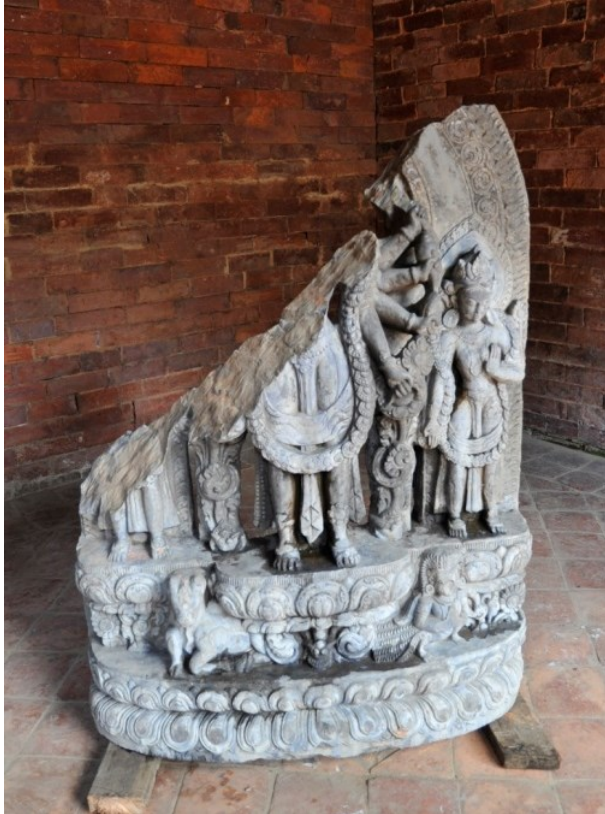
- Monolithic stones at the inner threshold at the north and south completely broke in the middle
- Sculpture broke in two at the waist; Parvati's head, the mace of Vishnu, Garuda's hands and a small part from the outer circle broke off

*Fig. 20: Broken sculpture of Harishankara, 2015*

- Two broken parts were re-adhered; reinforcement with two stainless steel pins (diameter 0.8 cm, length 10 cm) glued in drilled holed on both sides with hybrid mortar (HFX); dashes of epoxy resin (Akepox 2020) applied to the fractured surfaces
- Gluing of broken of head of Parvati with epoxy resin (Akepox 2010)
- Mechanical removing of deposits (spatulas, scapels)
- Reduction of residues with different solvents (Acetone, white spirit, ethanol and ammonium hydroxide) applied with brushes and cotton buds; oily components were reduced with additional lime putty poultice was applied; subsequent cleaning of all surfaces with water
- Reconstruction of missing attribute (stone indent) adhered to sculpture with epoxy resin (Akepox 2010)
- Pointing of breakage joints and filling of losses with mortar (in this way, the integrity and meaning of the sculpture could be fully restored)

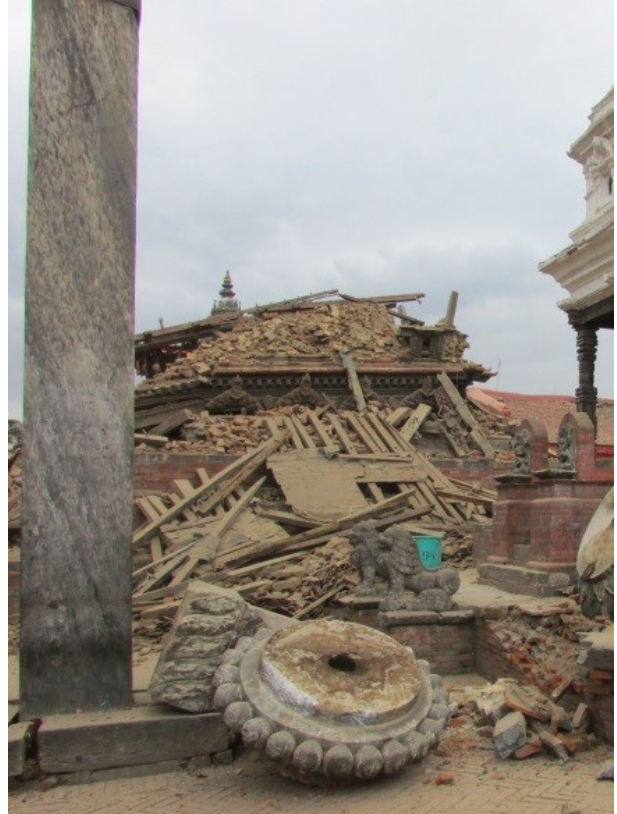
- Collapse of the temple during the Gorkha earthquake 2015 due to an insufficient connection between wooden pillars and stone blocks at the base; some of the tenons as well as edges of the holes deteriorated in the course of time and were not stable anymore

*Fig. 21: Collapsed temple, 2015, © KVPT*

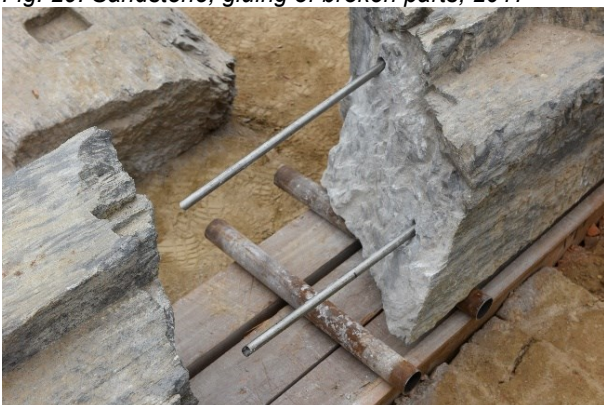
*Fig. 31: Schist, pins in threshold block (south), 2017*

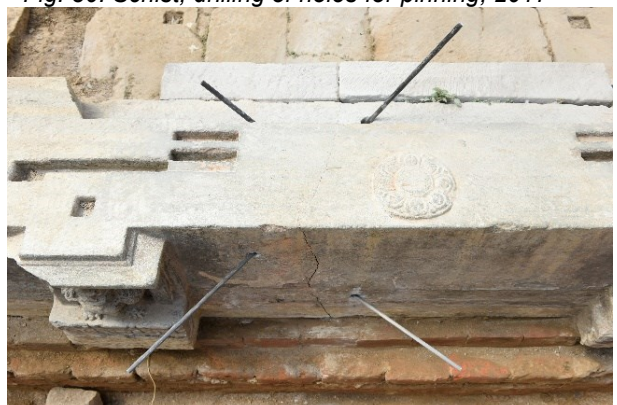
*Fig. 32: Schist, reinforced threshold block (north), 2017*

- Broken threshold block (north) was reinforced with carbon fibre rods glued into four holes drilled across the crack with hybrid mortar (HFX)
- Micro-pointing of breakage joints and splitting areas with mortar based on natural hydraulic lime

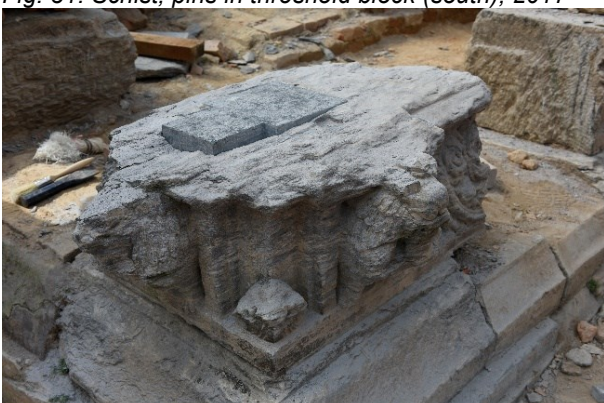
*Fig. 33: Schist, cornerstones with stone indent, 2017*

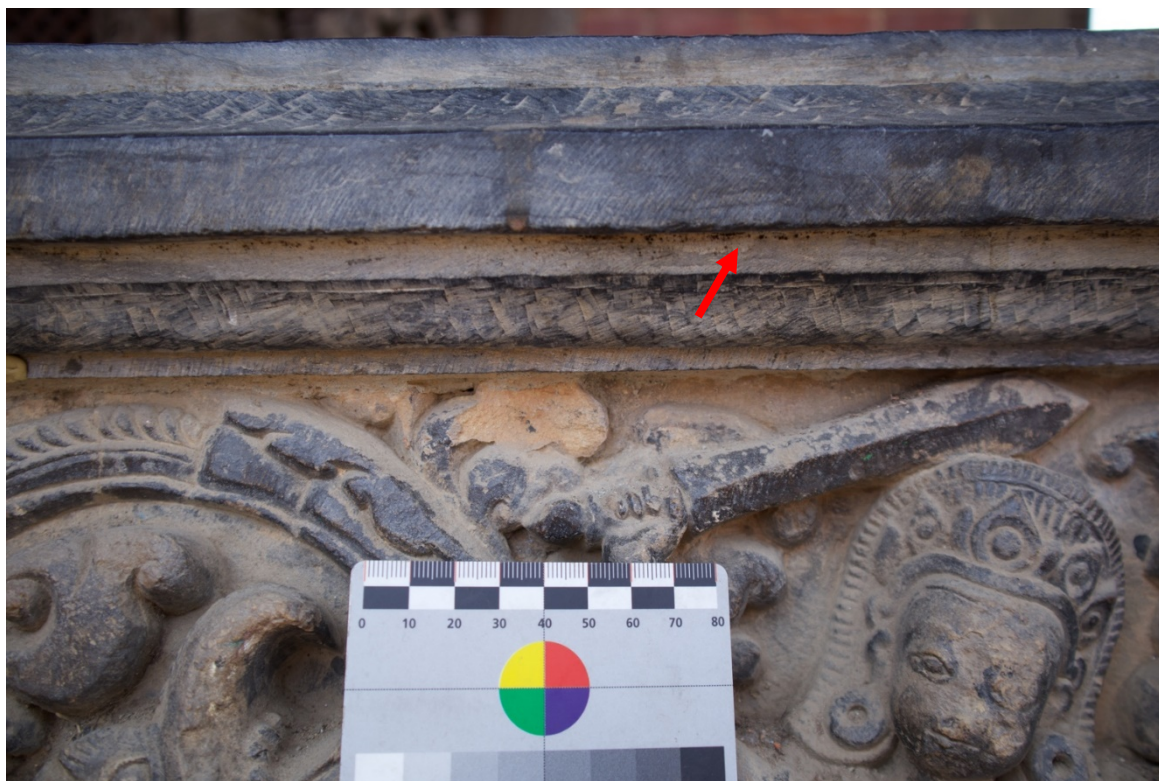
**Microbiological growth is present predominantly on schist stone**

Fig. 1: Microbiological growth in the form of black dots.

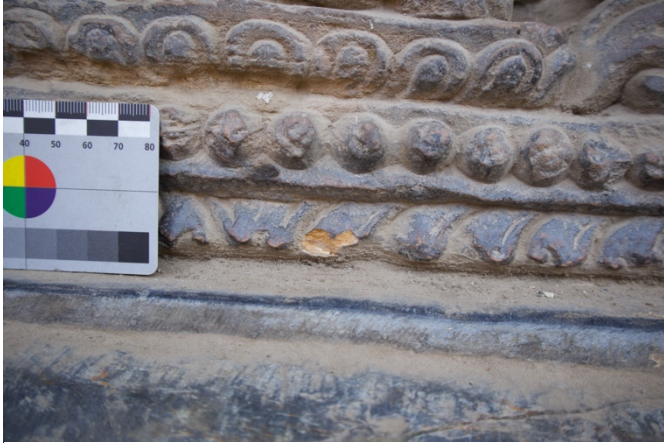
**Joints, especially those to the base, seem salt loaded at some parts - salt efflorescence is present**

Fig. 2: Material loss due to salt efflorescence.

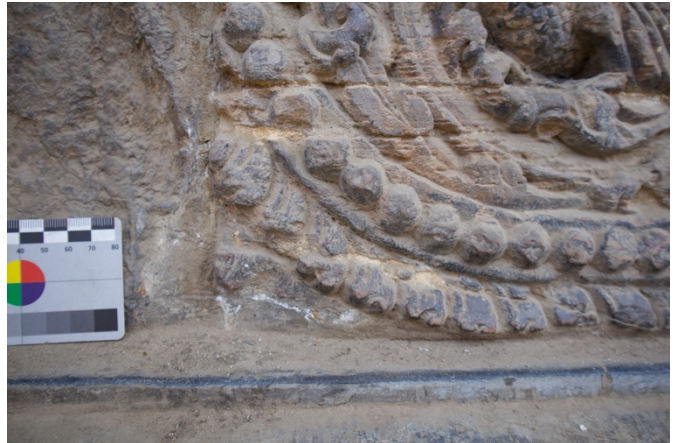
Fig. 3: Salt efflorescence.

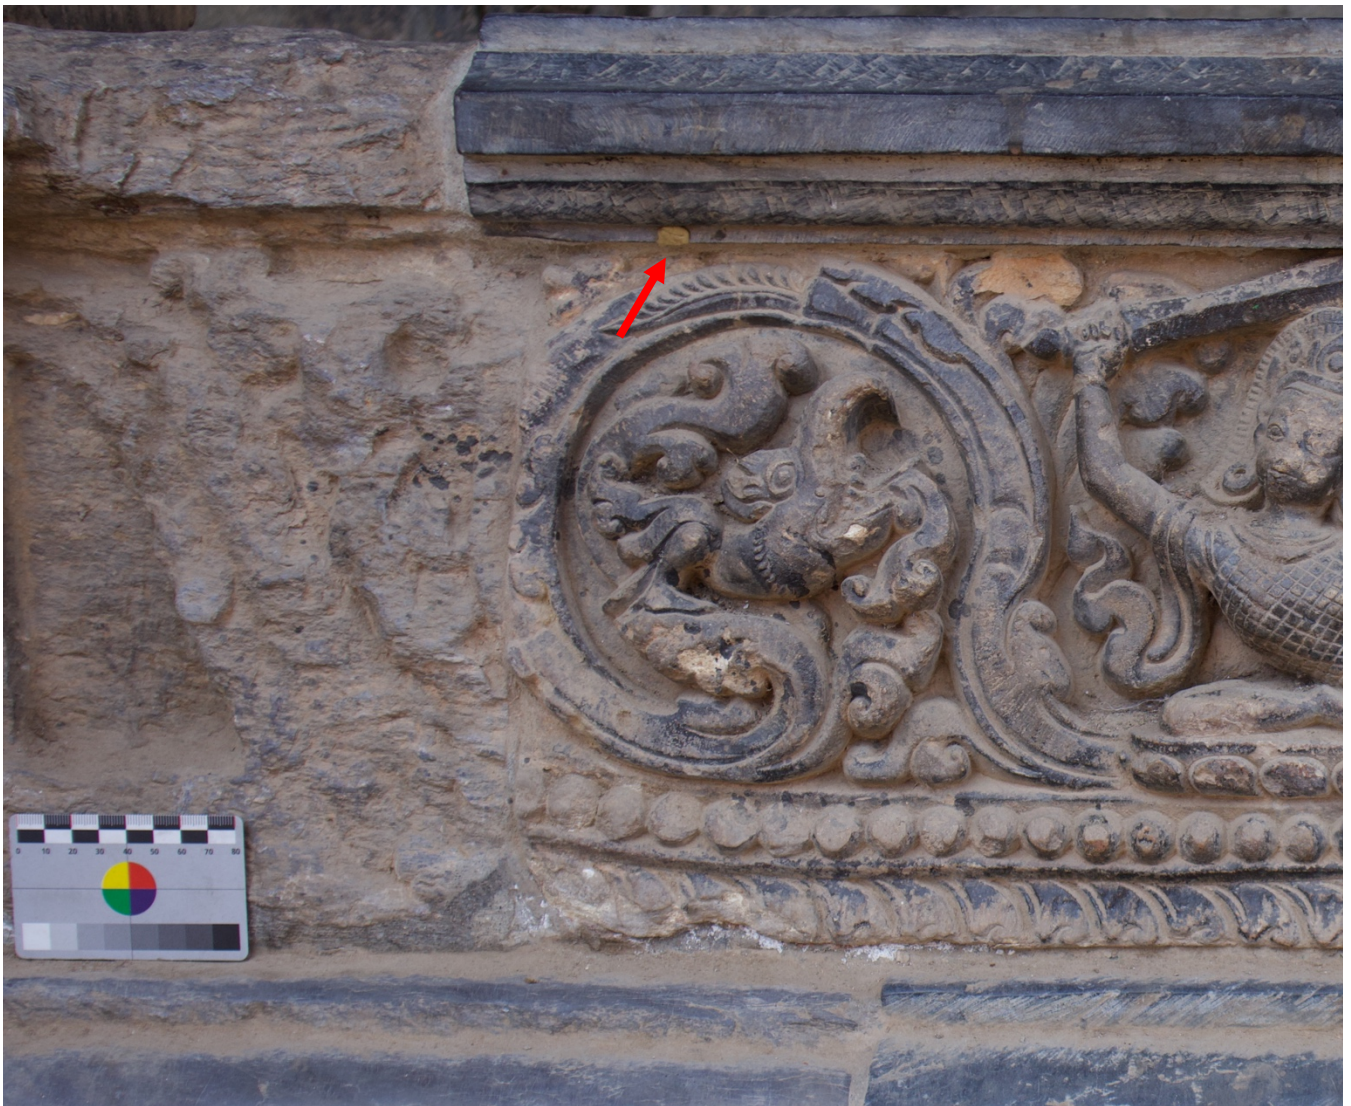
<input checked="" type="checkbox"/> Light	Chewing gum (Fig. 4), dust, dirt Epoxy remains on threshold blocks on the west side, from gluing of the replaced lion bust
Comment:		
<input checked="" type="checkbox"/> Other	Comment:

Fig. 4: Chewing gum under cornice.
