IVORY WINDOW ENSEMBLE OF SUNDARI CHOWK

Report of the Institute of Conservation (IoC), University of Applied Arts Vienna

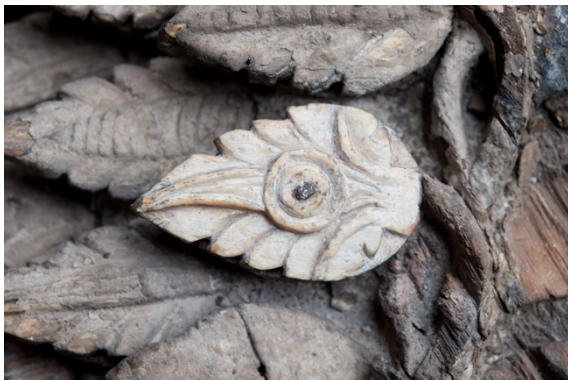
Fig. 3: Detail of fixing with nail within the wooden torana, 2013

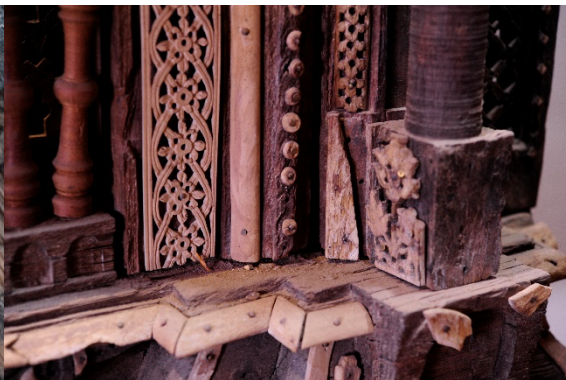
Fig. 4: Detail after conservation with brass nails, 2017

- Removal of iron nails;
- Dry cleaning with soft brushes;
- Mechanical removal of white paint by glass fibre etc.;
- Cleaning of ivory with laser;
- Consolidation with 7% Paraloid B72 in ethyl acetate;
- Loose textile wrapping at the pillars were fixed with 5 % Klucel E in ethanol before applying the ivory parts;
- Fixing and gluing of broken parts with 30% paraloid B72 solved in ethyl acetate by temporary fixing with scotch tape (24 h);
- Reconstruction of missing parts in epoxy resin with marble powder, and acrylic resin;
- Fixing with brass nails;

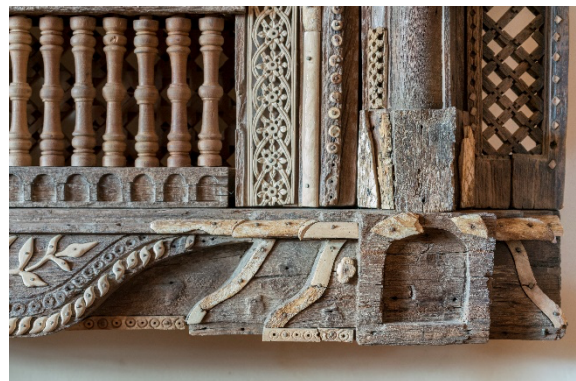
Fig. 6: Detail of wooden support with some ivory parts fixed with brass nails, 2017

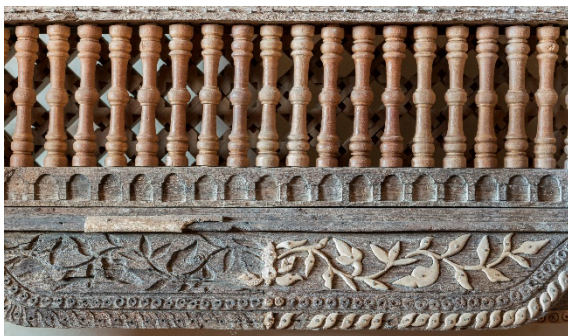
Fig. 7: Wooden reconstructed balustrade, 2017

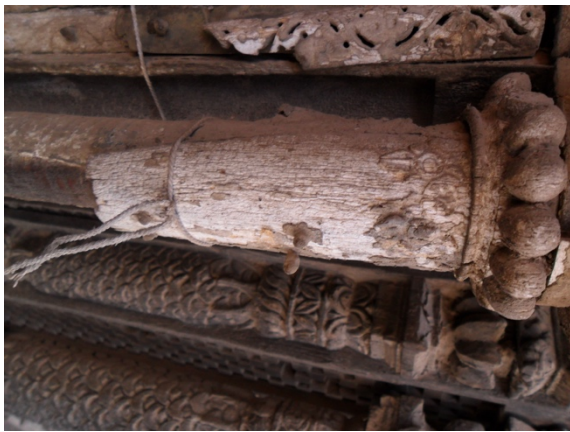
Unknown Application of white coating on wooden support imitate missing ivory parts;
 Unknown/
 Before 1975 Application of white coating (zinc white) on ivory parts in order to “clean” them;

Fig. 11: Detail of overpainted and brittle ivory, 2013 points, 2013

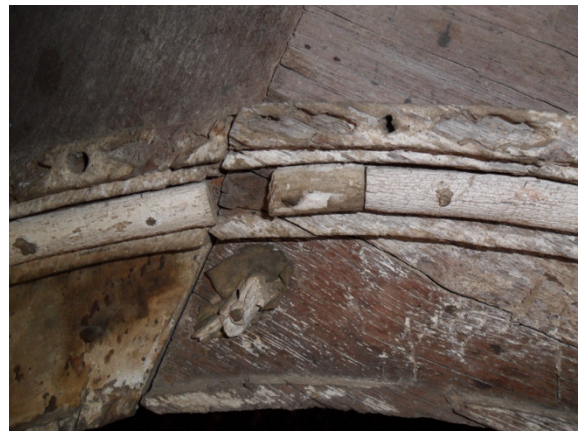
Fig. 12: Loose and missing parts, visible fixing

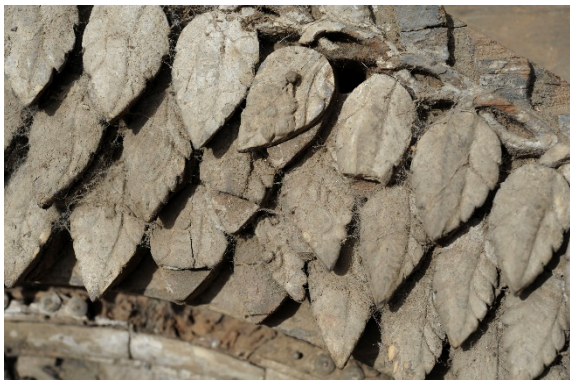
Fig. 13: Extremely dirty and damages ivory leaves, 2013

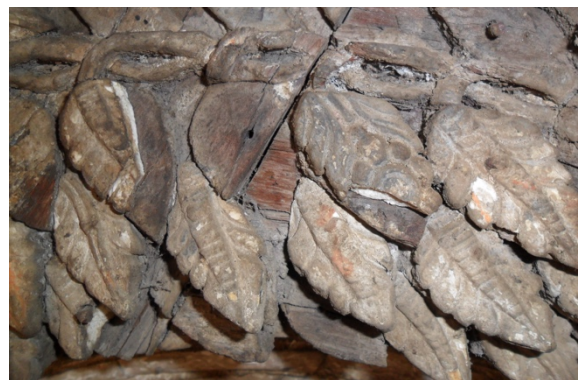
Fig. 14: Wooden Support after dry cleaning, 2013

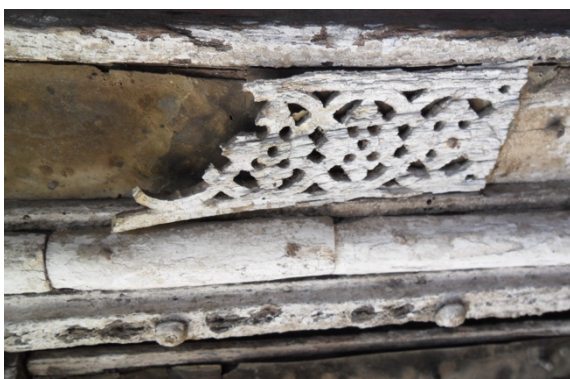
Fig. 15: Deformed, broken and brittle ivory parts, 2013

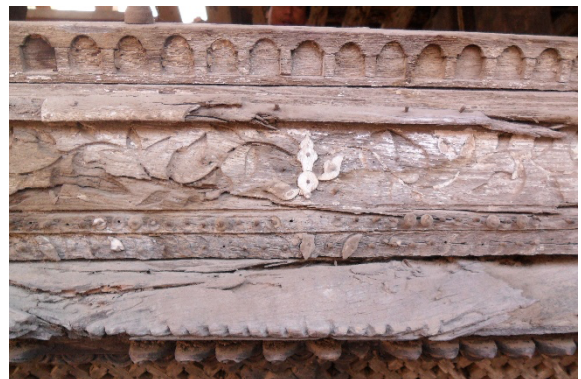
- 70-80% of ivory was missing;

Fig. 16: Wooden support with missing ivory parts, 2013

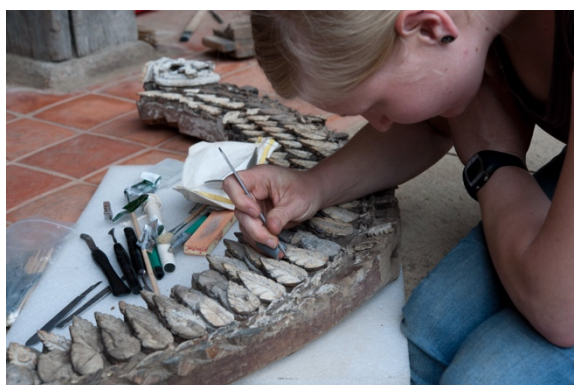
Fig. 17: Mechanical cleaning of ivory parts, 2013

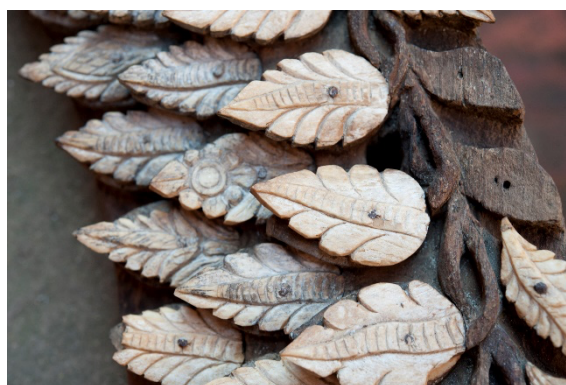
Fig. 18: Front row of ivory leaves cleaned by laser, 2013

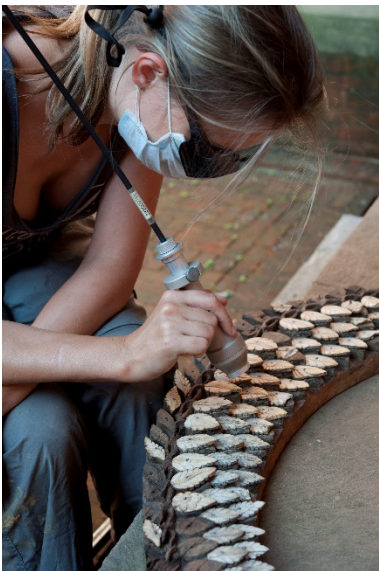
Fig. 19: Laser cleaning of the ivory parts, 2013

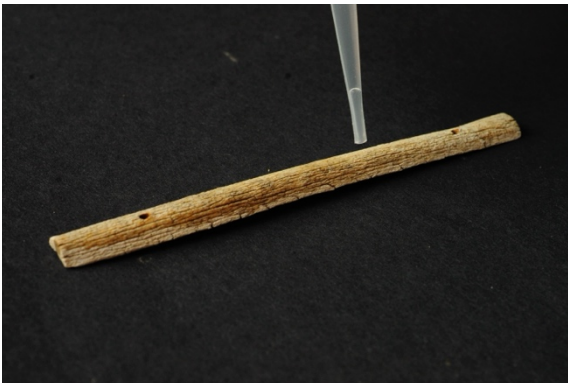
Fig. 20: Consolidation of ivory within the Museum, 2017

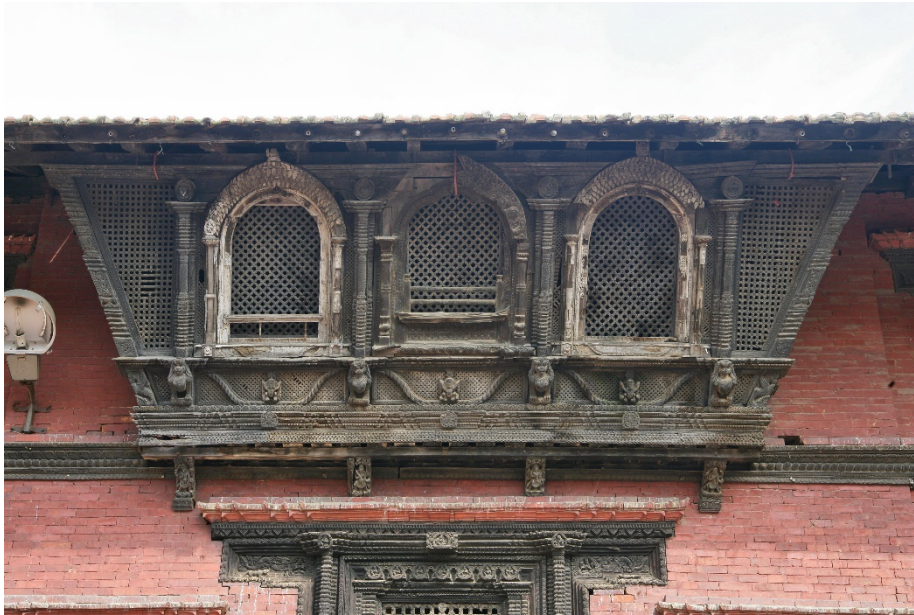
Fig. 29: Overview of the Ivory Window ensemble from the Patan Durbar Square before conservation, 2013

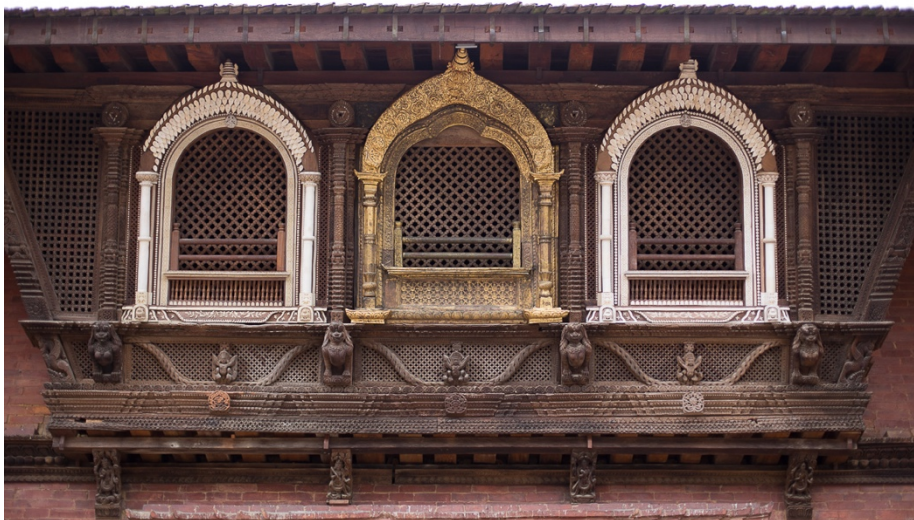
Fig. 30: Overview of the Ivory Window ensemble with reconstructed windows from the Patan Durbar Square after conservation, 2017

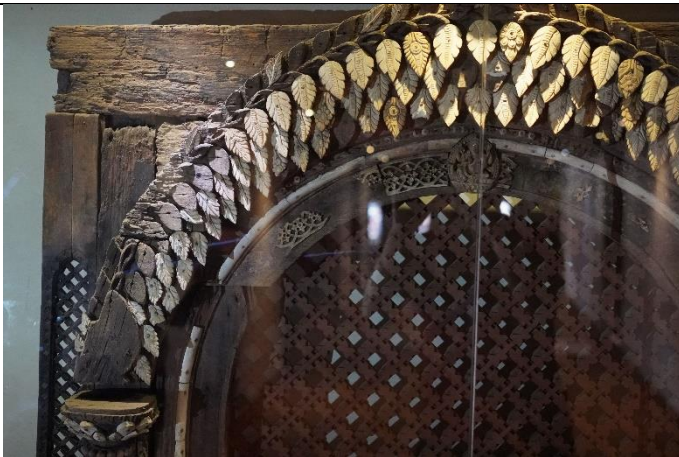
Fig. 3: Carved ivory and wooden leaves on the arch and missing deity at the top of the left column, May 2024

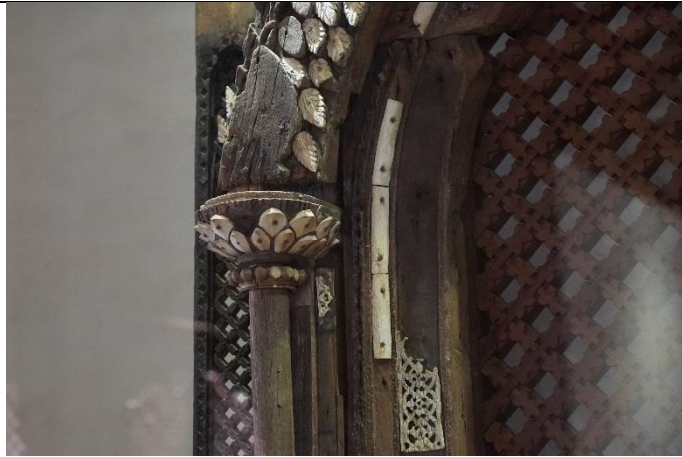
Fig. 7: Some missing elements on the left of the window, May 2024

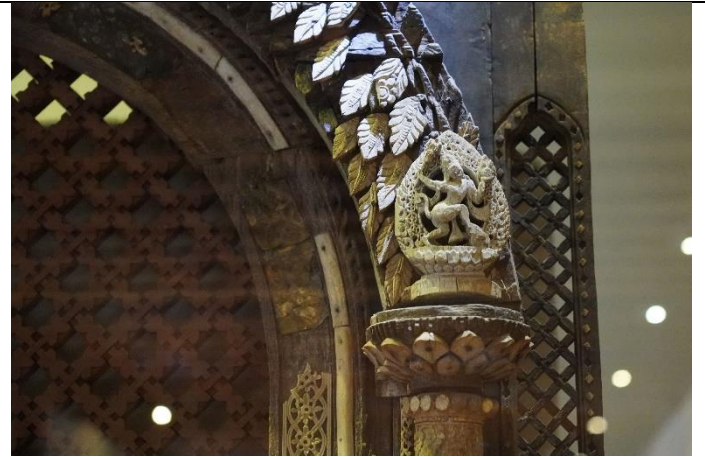
Fig. 8: Som missing elements on the right of the window, May 2024

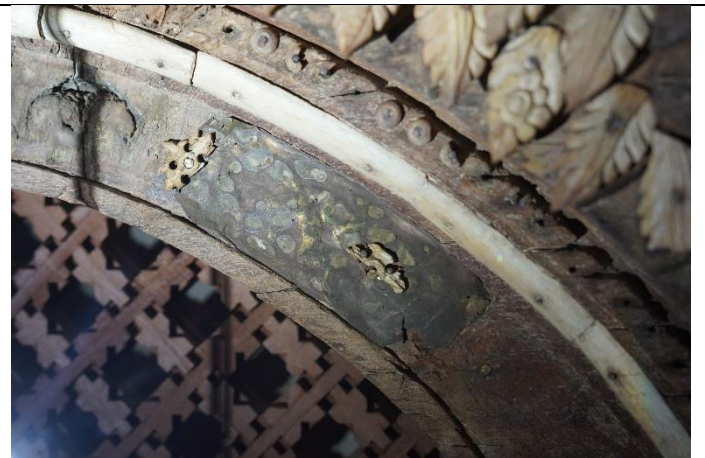
Comment:		
<input checked="" type="checkbox"/> Corrosion	<input type="checkbox"/> Major <input type="checkbox"/> Medium <input checked="" type="checkbox"/> Minor	- Slight green corrosion on the copper sheets - Slight corrosion of the iron nails

Fig. 10: Green corrosion on the copper sheets with almost all the gilding worn out, May 2024

Deposits (soiling, bird droppings) that accumulate on the surface over time are a major cause of corrosive reactions. In this respect, maintenance is the key to the long-term preservation of the Golden Window, but also of the epoxy reconstructed windows. Regular cleaning and removal of bird droppings must be considered by the local community as the most important factor in long-term conservation. Where citric acid is used to chemically reduce corrosion on the metal elements, it is essential that the surface is thoroughly rinsed after cleaning, as acidic residues accelerate corrosive reactions.

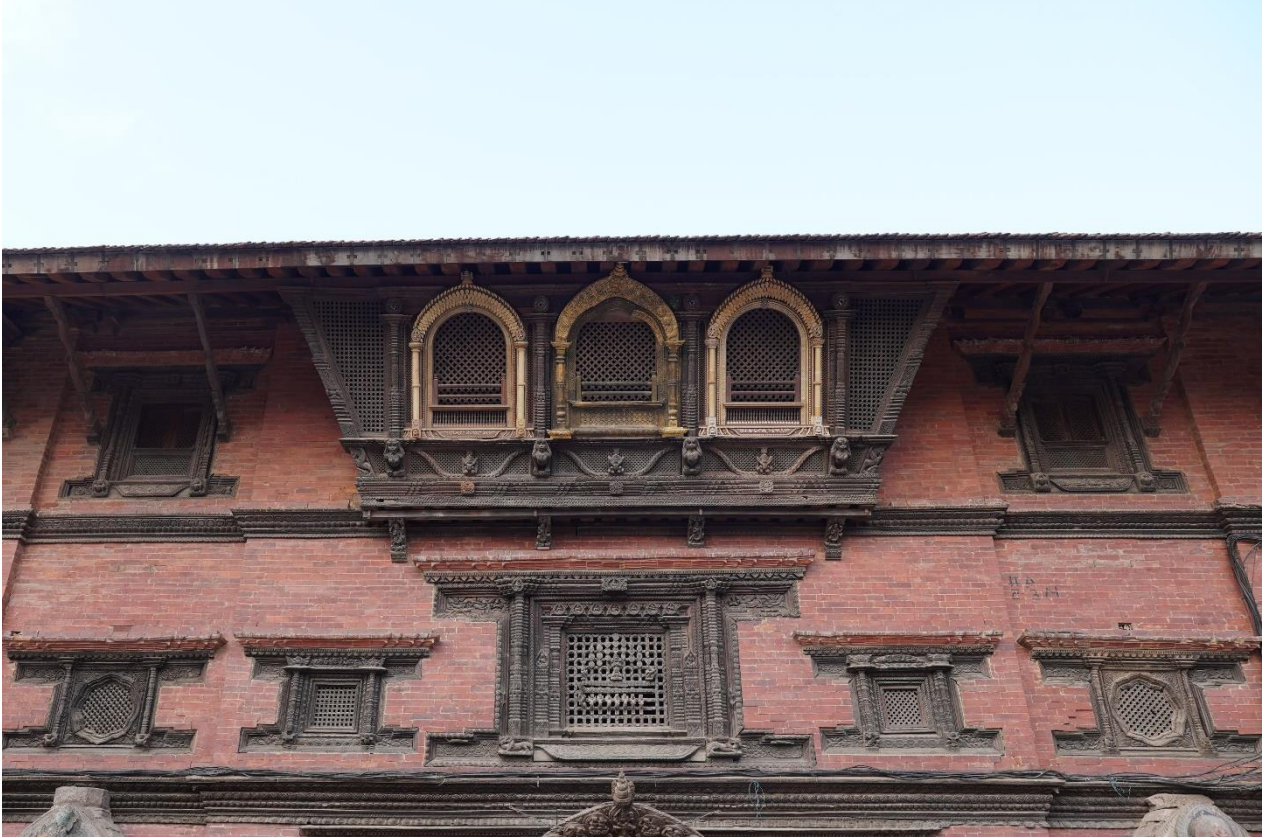
The condition of the golden window and the two reconstructed ivory windows on the facade of Sundari Chowk, facing west towards the Krishna temple, were judged to be satisfactory. The original ivory windows were replaced in 2017 by two reconstructions made with epoxy resin, which was adjusted to look like ivory by adding fillers and pigments, as part of Marina Paric's diploma.

Fig. 1: Golden window and reconstructed ivory windows on the facade of Sundari Chowk, May 2024

Deposits (soiling, bird droppings) that accumulate on the surface over time are a major cause of corrosive reactions. In this respect, maintenance is the key to the long-term preservation of the Golden Window, but also of the epoxy reconstructed windows. Regular cleaning and removal of bird droppings must be considered by the local community as the most important factor in long-term conservation. Where citric acid is used to chemically reduce corrosion on the metal elements, it is essential that the surface is thoroughly rinsed after cleaning, as acidic residues accelerate corrosive reactions.

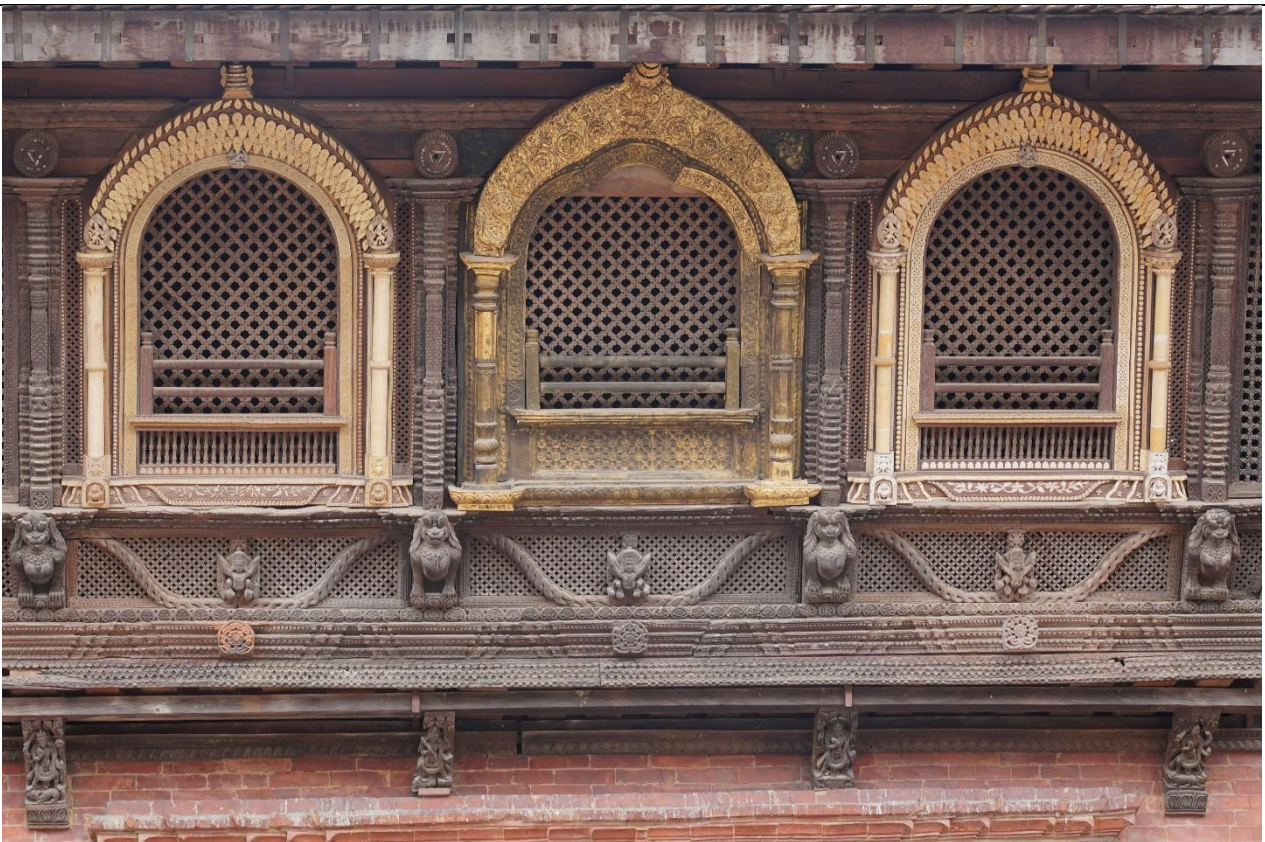
The surface of the three windows is generally in good condition, but much dust has accumulated on the surface. There is some darkening of the gilded surface of the metal window, particularly in areas of worn gilding. Minor green corrosion has been noted. The reconstructed epoxy resin elements show varying degrees (condition 1-4) of ageing and yellowing, probably due to the use of different epoxy resins and varying amounts of fillers and pigments, but the overall appearance blends well with the surroundings.

Fig. 2: Close-up of the golden window and reconstructed ivory windows on the facade of Sundari Chowk, May 2024
