## KING'S THRONE

Report of the Institute of Conservation (IoC), University of Applied Arts Vienna

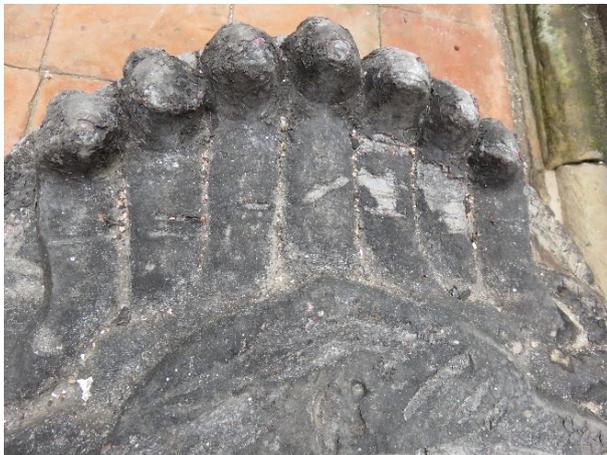
- Due to the collapse of the mandapa in 2015, formerly housing the King's Throne, the object suffered damage
- Back of the backrest broke, whereby the fracture runs horizontally through the rectangular hole
- At the base a piece broke apart, probably due to the strong movement of the backrest during the earthquake
- All stone surface (especially at the inscription and detail carvings) covered with layers of ritual offerings (ghee, tikka paste, etc), dust and dirt deposits

Fig. 8: Backrest's front covered with layers of dirt, 2015

- Transfer of backrest (2015) and dismantling of the of the base and seat (2016, done by the KVPT)
- Mechanical removing of thick layers of dirt and worshipping residues with scalpel and spatulas
- Remaining thin layers on the stone surfaces were reduced by using chemical agents, as ethanol and a weak solution of tenside (dish detergent) in water in addition to cotton swabs and brushes;
- Final cleaning with pure water (rain or drinking water)
- Re-adhering of broken back of backrest; two holes were drilled vertically into the upper and lower part; carbon fibre pins were then glued to both sides with an epoxy resin (Akepox 2020); additionally, dashes of epoxy resin were applied to the fractured surface
- Re-adhering the broken part of the base; reinforcements with carbon fibre pins glued with epoxy resin (Akepox 2020®)
- Pointing the joint of the fractured base with mortar

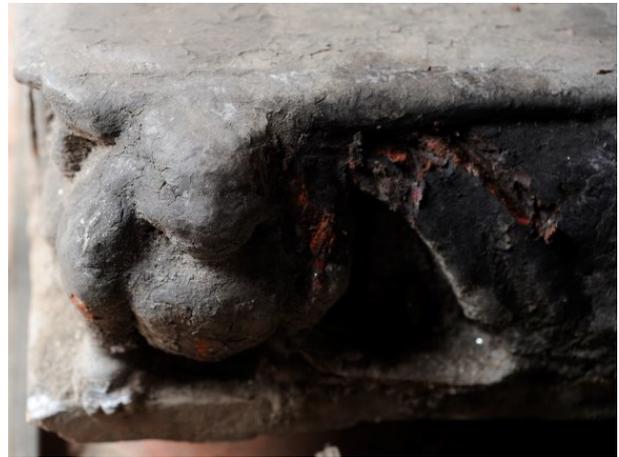
Fig. 9: Seat covered with layers of dirt, 2016

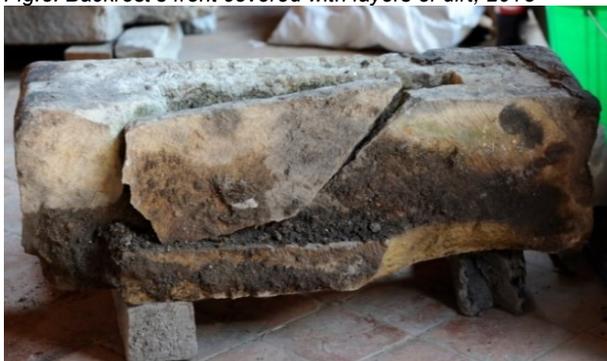
Fig. 10: Broken part at the base element, 2016

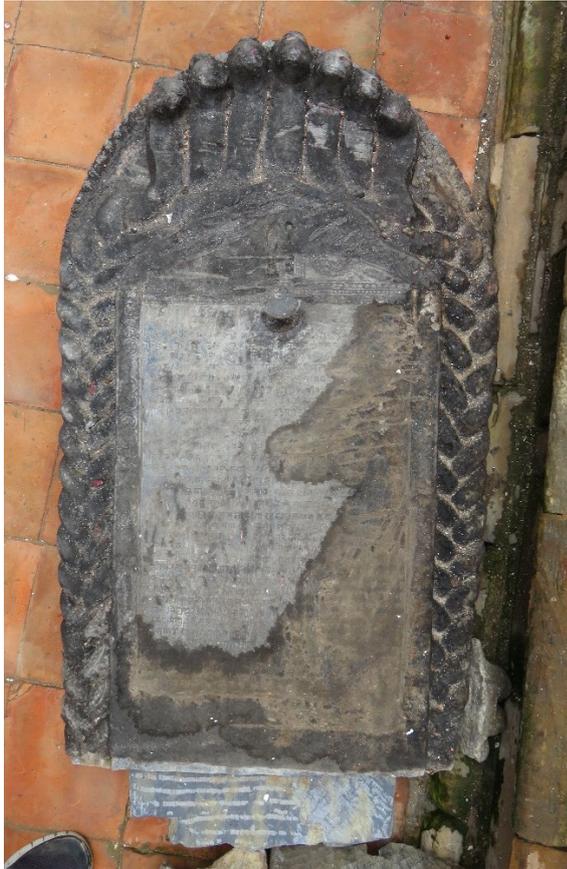
Fig. 20: Throne before conservation, 2015

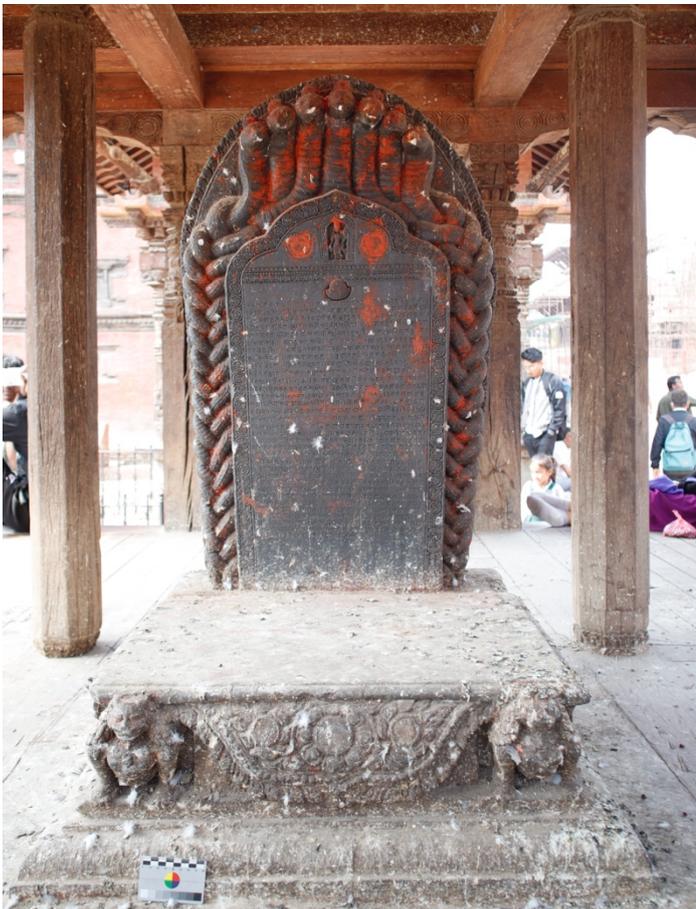
All surfaces have been found heavily soiled, but the inscription is still readable, also the fine carvings around the inscription.

The Heads of snakes show a thicker soiling layer, the front part of the seat was also covered with a thicker soiling layer.

Fig. 1: Kings throne, front, condition 2024.

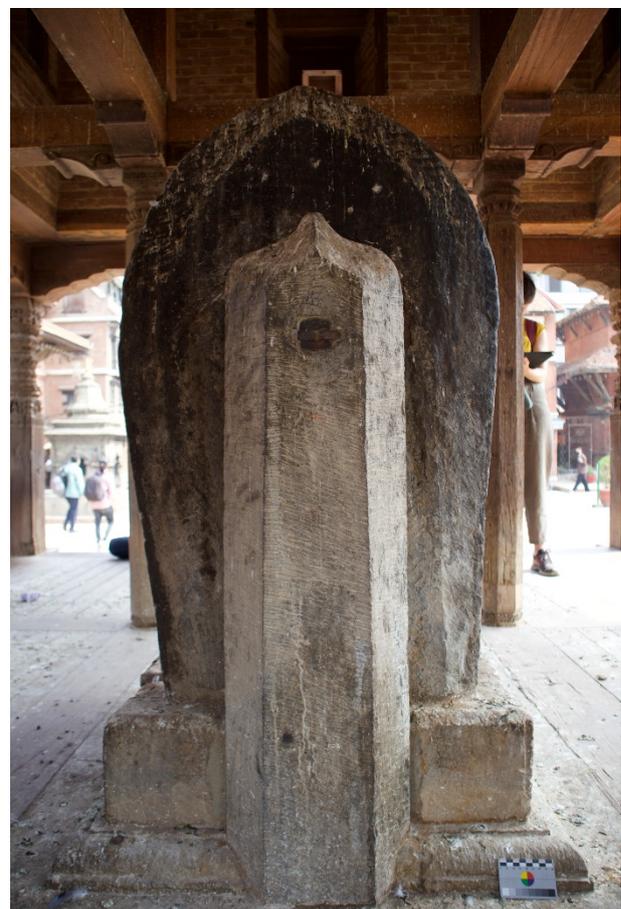
Fig. 2: Kings throne, back, condition 2024.
