MUL CHOWK GATEKEEPER LIONESSE

Report of the Institute of Conservation (IoC), University of Applied Arts Vienna

Data Sheet

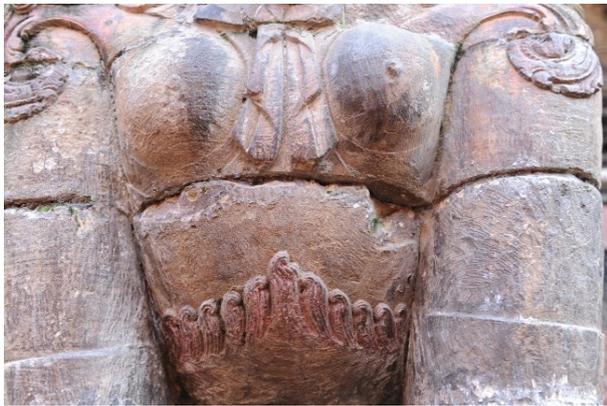
The main problem prior to the conservation was the inadequate joint mortar. It was too dense for the surrounding stone and also partly missing, which caused increased water penetration. The high water retention ability of the brick core further impaired the situation and caused long-lasting wetness of the stone blocks. All these factors favoured biological growth and accelerated deterioration.

- Damaged and open joints
- Microbiological growth and growth of higher plants within damaged areas (cracked joints) and uncovered areas (overhanging roof only partly protects monument from rain water)
- Loose stone blocks
- High water retention of brick core keeps stones wet longer which favours microbiological growth

Fig. 8: Damaged and open joints, 2011

- Repointing of joints by using a mortar based on lime and white cement as binding media (cement was necessary due to the continuous rain load on the front parts of the monument); scratching off the joints to surface level of the stone

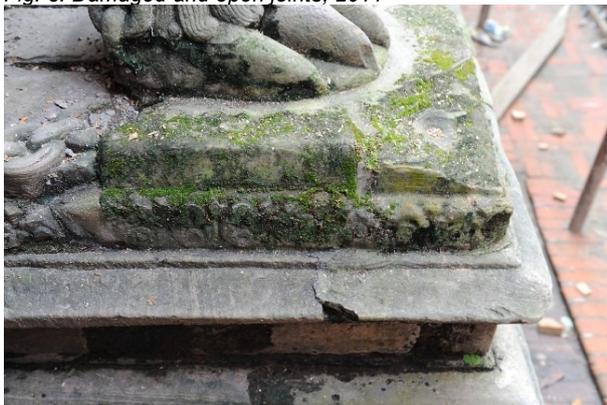
Fig. 10: Broken edge and biological colonization, 2011

- Exchange of highly damaged stones (new stone blocks were carved by KVPT)
- Former brick-filled core was left hollow (improved stability was provided by clamps)

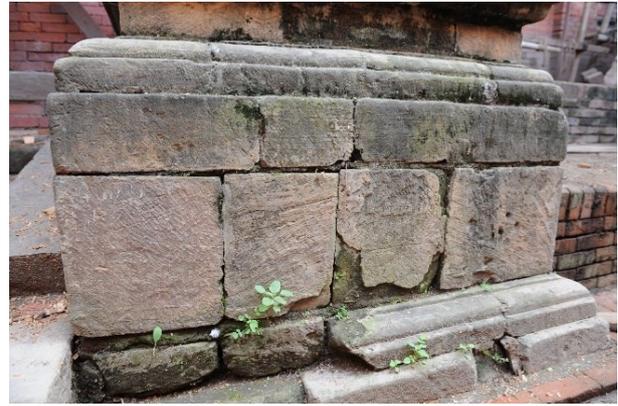
Fig. 9: Damaged / open joints biological colonization, 2011

- Opening of joints in remaining structure to a depth that allows a proper repointing
- Cleaning of all parts with (rain) water and brushes
- Biocide treatment (2% in water), three-time application

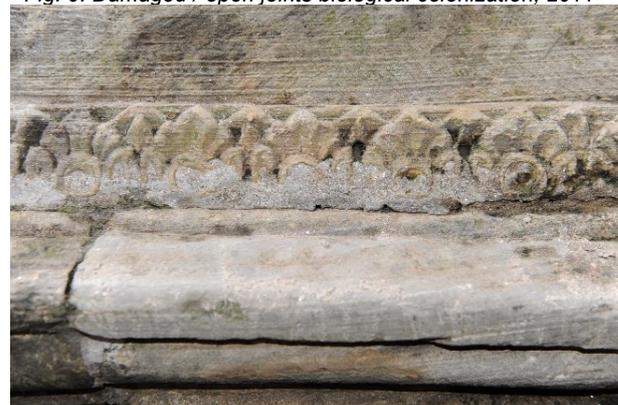
Fig. 11: Inappropriate application of joint mortar, 2011

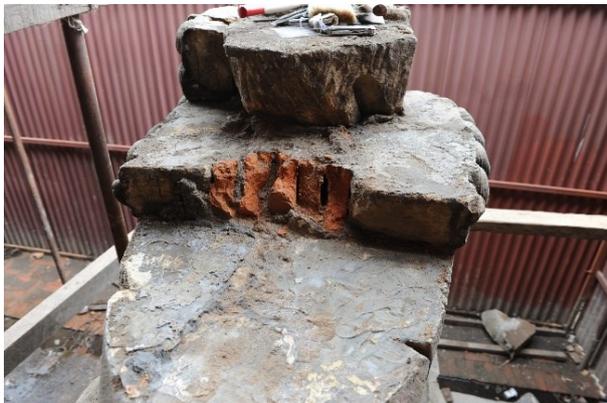
Fig. 12: During dismantling, brick core, 2011

- Dismantling of upper part, removing of the brick core
- Mechanical removing of joint mortar and mortar residues on dismantled blocks with glass fibre pencils, scalpel, hammer and chisel

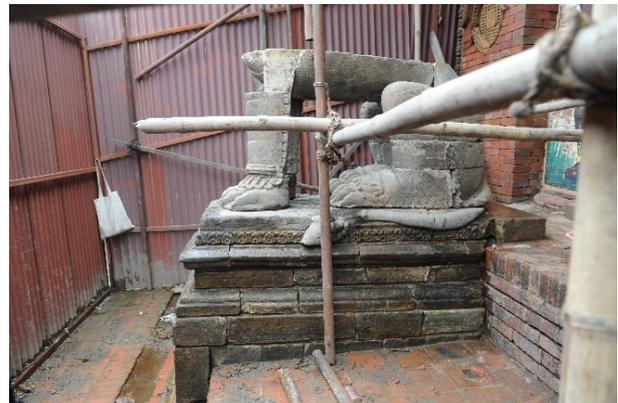
Fig. 13: Upper part dismantled, 2011

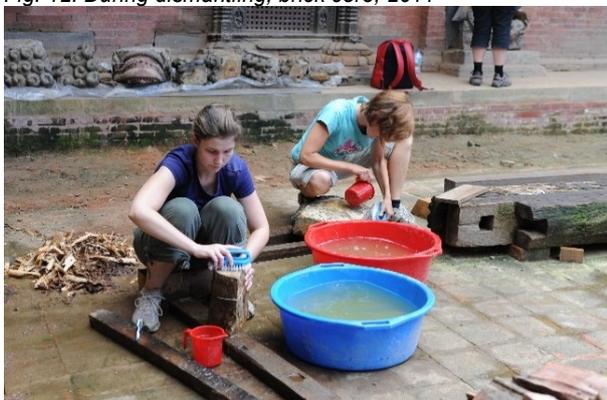
Fig. 14: Cleaning of stone parts, 2011

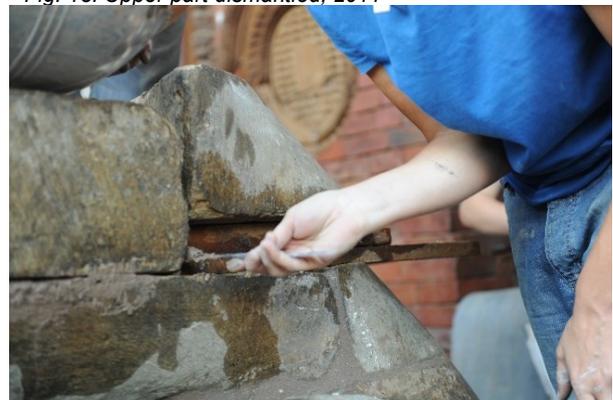
Fig. 15: Repointing joints, 2011

- Alkylbenzyltrimethylammoniumchlorid Merck® (Sigma-Aldrich)
 - Inox clamps and needles
- Joint mortar:** 1 vol. part cement : 2 vol. parts lime : 6 vol. parts sand : 3 vol. parts brick dust
- white cement
 - slaked lime (pigmented)
 - pigments black (local) and green ('oxide pigments' - NCS S 7010-G10Y)
 - sand
 - brick dust

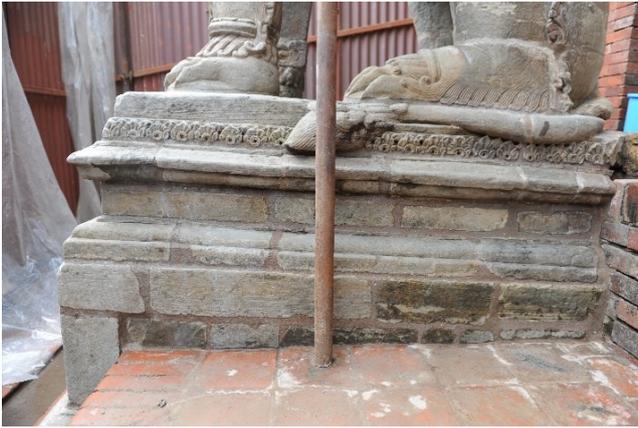
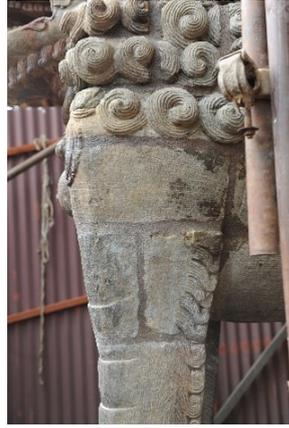
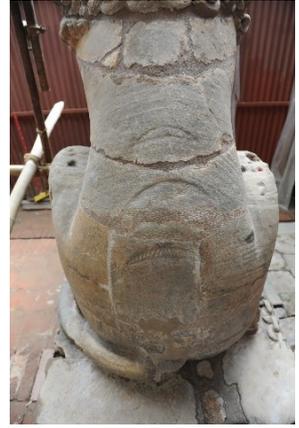
Fig. 16, Fig. 17, Fig. 18: Repointed joints, 2011

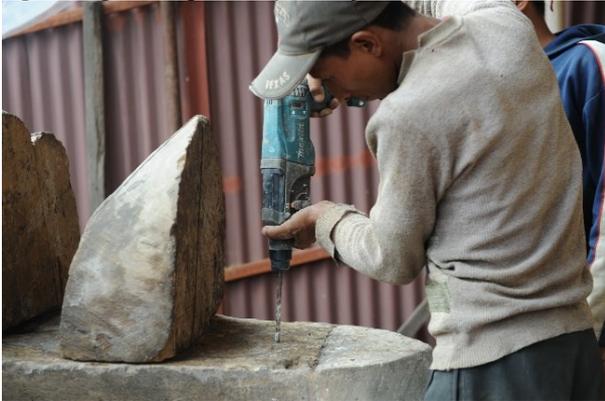
Fig. 19: Drilling holes for the inox needles, 2011

- Reassembling of dismantled parts and introducing inox clamps to create a kind of ring bracing in two different levels (earthquake reinforcement); in between vertically inserted inox needles interconnect stone block layers

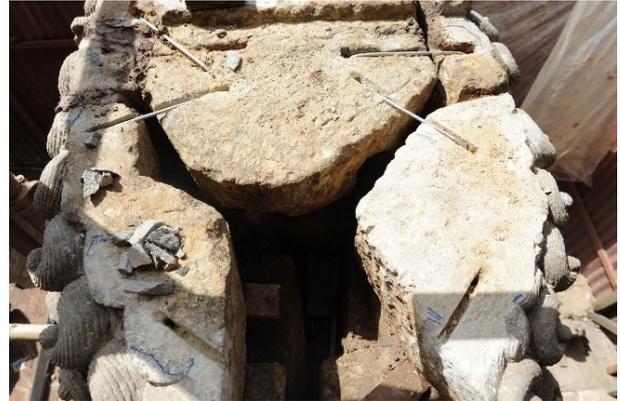
Fig. 20: Introduced inox clamps, 2011

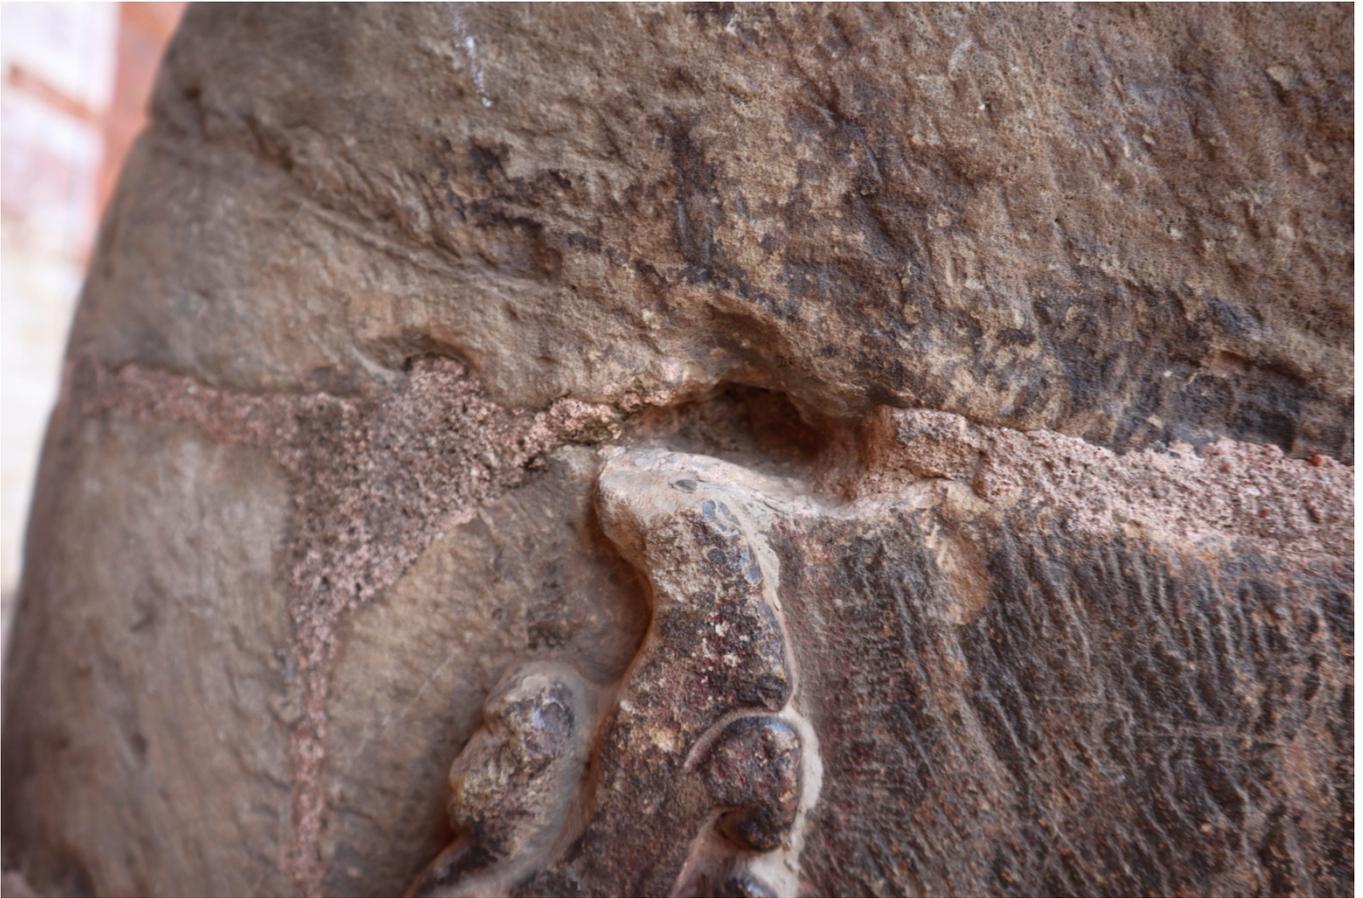
Fig. 5: Cracked and open joint.

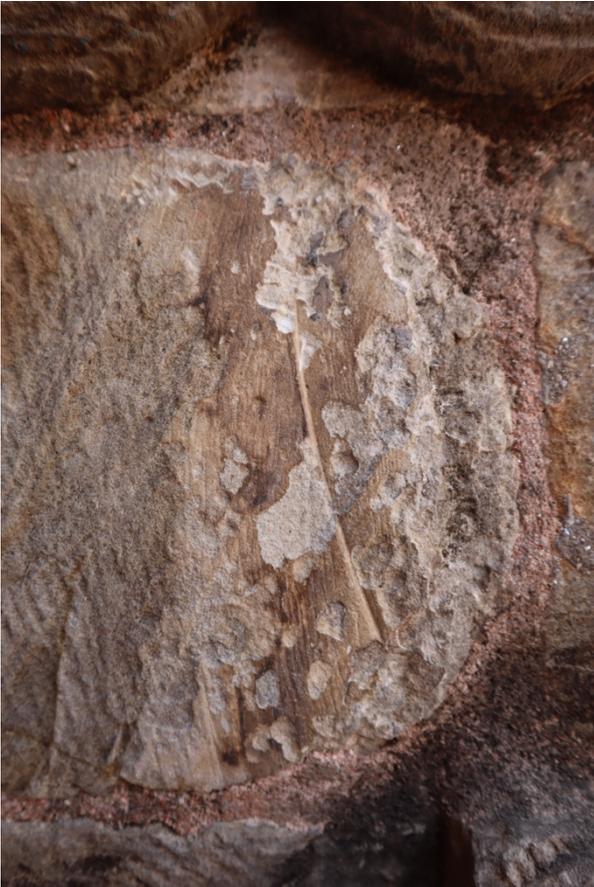
Thin scales on the right side and front foot with no salts visible.

Scaling may be caused by material-immanent problems.

Fig. 6: Darkened crust and scaling on stone surface.
