NARASIMHA TEMPLE

Report of the Institute of Conservation (IoC), University of Applied Arts Vienna

Condition Assessment

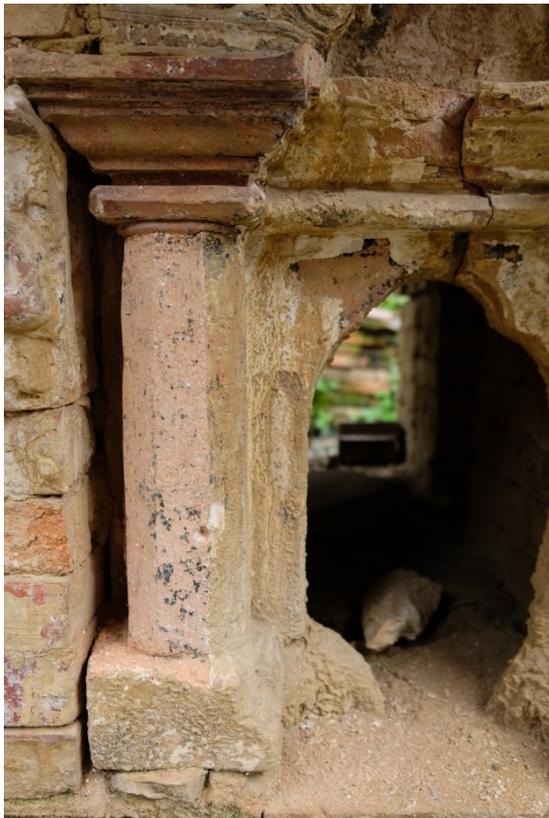
Fig. 5: Old reconstruction of terracotta element

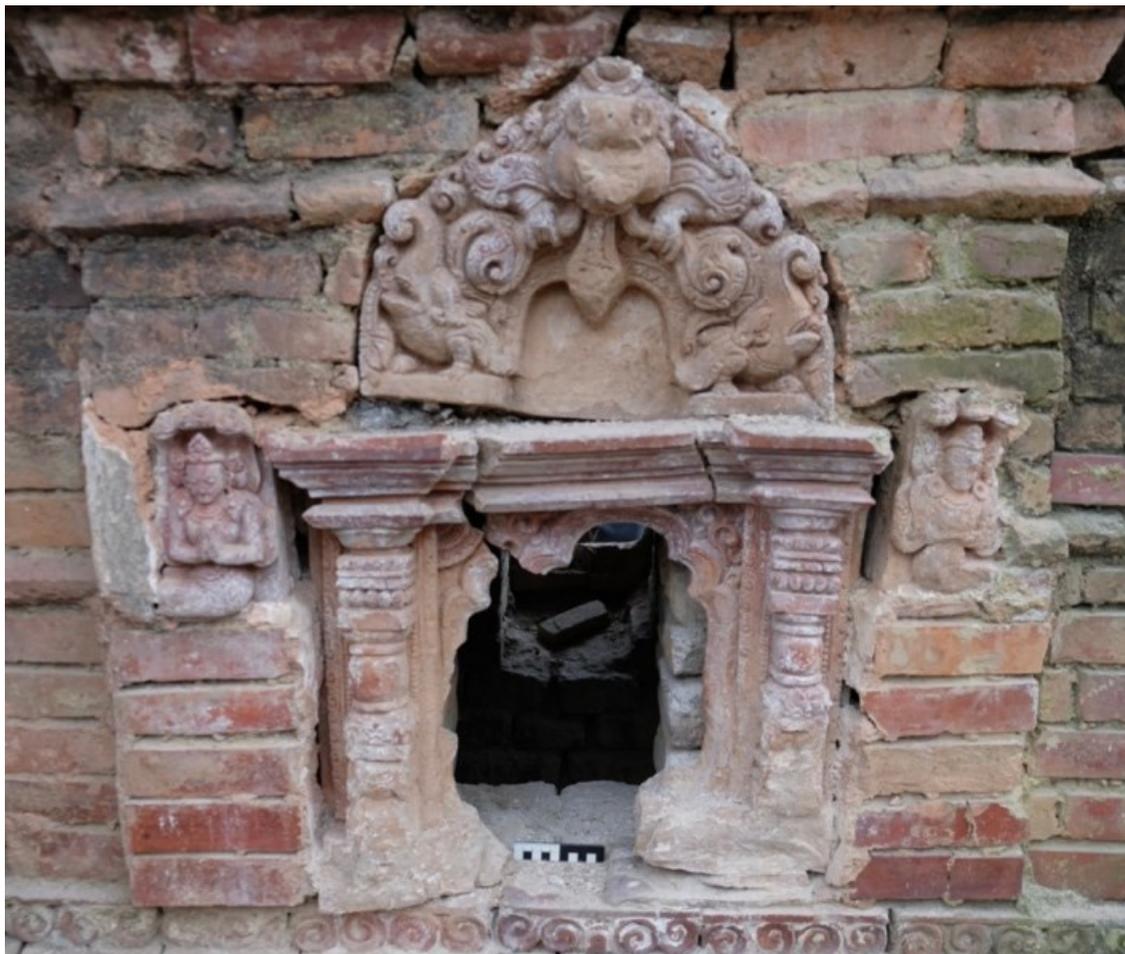
- Partial damage due to the earthquake 2015, wooden pillar inside the temple broken and bricks partly loose or missing
- Strong biological colonisation at the south side (moss, algae, lichen)
- Wooden bars on which miniature temple rests, are partly weathered
- Open joints and plant growth inside these joints
- Soiling of all surfaces, on the terracotta elements intensity of soiling differs and is probably linked to irregular sinter layers due to irregular firing (areas with higher moisture penetration are more soiled)
- Terracotta elements show heavily weathered areas, partly elements are missing completely, mainly due to continuous water penetration
- Cracks in terracotta elements

Fig. 9: Terracotta elements showing fractures, deformations and weathered surfaces

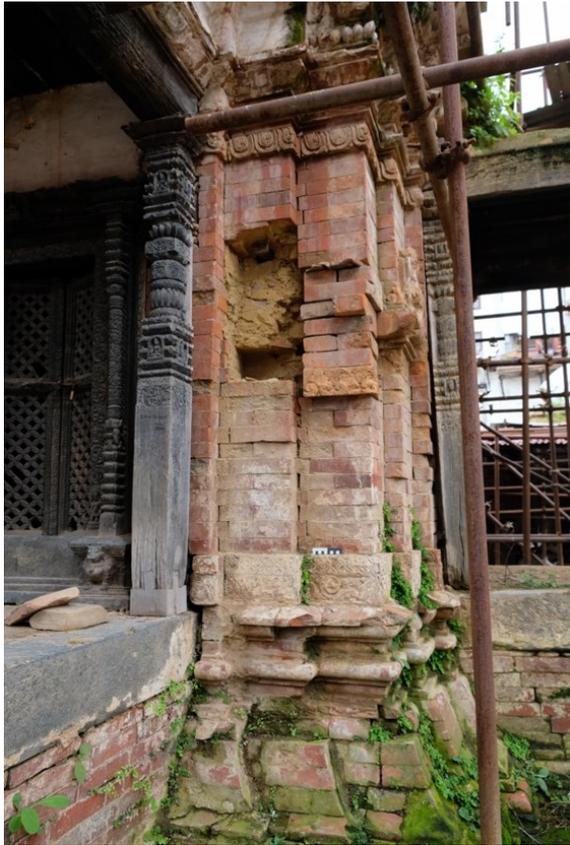
Fig. 10: Missing and loose bricks

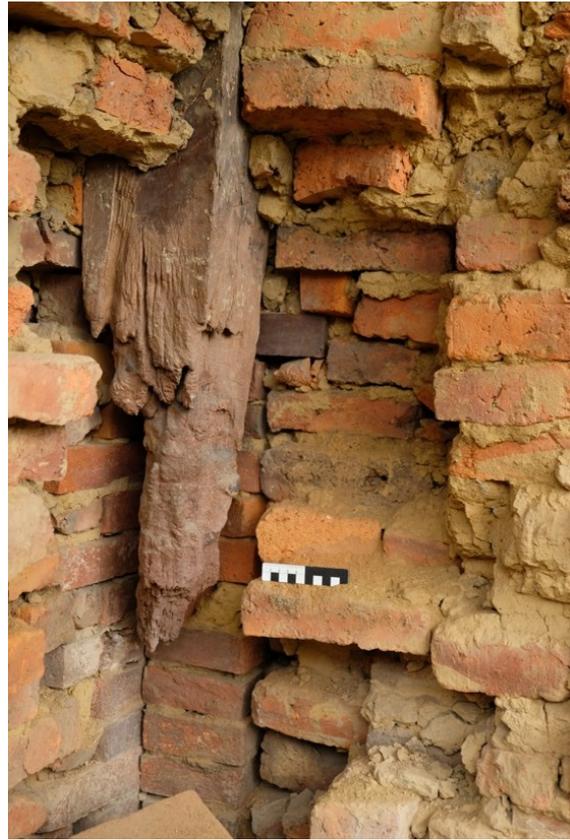
Fig. 11: Broken wooden pillar

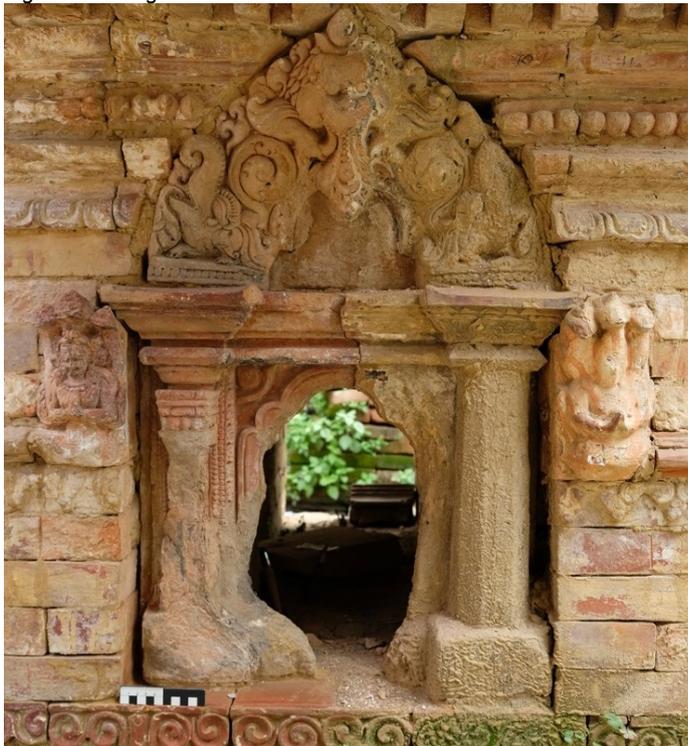
Fig. 12: Material loss and weathered surfaces

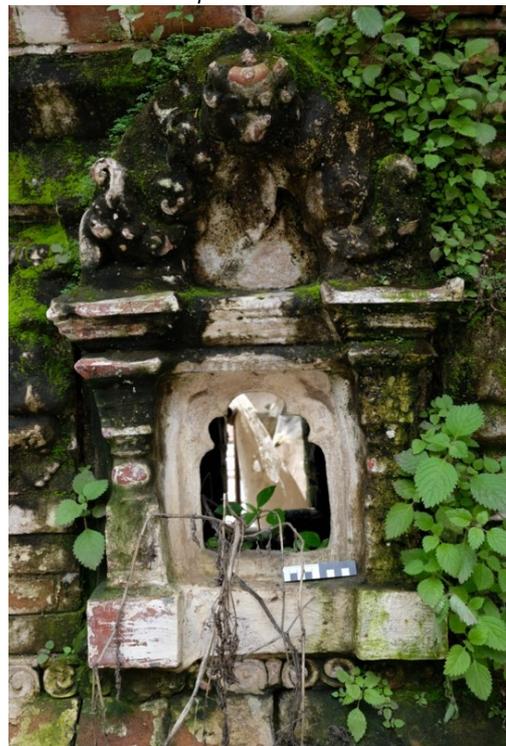
Fig. 13: Plant growth

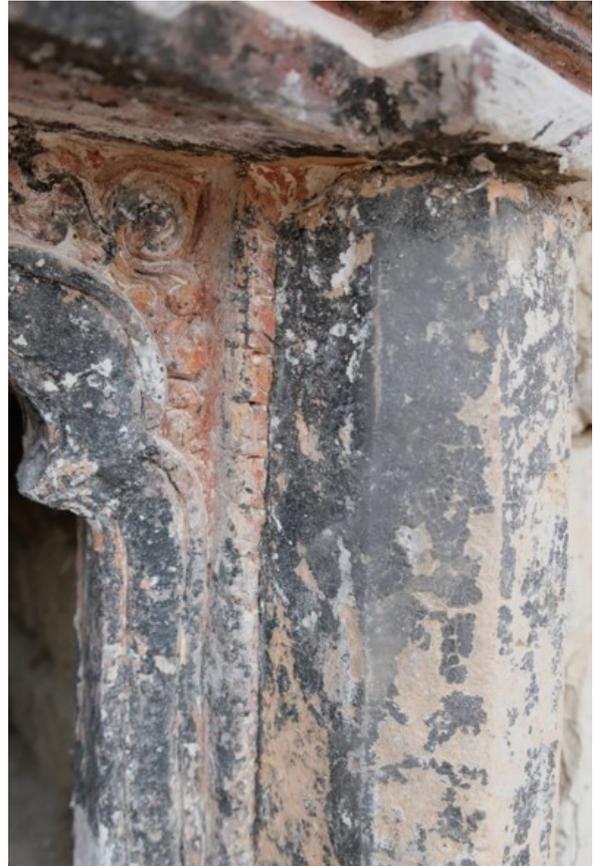
Fig. 15: Black crust / layer beneath the lime layers

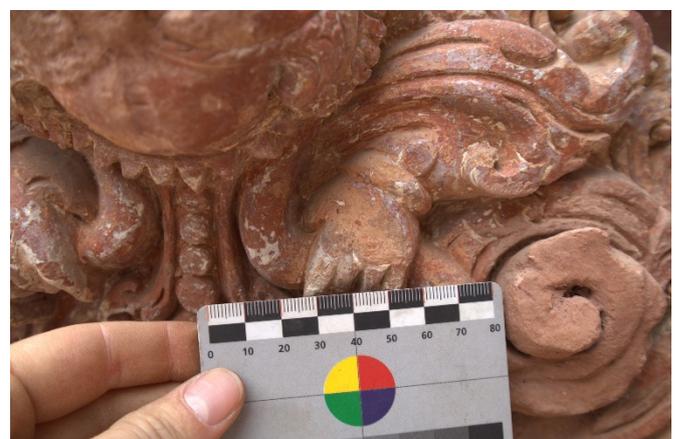
WS Scaling in the middle of the Torana (recent?), Small cracks in the coarse mortar, no powdering or sanding of the protective coating.

Figure 5: Detail, scaling at the left backhand of the Kirtimuga, WS Window, Torana.

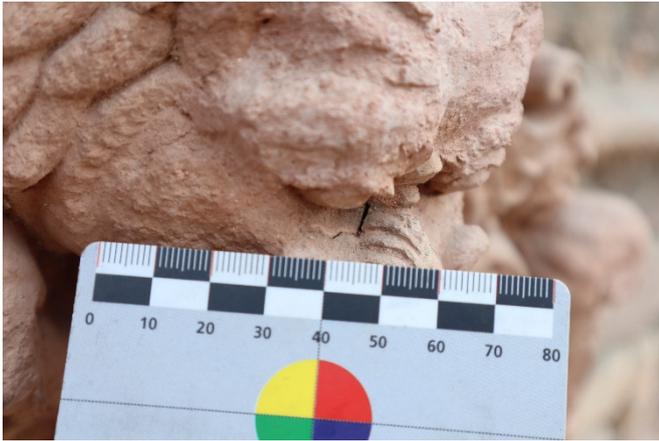
W Cracks (detachment of coarse mortar due to manufacturing errors), no powdering of the protective coating.

Figure 12: W-Window, Detail Torana, Crack at the Nose of the Kirtimuga.

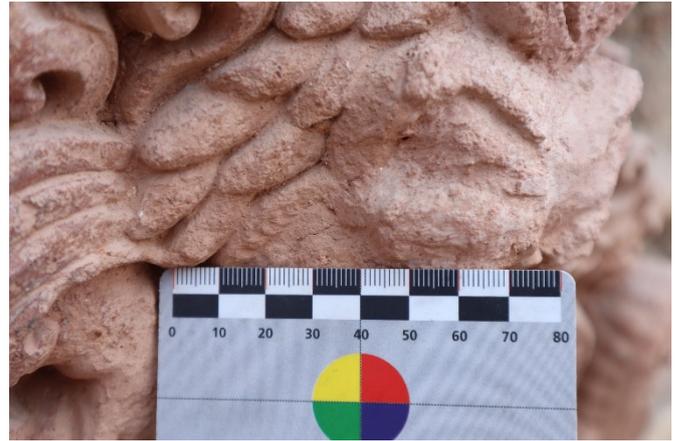
Figure 11: W-Window, Detail Torana, Crack at the border between mortar and terracotta.

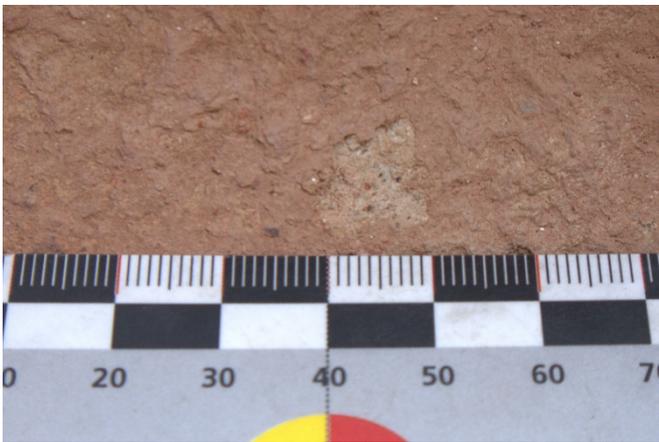
Figure 14: W-Window, Middle of the Torana, Scaling of the protective layer.

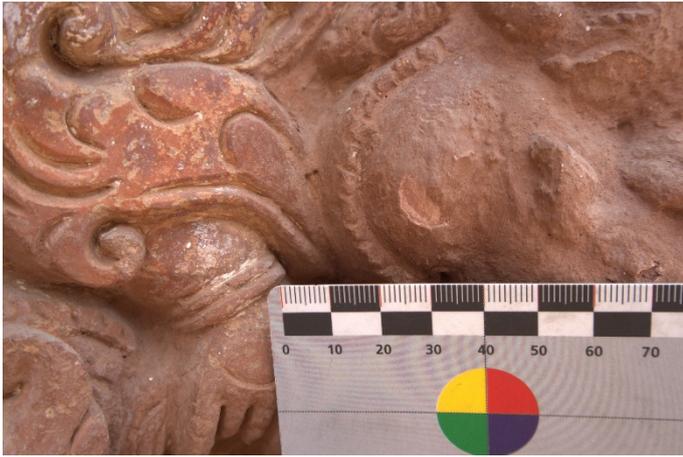
WN Coarse mortar is partly crumbling, no powdering of the protective coating.

Figure 19: WN-Fudja, left cheek Kirtimuga, Scaling of Terracotta.

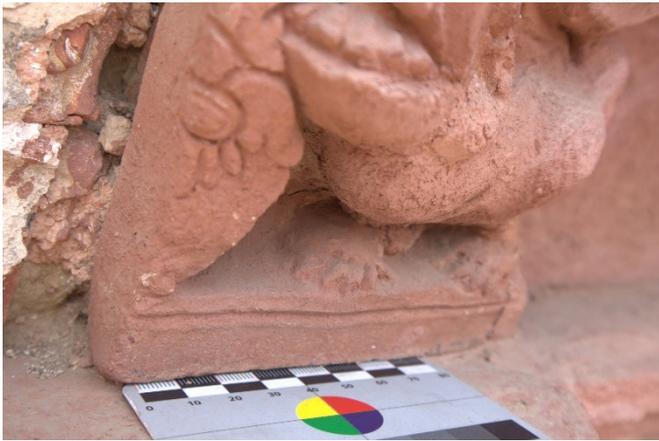
EN Cracks in the coarse mortar, rough/inappropriate application (regarding formal reconstruction), no powdering of the surface coating.

Abbildung 6: EN-Window, Detail Torana: Crack and scaling of Terracotta under the head of left Makara.

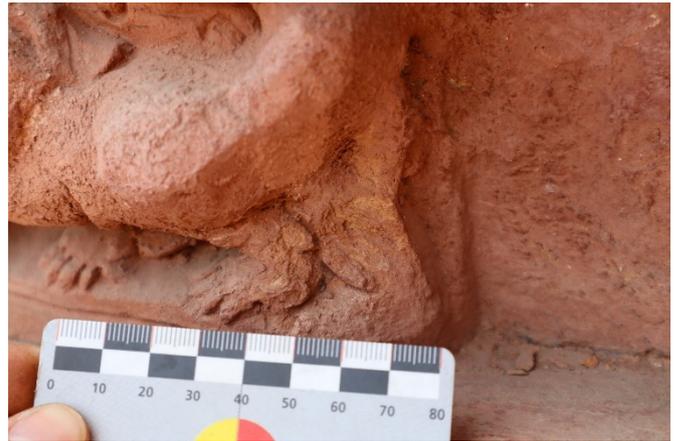
Abbildung 5: EN-Window, Detail Torana: Scaling of the Tail of the right Makara.

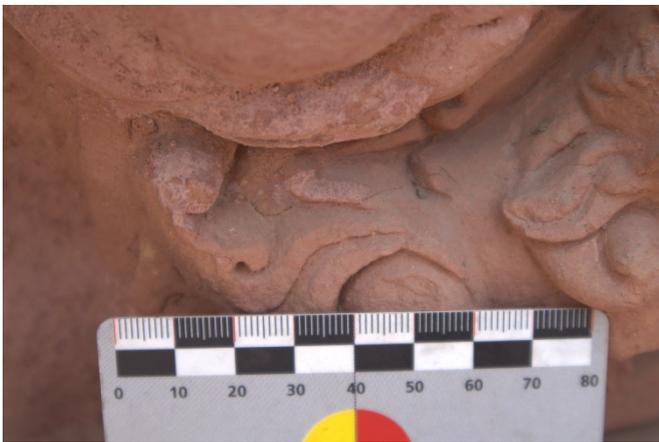
Abbildung 8: EN-Window, Detail Torana: Crack at the back of the left Makara.

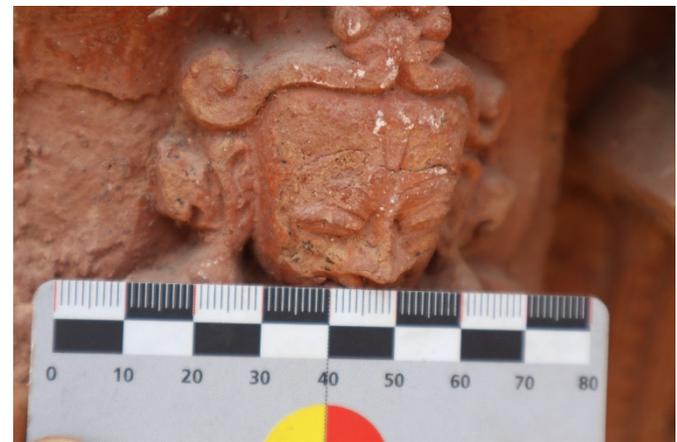
Abbildung 7: EN-Window, Detail at the left Nagar face: Scaling, not sure if due to manufacturing mistakes or conservation treatment.

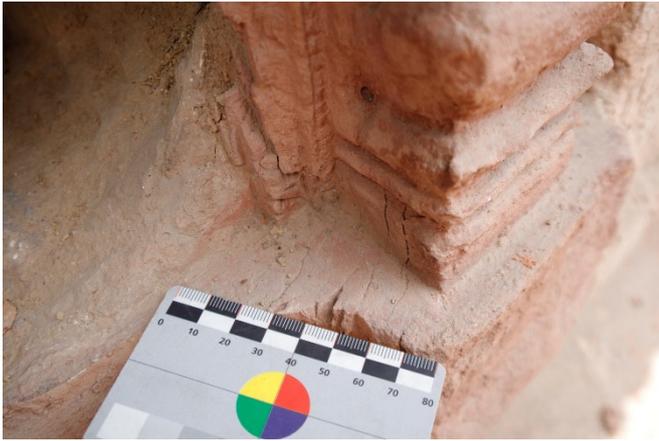
ES Crack at the boarder of mortar and terracota, a bit of powdering of the surface coating, cracks in the terracotta (recent?)

Figure 30: ES-Window, Detail cracks at the bottom of the right Pillar.

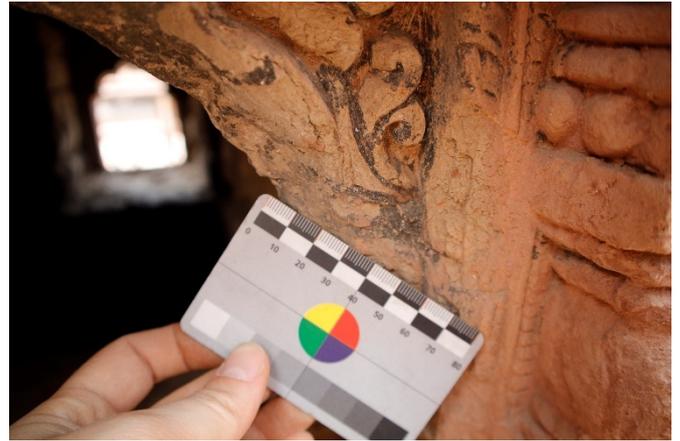
Figure 29: ES-Window, Scaling at the right side of the arch.#

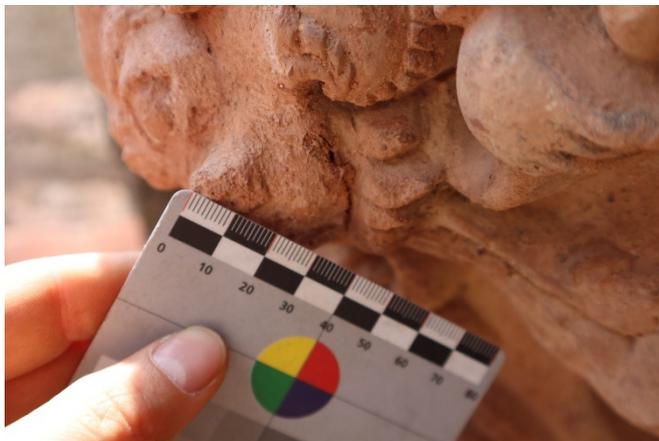
Figure 31: ES-Window, Detail at the Torana of a crack at the mouth of the Kritimuga.

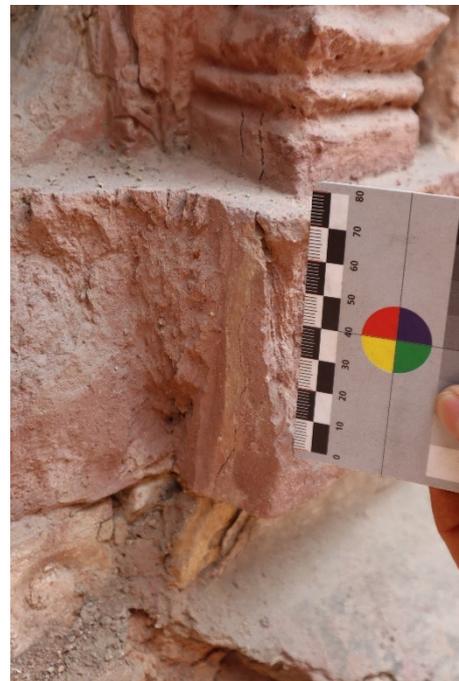
Figure 32: ES-Window, Detail of the cracks at the right bottom of the Window.

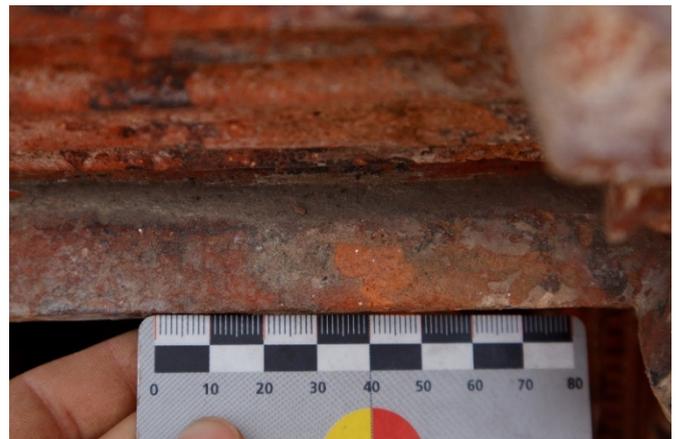
SE Protective coating on sinter-surface (?), moss/funghi grows on coating in shape of dots (coating with acrylic resin (Primal?)), powdering of the protective coating.

Figure 37: SO-Window, detail scaling at the cornice.

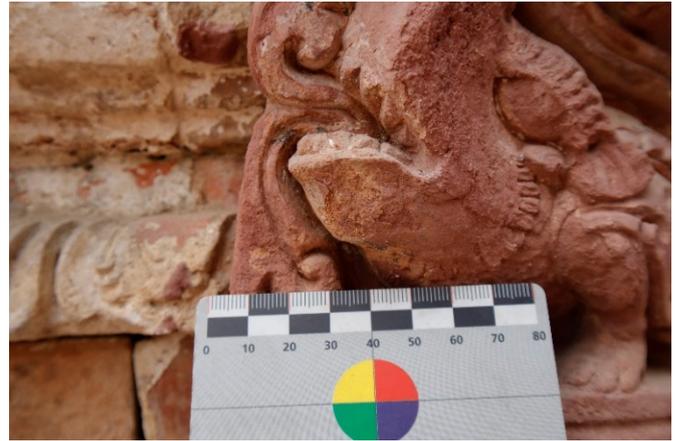
S Mortar is soft and crumbling (not cured properly, can be easily scratched off), protective coating is powdering, colour a bit too pinkish, cracks at boarder of mortar and terracotta.

Figure 44: S- Window, Detail Torana, flaking off from the protective layer.

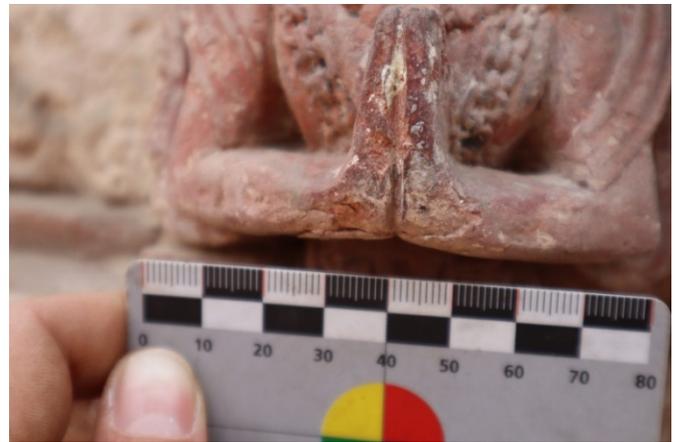
Figure 46: S-Window, Detail left Nagar, Scaling of the Terracotta at the Hands.

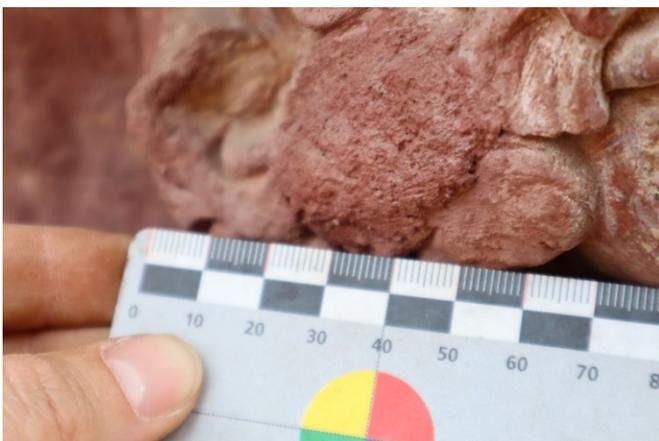
Figure 48: S-Window, Detail Torana, replacement with coarse mortar.

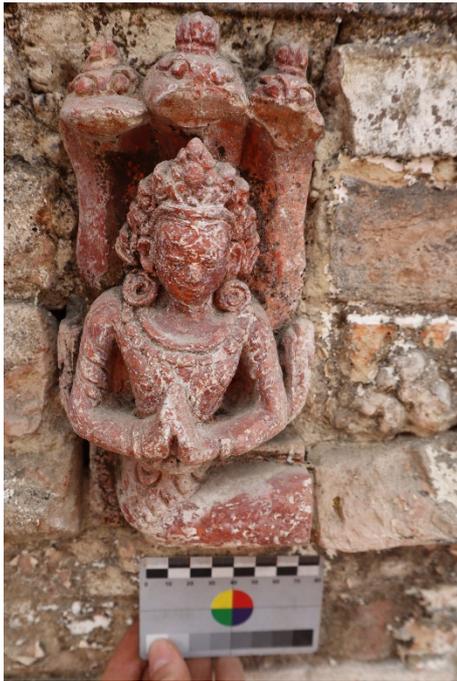
SW Only Naga is preserved, no Torana. Good condition.

Figure 49: South-Fudja, SW-Window, only the right Nagar is left.

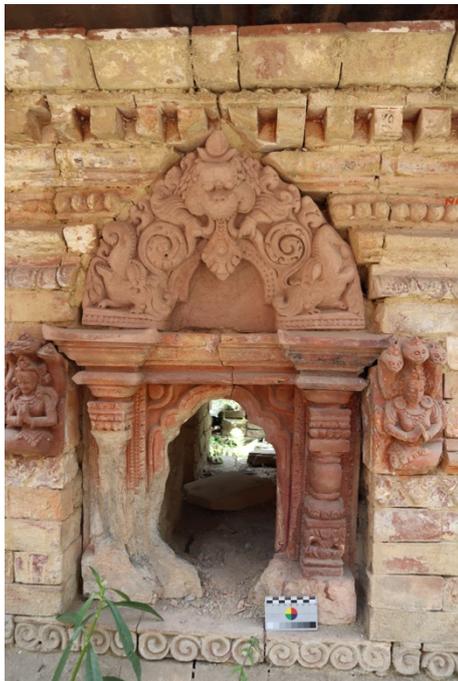
NN Crack in the middle of the cornice; missing part at left pillar; joints partially open; major scaling, sanding and powdering on the left pillar and the right base – probably due to salt deterioration; medium soiling, mostly dust and bird droppings;

Figure 50: North-Fudja, North-North Window.

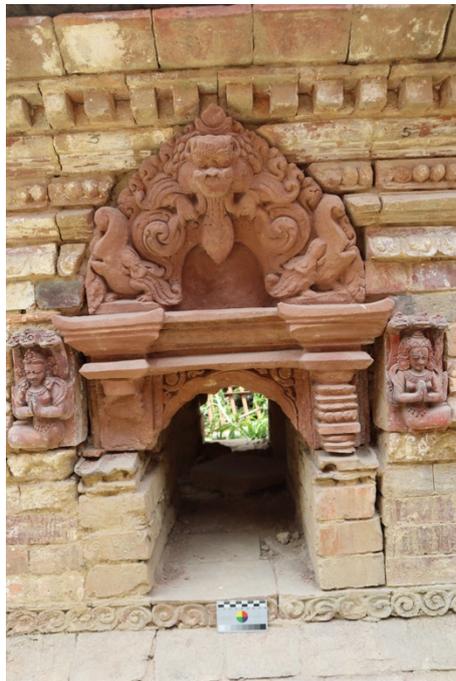
EN open joints; medium soiling with dust and dirt;

Figure 51: North-Fudja, North-East Window.

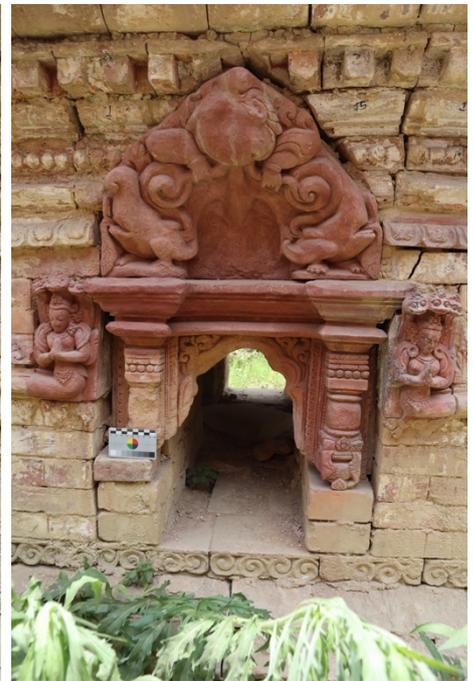
WN joints partially open; major scaling sanding and powdering on the left pillar – probably due to salt deterioration; medium soiling mostly dust;

Figure 52: North-Fudja, North-West Window.
