## STONE GATES

Report of the Institute of Conservation (IoC), University of Applied Arts Vienna

GENERAL INFORMATION		
<b>Monument</b> Stone Gates (Gate A)	<b>Orientation</b> -	<b>Size (H x L x W)</b> -
<b>Date of Production</b> 1640-1734	<b>Location</b> Flanking Degutale Temple	
<b>Date of the last Treatment</b> Conservation 2012-2014	<b>Institutions of the last Treatment</b> IoC

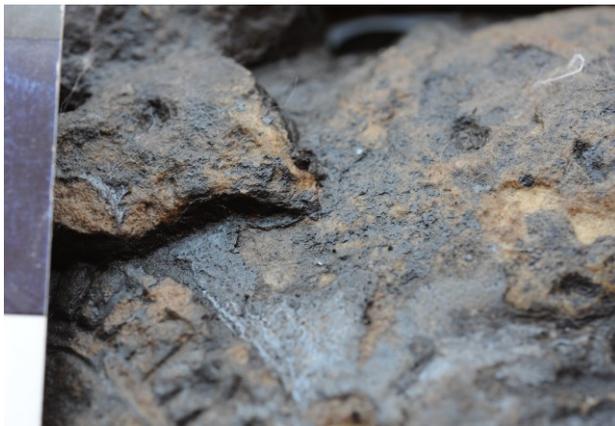
- Missing parts
- Bursted parts at exposed areas
- Salt deterioration appearing as surface loss through sanding, flaking and scaling of the first stone grain layers; salt crystallization beneath the water repellent layer (bituminous coating)
- Cement joints and infills and partial cement layer over surfaces
- Biological colonisation
- Soiling
- Most of damage (e.g., sanding, scaling, flaking, biological colonisation) accelerated by impaired drying behaviour and retention of water mainly caused by too dense joint mortar and bituminous coating

Fig. 7: Bituminous coating, scaling due to salinisation, 2012

- Mechanical removal of thick layers of bitumen with spatulas and scalpels
  - Cleaning with acetone and acetone-poultices (cotton soaked with acetone and covered with aluminium foil)

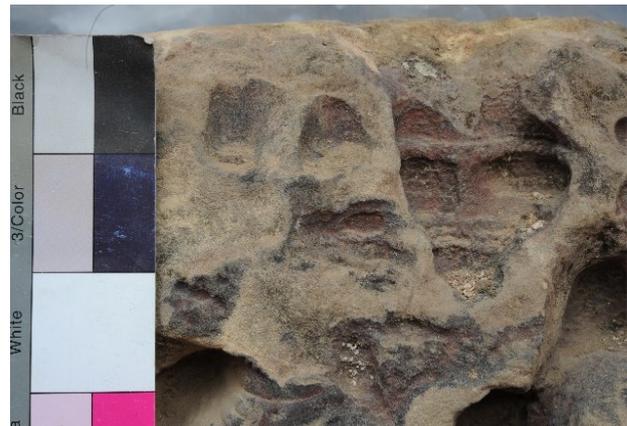
Fig. 8: Surface loss due to salinization, 2012

- Biocide treatment with QUATS (solved in water 1:10), applied twice with an application time of 12-24 hours, cleaning with water afterwards
  - Desalination bath with collected rain water

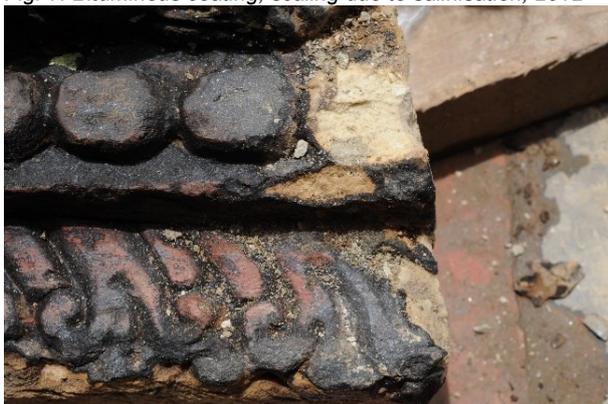
Fig. 9: Bursted edges due to inappropriate handling, 2012

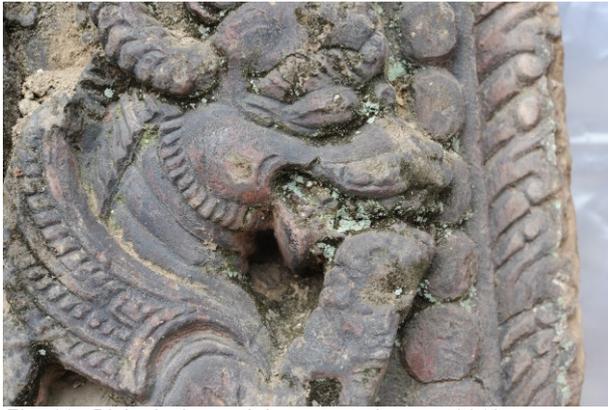
Fig. 11: Biological growth in protected areas, 2012

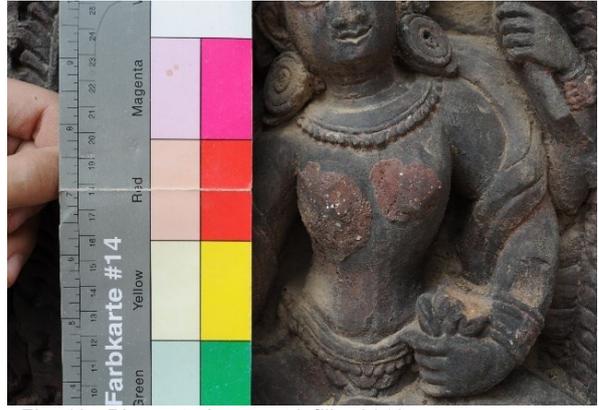
Fig. 12: Pigmented cement infills, 2012

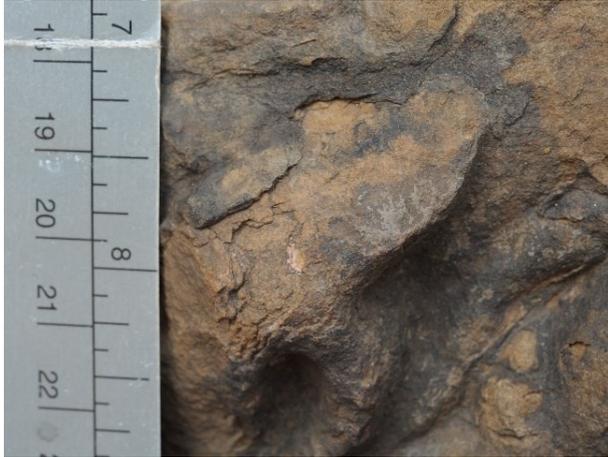
Fig. 13: Scaling of grain layers, 2012

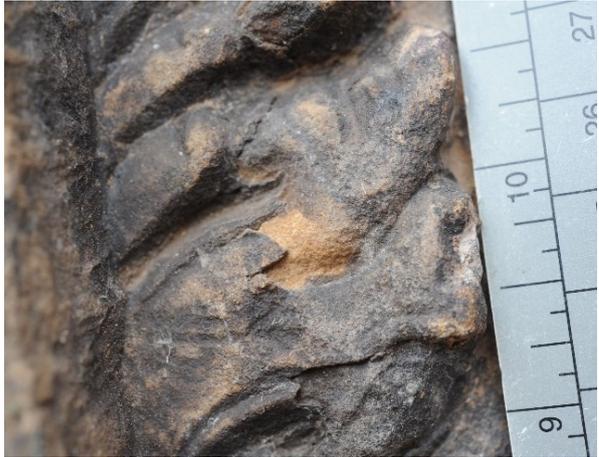
Fig. 14: Peeling of first grain layers, 2012

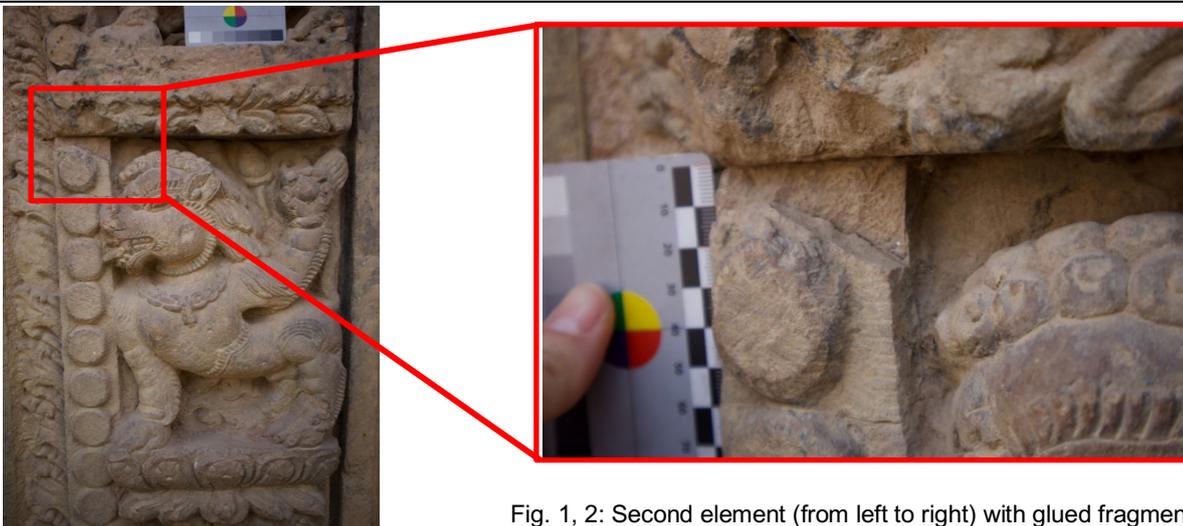
Second element piece at the left upper corner

broken that was already glued? Glue still intact (Fig. 1, 2).

Fig. 1, 2: Second element (from left to right) with glued fragment.

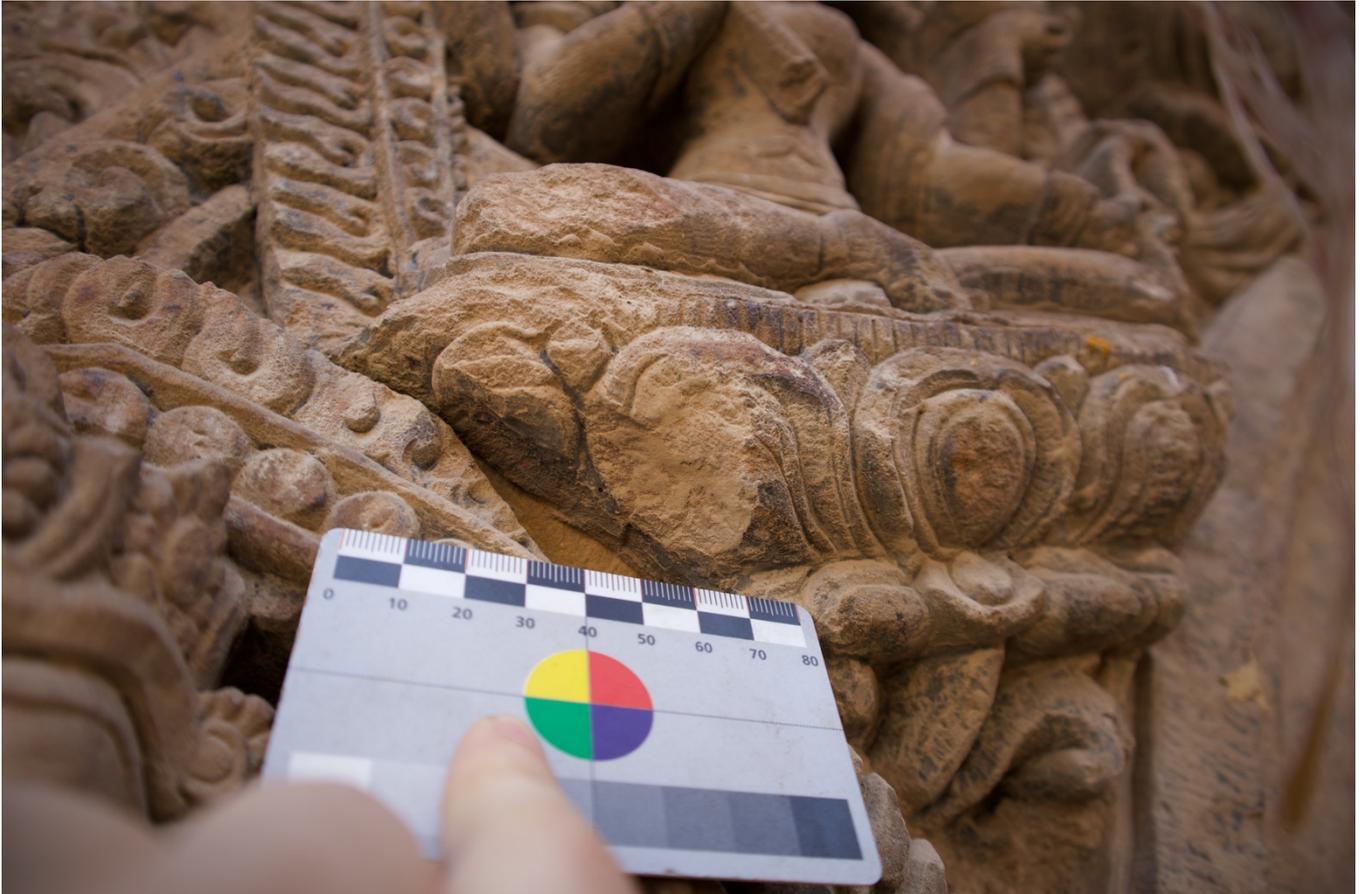
6<sup>th</sup> element, lotus seat at blossom (Fig. 3).

Fig. 3: Missing part at lotus seat.

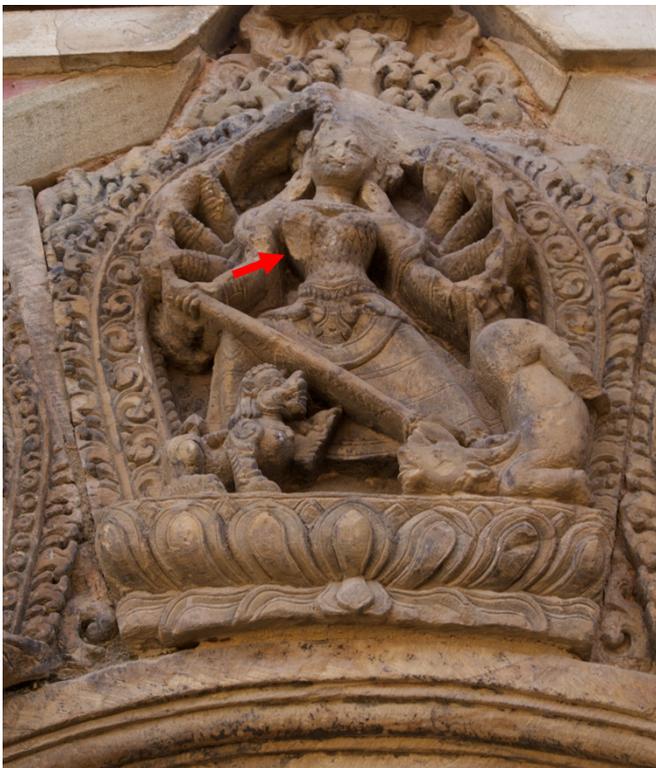
8<sup>th</sup> element, breast area (Fig. 4)

Fig. 4: Missing part on breast of the figure.

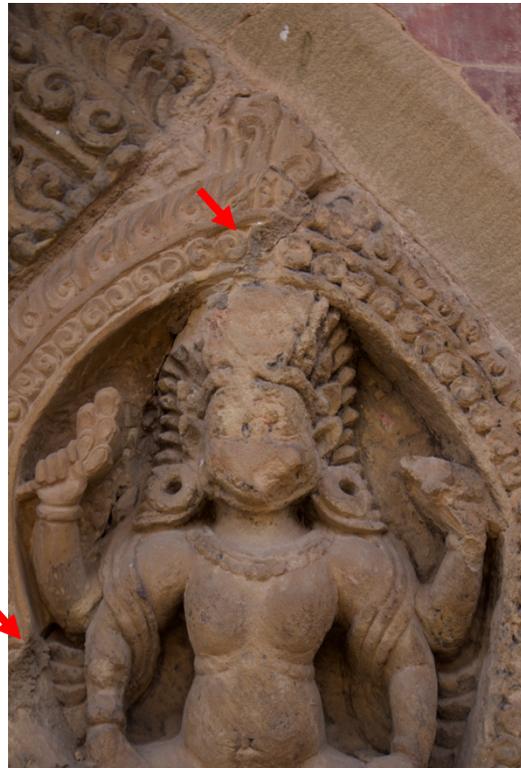
10<sup>th</sup> element head (Fig. 5)

<input checked="" type="checkbox"/> Other	Comment: 10 <sup>th</sup> element joint to indent not properly pointed (Fig. 5, red arrows).
-------------------------------------------	-------------------------------------------------------------------------------------------------

Fig. 5: Missing part on the head of the figure.  
Red arrows: inadequate pointing.

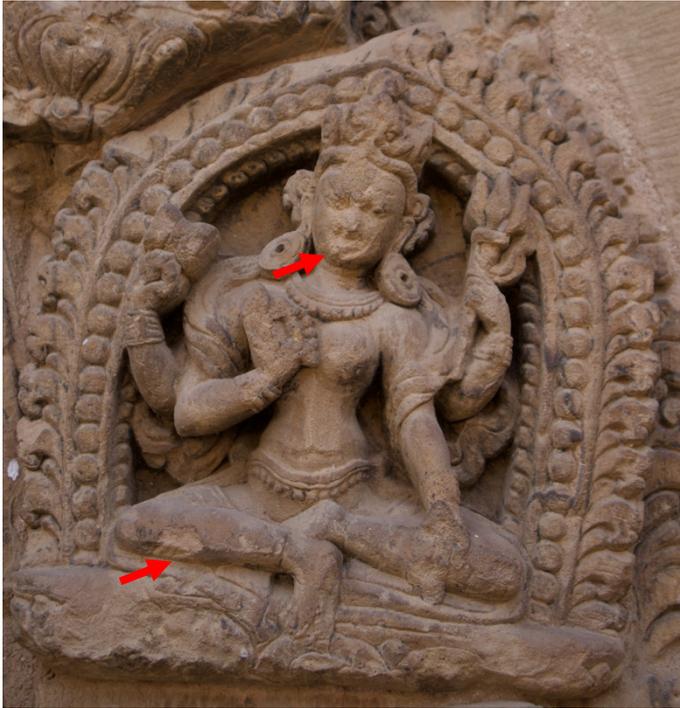
11<sup>th</sup> element, head and right leg (Fig. 6)

Fig. 6: Missing part on right leg and head of the figure.

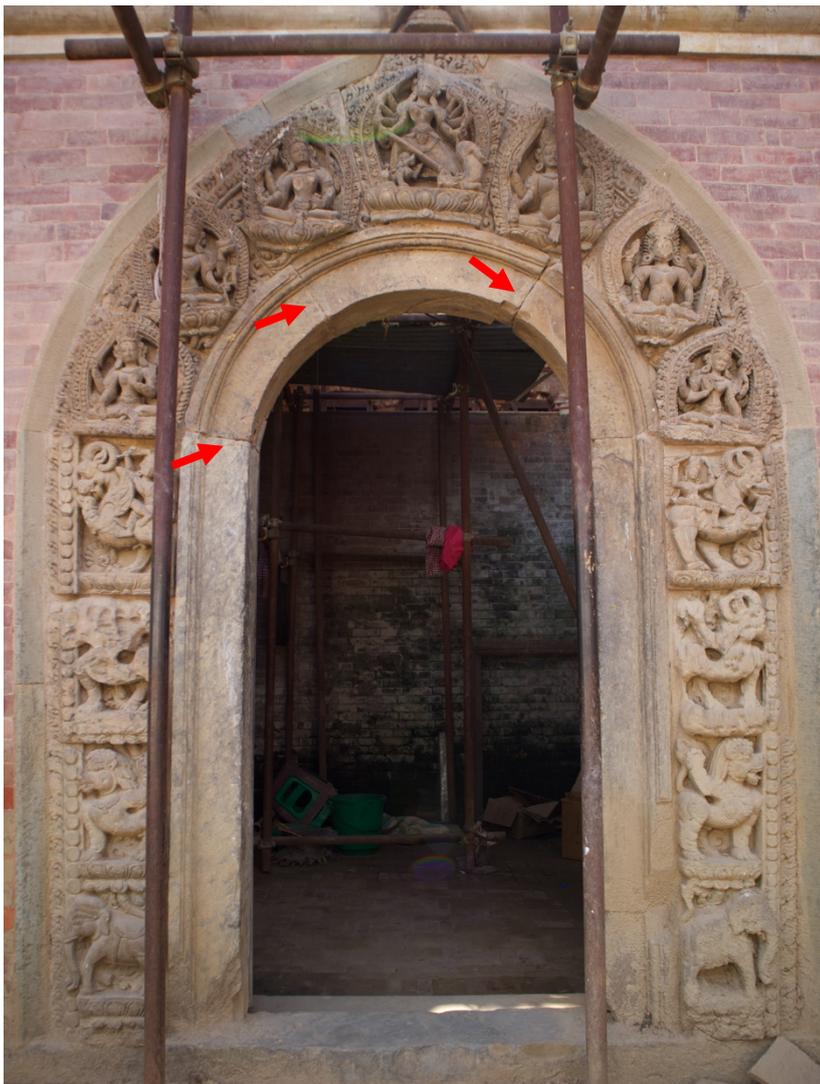
Thin joints (Fig. 7)

Fig. 7: Opened thin joints.

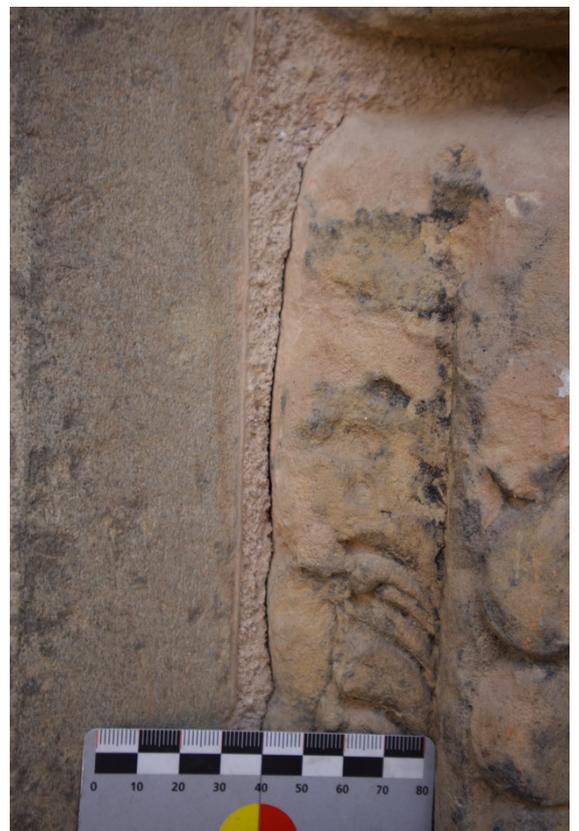
<input checked="" type="checkbox"/> Some <input type="checkbox"/> Few	At the borders to the stone (Fig. 8)
--	--	--------------------------------------------------------------------------	--------------------------------------

The joint mortar is, apart from cracks at the border to the stone, in good condition: stable, no sanding and the colour is not pinkish.

Fig. 8: Joint cracked along the edge.

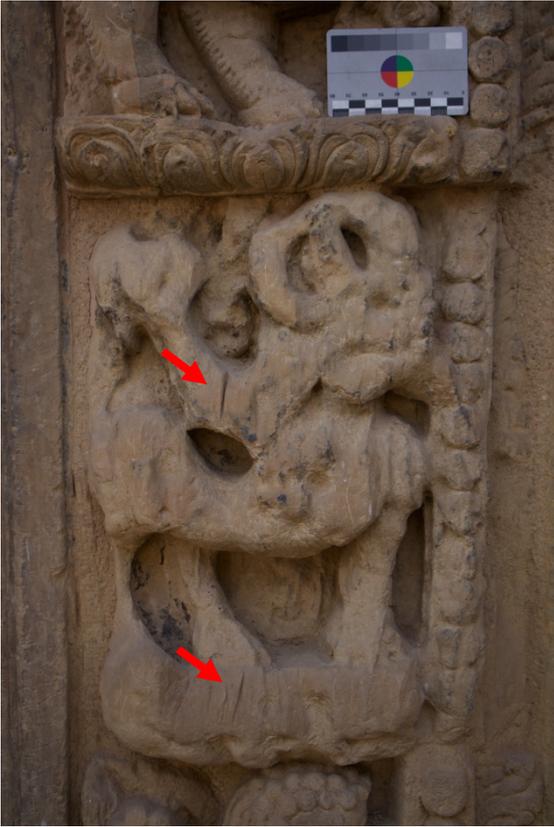
Fig. 9: Vertical cuts from stone cutting tool (?).

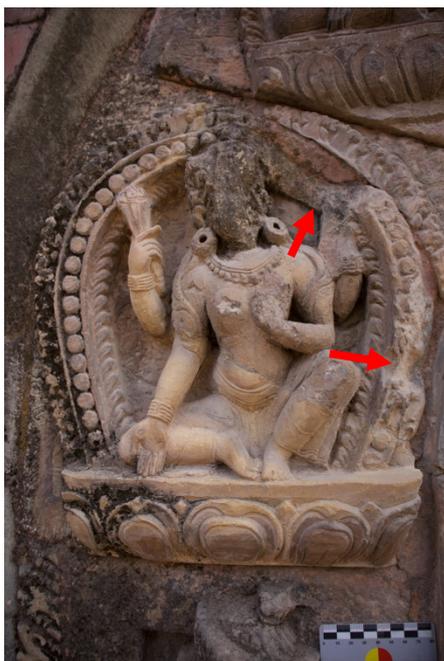
5<sup>th</sup> element, frame on the right (Fig. 1).

Fig. 1: Missing pieces on the ornamental frame.

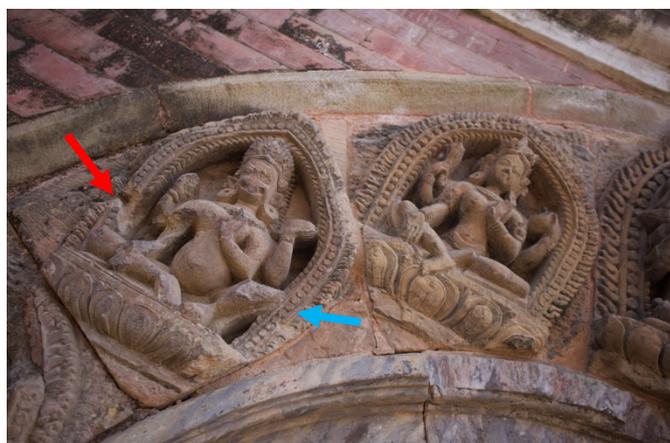
6<sup>th</sup> element lotus, right chisel? (Fig. 2)

Thin joints (Fig. 2, blue arrow)

Fig. 2: Missing pieces on the figures' arm and the frame. Blue arrow: open thin joints.

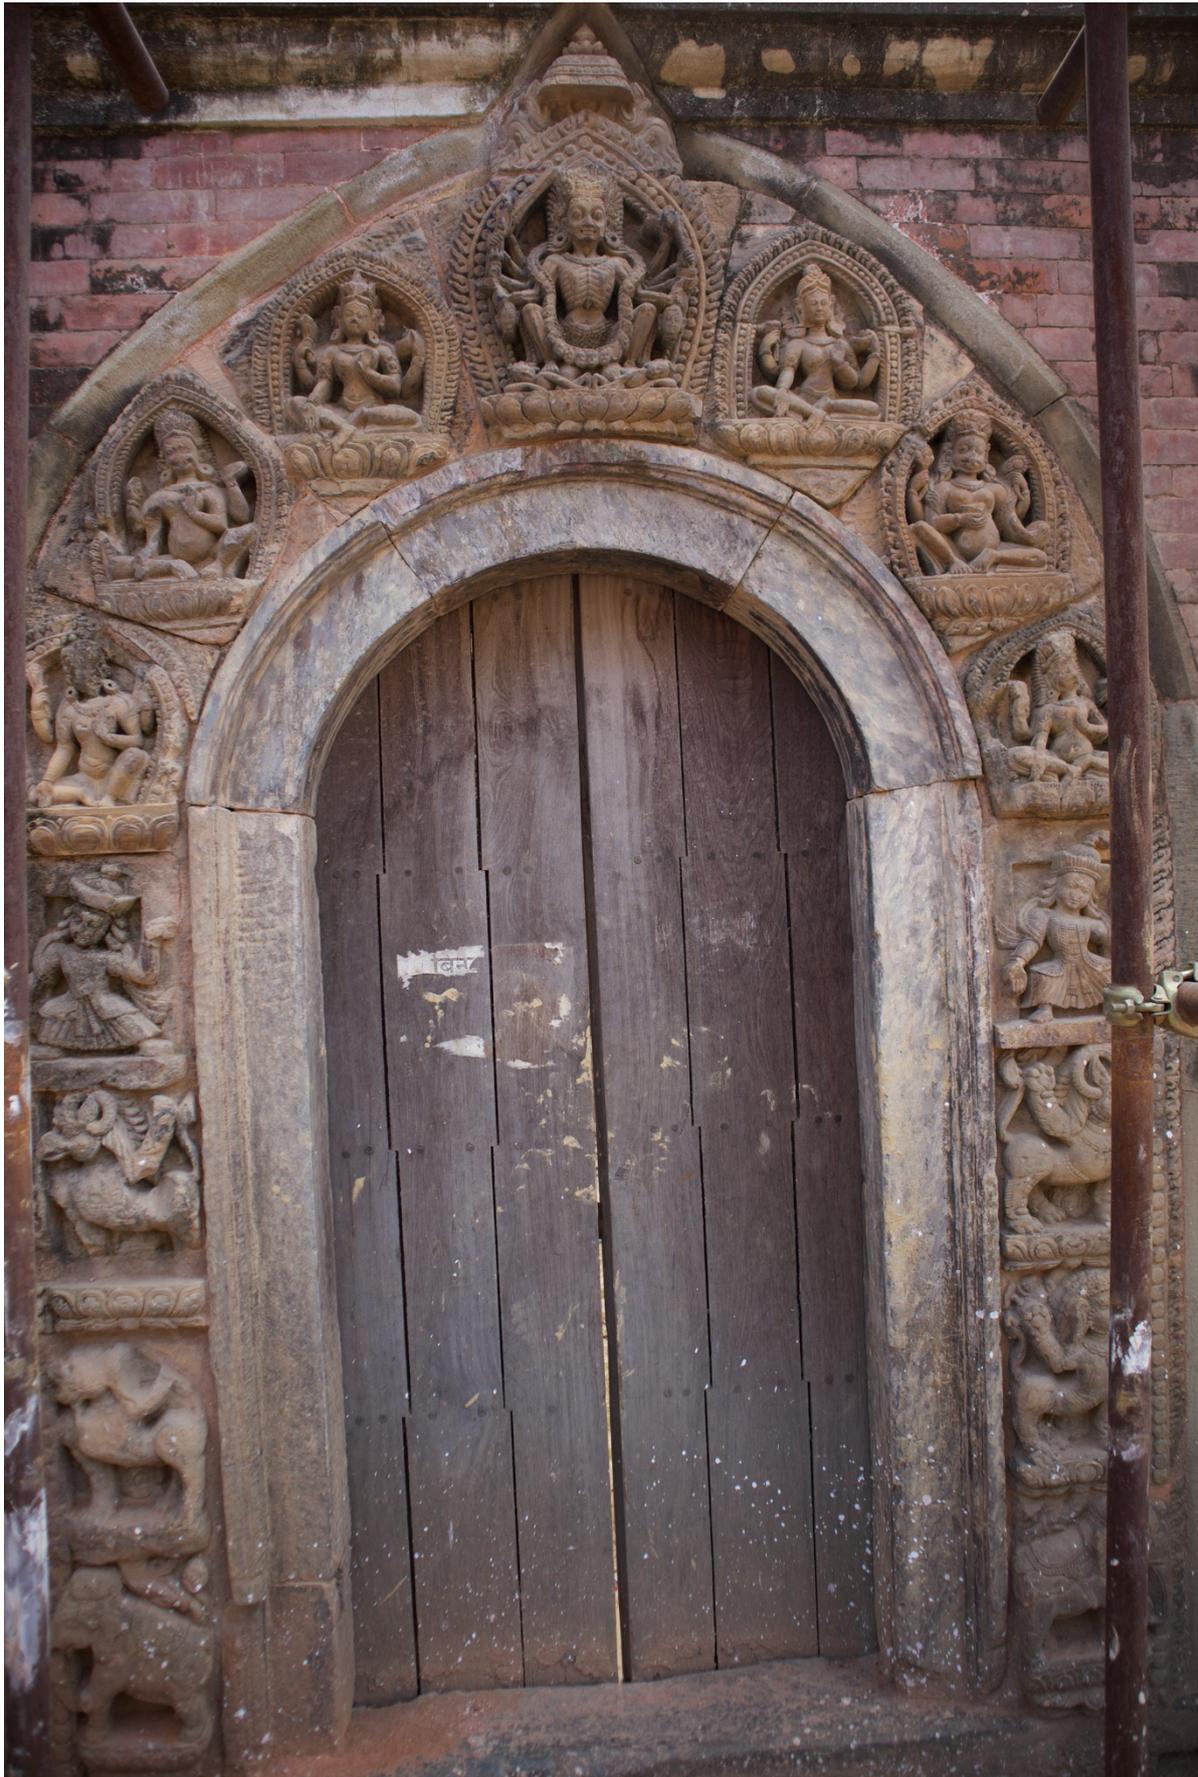
**Joint mortar is generally in good condition: stable, no sanding, colour adequate, more biological growth than on gate A)**

Fig. 3: Condition of Gate B in 2024.
