PINNACLES OF THE TALEJU TEMPLES

Report of the Institute of Conservation (IoC), University of Applied Arts Vienna

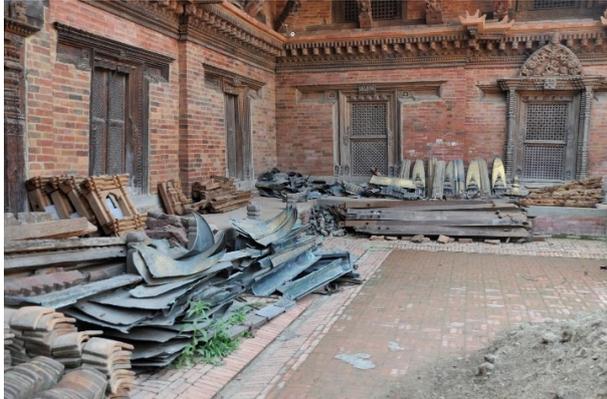
Fig. 3: Dismantled pieces of South Taleju pinnacle

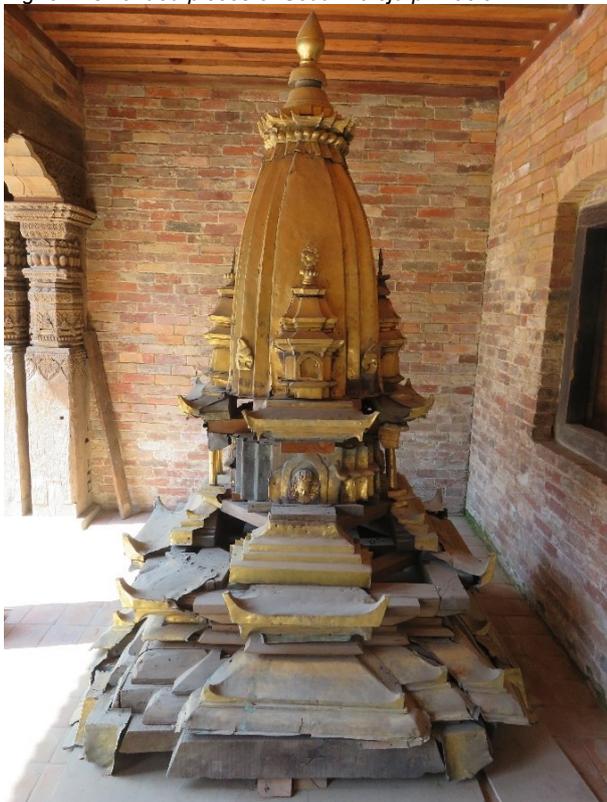
Fig. 5: Dismantled North Taleju pinnacle

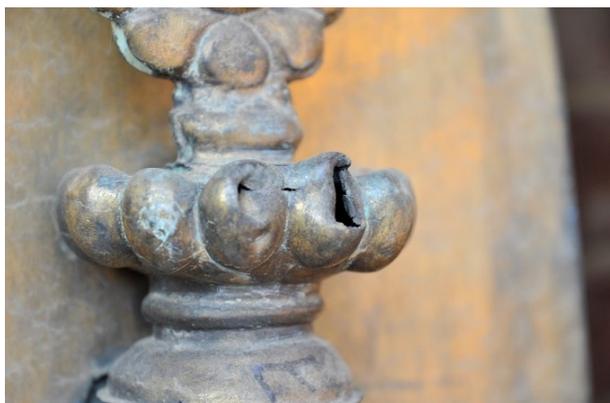
Fig. 7: Holes, element of South Taleju

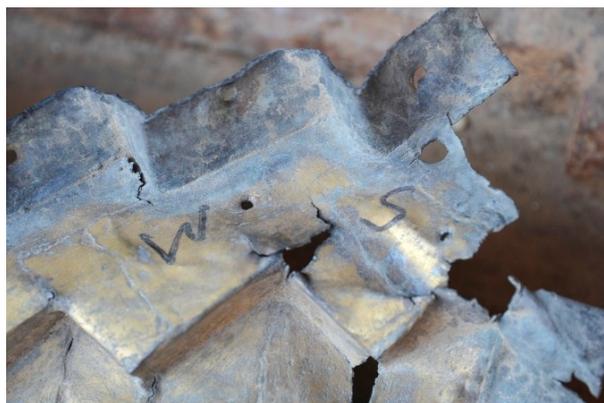
Fig. 8: Cracks and holes, element of South Taleju

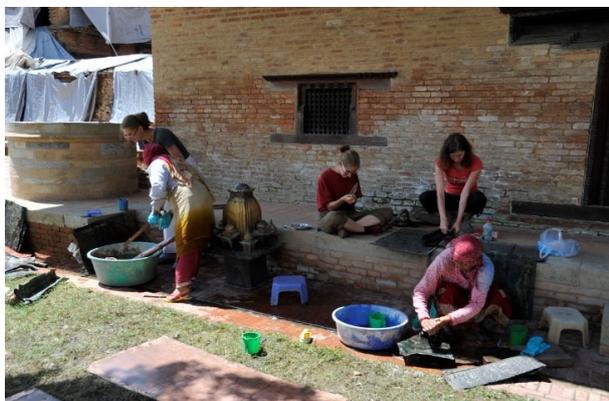
Fig. 9: Wet cleaning

- Dry cleaning with soft brushes to remove loose layers of dust
- Wet cleaning of metal parts with drinking water and surfactant (dish detergent) with sponges and brushes, rinsing off with drinking water and exposure to sun for drying

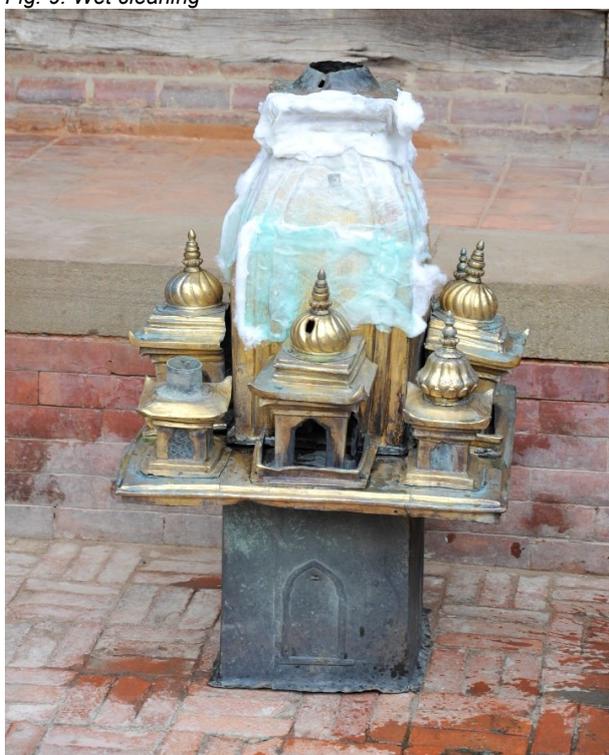
Fig. 11: Removal of corrosion with poultices

- Removing of copper corrosion with citric acid (complexing agent), elements were either placed in citric acid bath (1:10 citric acid and water) or treated with cotton wool patches soaked with citric acid, on bigger parts citric acid was sprayed, application time for all methods 4 to 6 minutes, immediate subsequent cleaning with drinking water and brushes

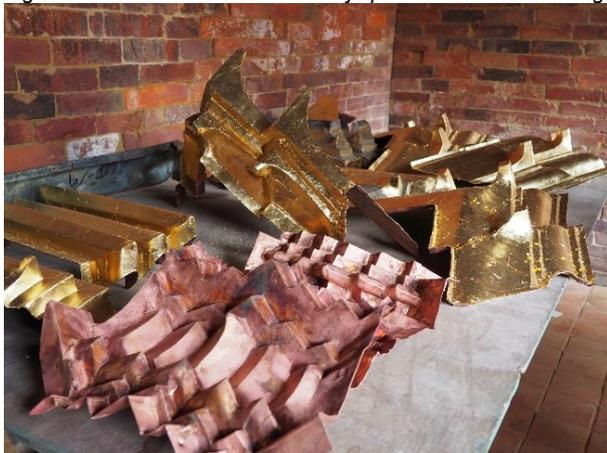
Fig. 15: Newly manufactured elements, partly already gilded

- Manufacture of new copper elements by coppersmith to replace missing elements, surfaces were etched with citric acid (diluted in water 1:10) and re-gilded using leaf gilding and linseed oil

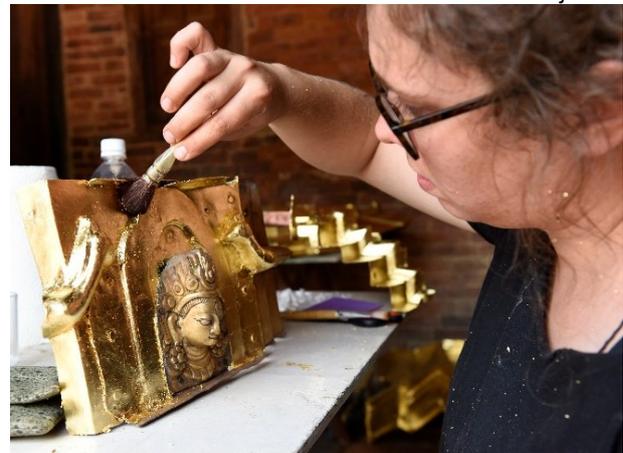
Fig. 16: Re-gilding

- Partial regilding of worn-off parts / surfaces with gold leaves (Dukaten-Doppelgold) using Mixtion, newly gilt areas were covered with a protective layer of acrylic resin (Paraloid)

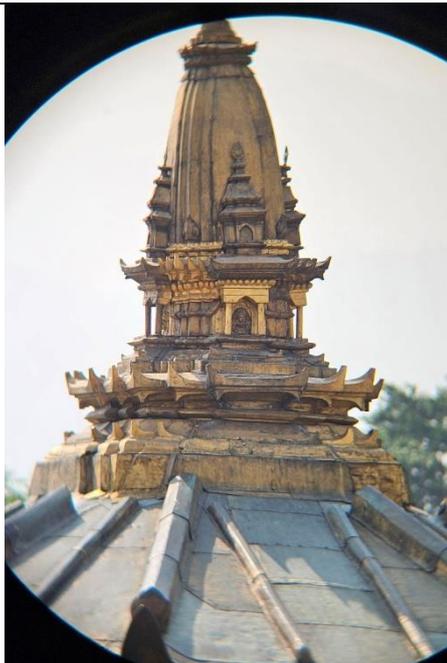
| <input checked="" type="checkbox"/> Abrasion / Worn out Gilding | <input type="checkbox"/> Major <input checked="" type="checkbox"/> Medium <input type="checkbox"/> Minor | <ul style="list-style-type: none"> - w.o.g. on the pinnacle tip part (<i>cvalāmū</i>, <i>hah</i>) and lotus base (<i>gam</i>) → the three middle parts (<i>hah</i>, <i>kalas</i>, <i>ambahsāh</i>) were regilded in 2017 - Some of the temple elements of Shikhara and also the <i>kulām</i> on the roof have w.o.g. or abraded areas (more pronounced on the north side <i>kulām</i>) - evenly slightly worn out on the whole Shikhara - roof sheets and semi-round shaped rib elements (<i>nāgvah</i>) are mostly worn out |

Fig. 9: Abraded and darkened areas on the roof slabs and Shikhara finial

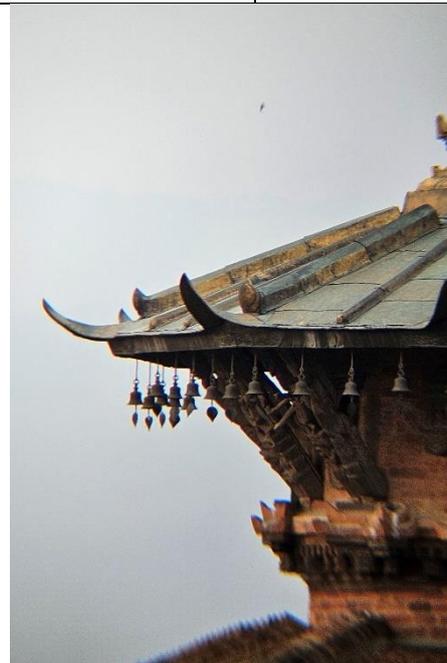
Fig. 10: Worn of gilding on some of the kulām

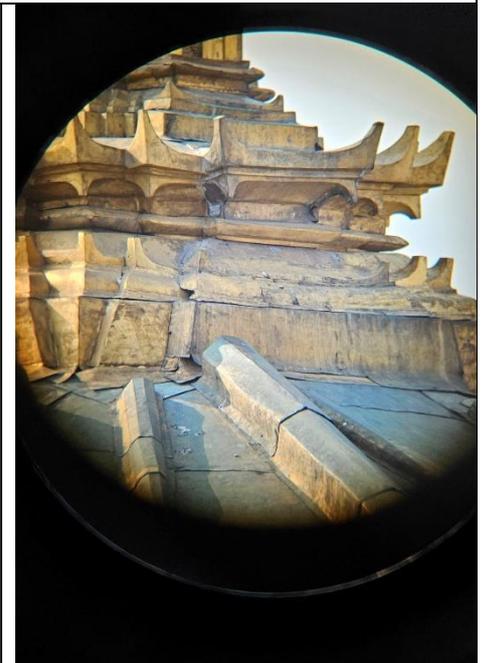
| <input checked="" type="checkbox"/> Soiling | <input type="checkbox"/> Dust | <input type="checkbox"/> Heavy <input checked="" type="checkbox"/> Medium <input type="checkbox"/> Light | - Especially on top sides |

Fig. 11: Soiling and darkening on roof plates and Shikhara base

Deposits (soiling, bird droppings) can be found on the surface and are a major cause of corrosive reactions. In this respect, maintenance is the key to the long-term preservation of the North Taleju finial. Regular cleaning and removal of bird droppings must be considered by the local community as the most important factor in long-term conservation. Where citric acid is used to chemically reduce corrosion, it is essential that the surface is thoroughly rinsed after cleaning, as acidic residues accelerate corrosive reactions.

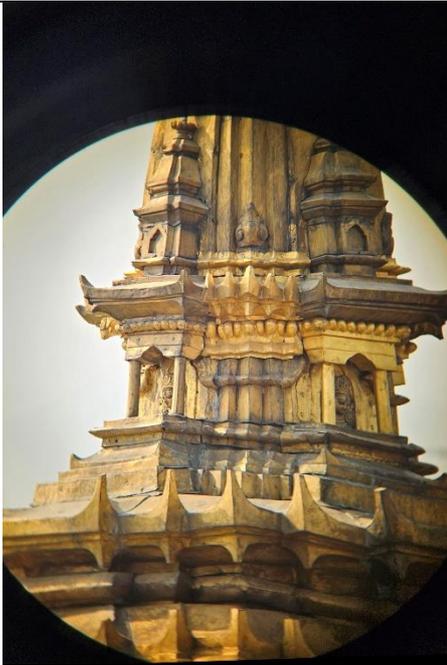
Fig. 12: Gilded metal with different grades of darkening on Shikhara base

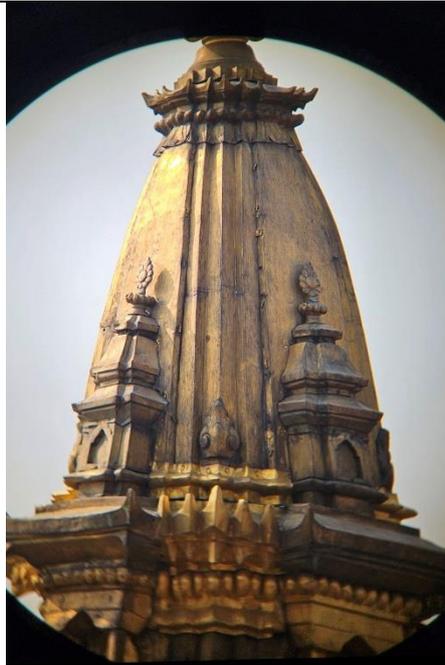
Fig. 13: Gilded metal with different grades of darkening on Shikhara style finial

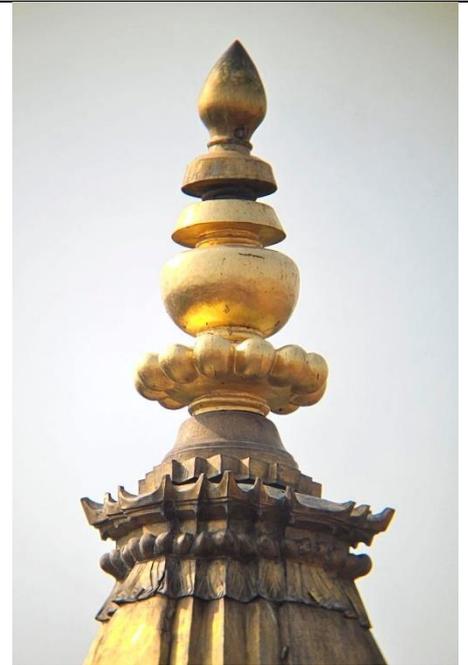
Fig. 14: Gilded metal with more pronounced darkening on the tip part (*cvalāmū, hah*) and lotus base (*gam*) of the pinnacle

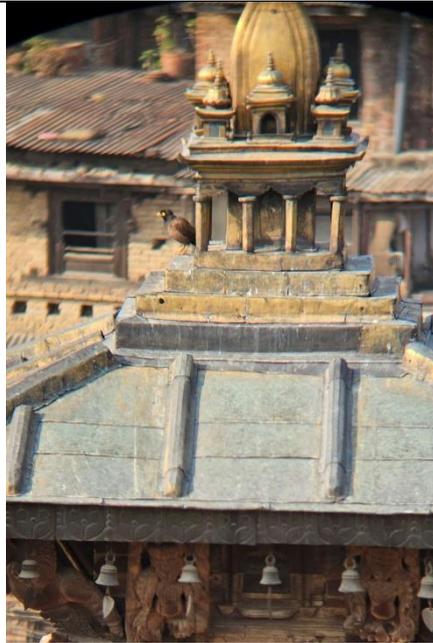
| <input checked="" type="checkbox"/> Abrasion / Worn out Gilding | <input type="checkbox"/> Major <input checked="" type="checkbox"/> Medium <input type="checkbox"/> Minor | - <i>nāgvaḥ</i> and roof slabs (roof surfaces) are mostly worn out - shikhara: mostly visible on the steps and the capitals as well as on the very small pinnacle on top of the umbrella |

Fig. 6: Roof with abraded areas on the gilded surface, May 2024

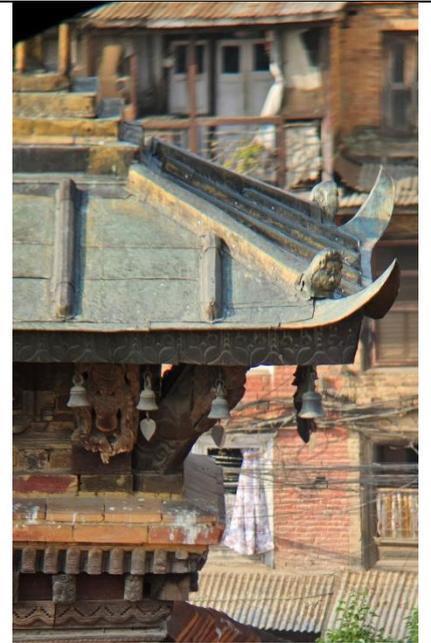
Fig. 7: Worn out gilding on the roof, May 2024

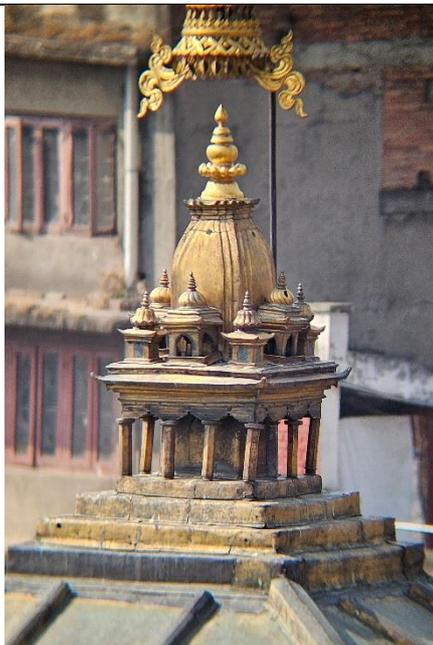
Fig. 8: Soiling and worn out gilding on the Shikhara finial, May 2024

Deposits (soiling, bird droppings) can be found on the surface and are a major cause of corrosive reactions. In this respect, maintenance is the key to the long-term preservation of the North Taleju finial. Regular cleaning and removal of bird droppings must be considered by the local community as the most important factor in long-term conservation. Where citric acid is used to chemically reduce corrosion, it is essential that the surface is thoroughly rinsed after cleaning, as acidic residues accelerate corrosive reactions.

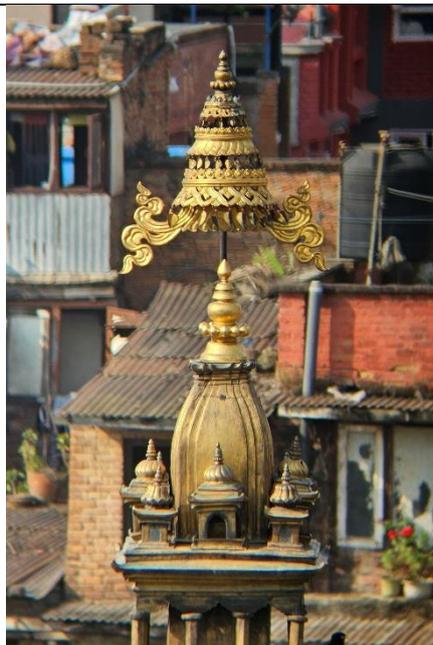
Fig. 9: Partial darkening on the Shikhara finial, May 2024
