## VISHVESHVARA TEMPLE BASE AND ELEPHANTS

Report of the Institute of Conservation (IoC), University of Applied Arts Vienna

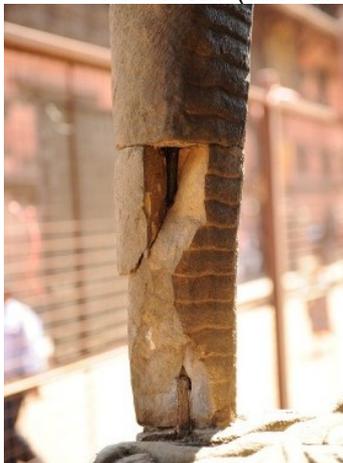
- Burst stone block due to iron corrosion (formerly introduced iron reinforcement)
- Insufficient joints (inappropriate material or damaged joint mortar)
- Biological colonisation (especially at damaged joints and horizontal areas)
- Few areas (back and lower parts) with blackish crusts

Fig. 9: Elephant: burst stone block due to corrosion

- Removing rust from a formerly introduced iron reinforcement (left front leg)
- Taking apart broken trunk (iron rod), upper part of rod was replaced with carbon fibre rod, while lower part of iron rod was treated with glass fibre pin to remove corrosion, uncovered iron was coated with lead paint (minium) removed parts of the trunk were glued back in place with acrylic resin

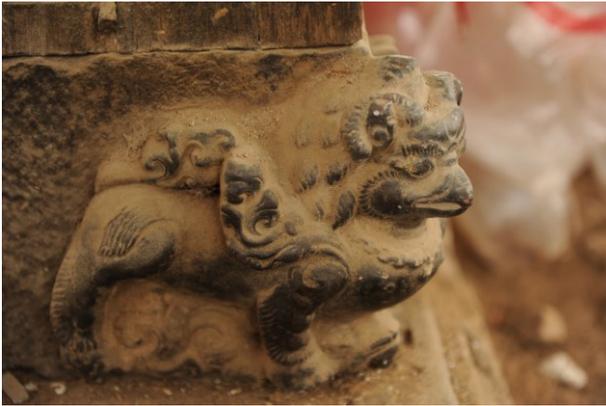
*Fig. 10: Heavily soiled stone block (covered with dust), 2017*

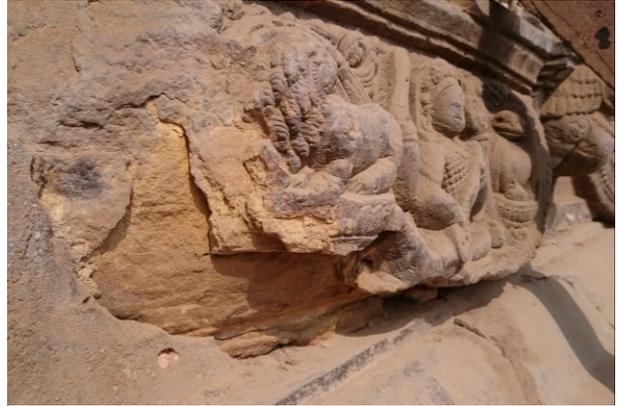
*Fig. 11: Burst stone block with figurative decoration, 2017*

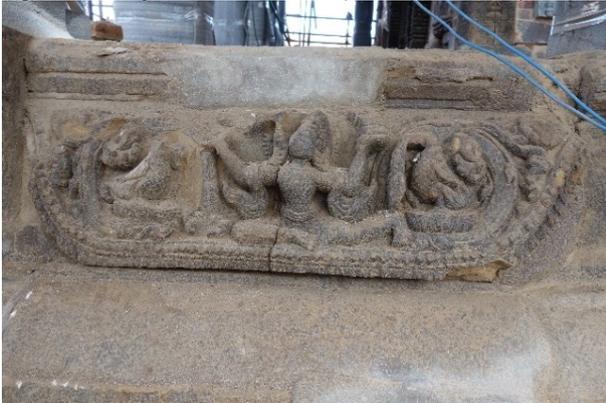
*Fig. 12: Heavily soiled stone block (covered with dust), 2018*

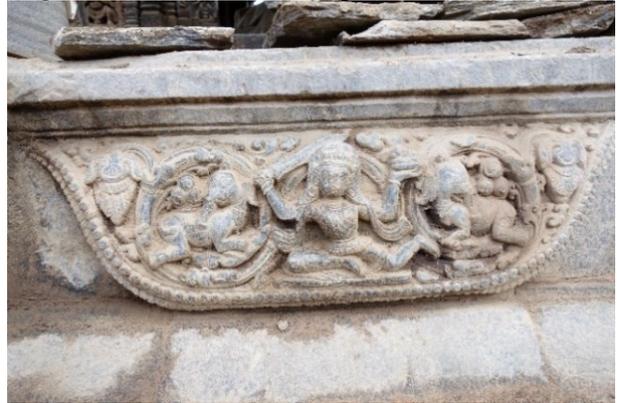
*Fig. 13: Infill with cement mortar, 2018*

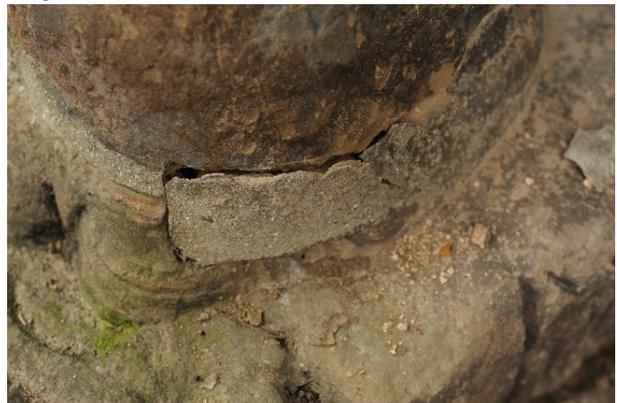
*Fig. 15: Elephant: broken and inappropriate joints, 2018*

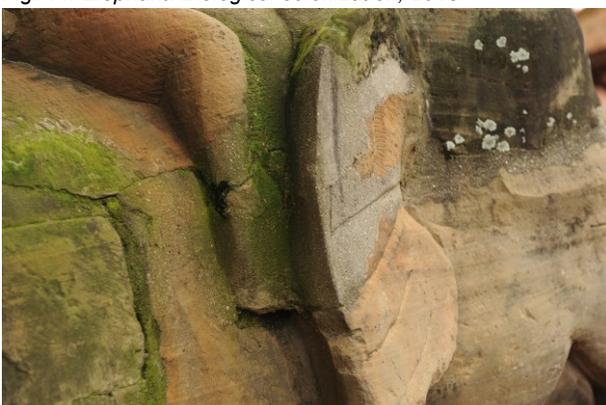
*Fig. 16: Elephant: inappropriate completion, 2018*

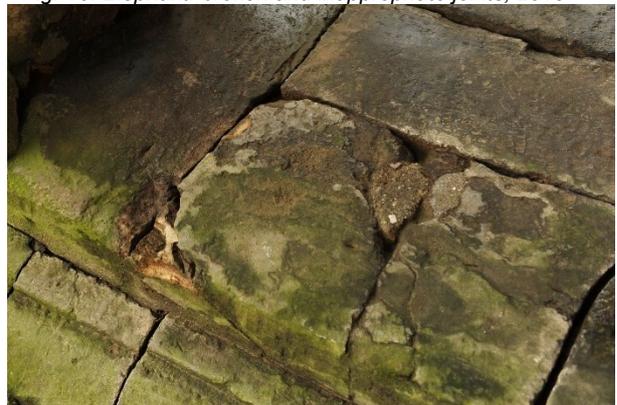
*Fig. 17: Elephant: broken edges of blocks at plinth, 2018*

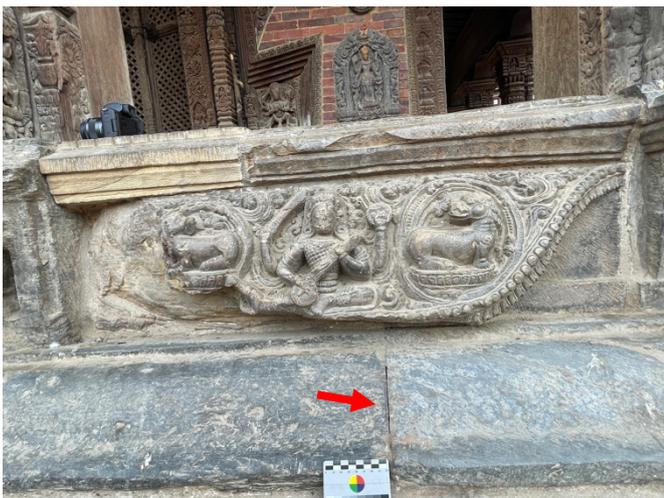
Particularly thin joints (Fig. 1)

Fig. 1: Thin open joint.

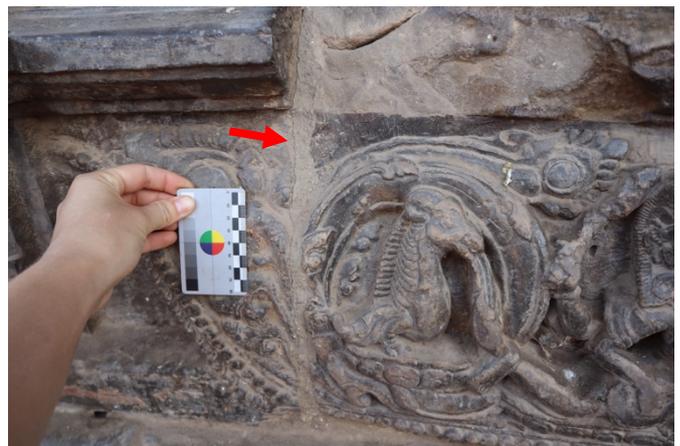
Often at border to stone (Fig. 2)

Fig. 2: Joint cracked along the edge.

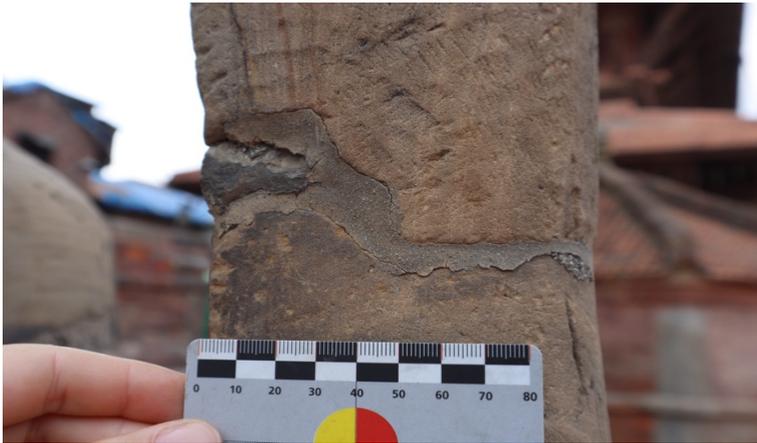
Few cracks were found at the joint's edges (Fig. 6 and 7)

Figure 6: Joints cracked along the edge to the stone.

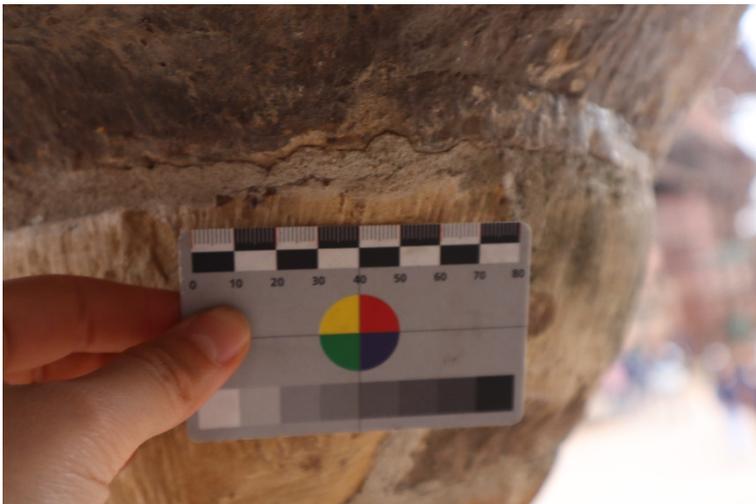
Figure 7: Crack at the border of the joint.

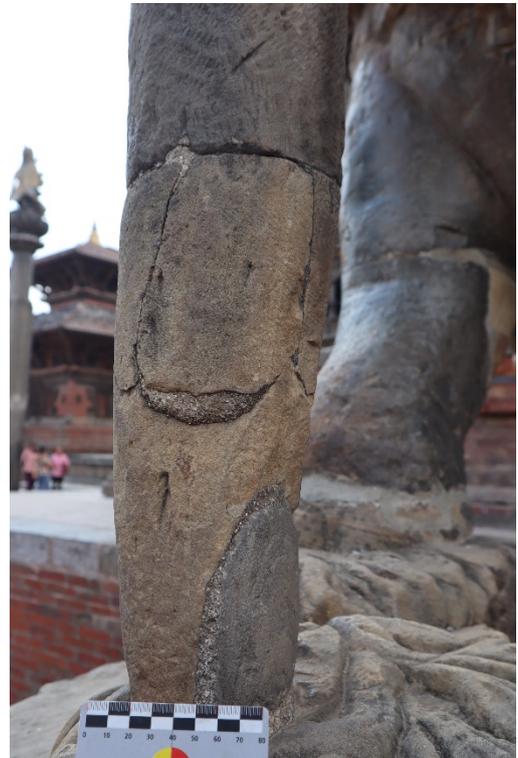
Figure 8: Crack, glued piece at the left elephants trunk.

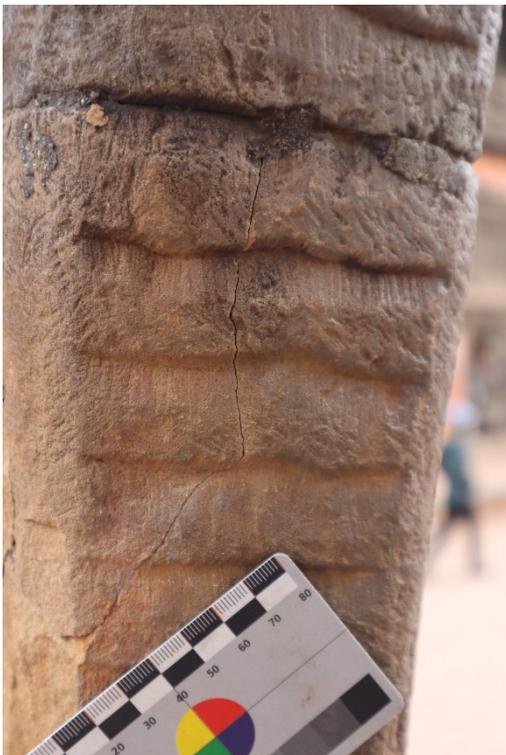
Crack on trunk of left elephant due to expanding of corroding iron (Fig. 9-11)

Figure 9: Crack at the backside of the trunk of the right elephant, recent?

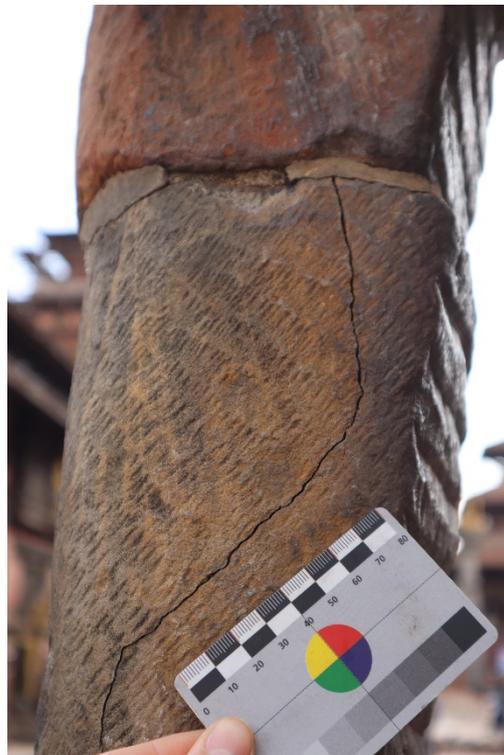
Figure 10: Same crack as shown before (right elephant, trunk from the side).

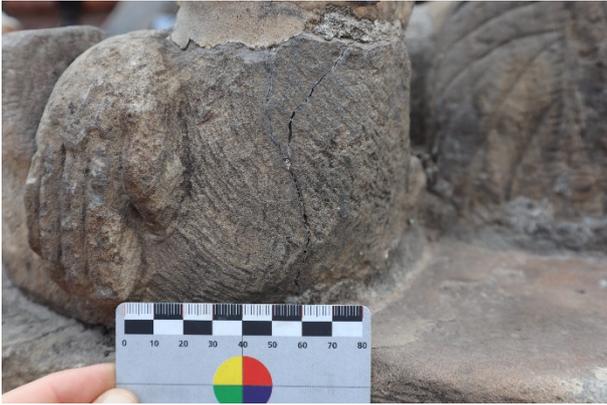
Figure 11: Right elephant, crack from the trunk is running further in the Man under his foot.

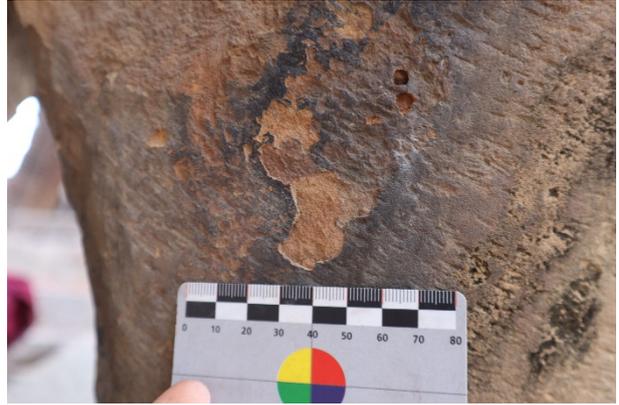
Scaling from the dark crust. Scaling on the left foot of the right elephant and under the head of the Elephants (Fig.12 and 13)

Figure 12: Scaling, exemplary.

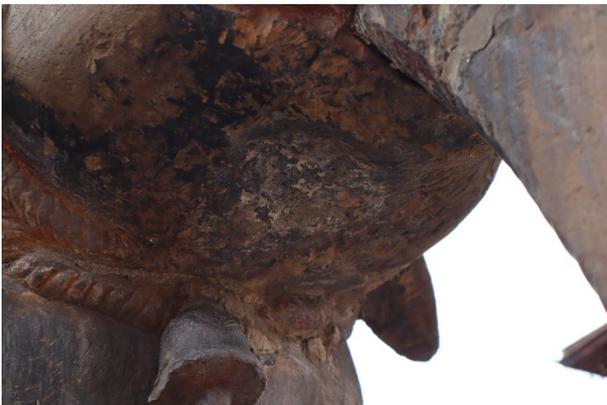
Figure 13: Crusts and scaling at the underside of the left elephant, maybe due to water.

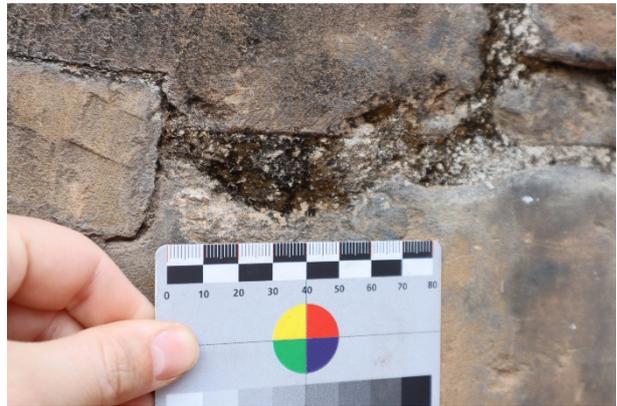
Present on joints, fillings and upper areas where water is allowed to accumulate, as well as on the heads of the elephants (Fig. 14 and 15)

Figure 6: Microbiology on the joints.

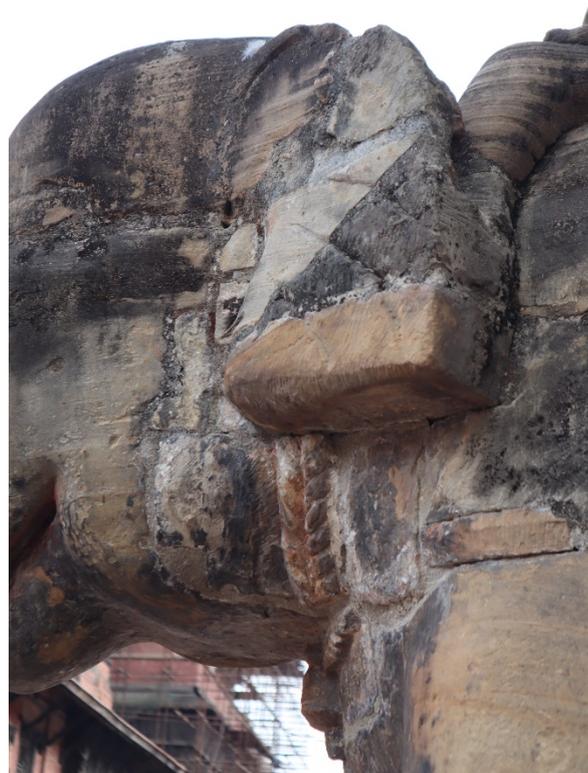
Figure 15: Microbiology on the head of an elephant.

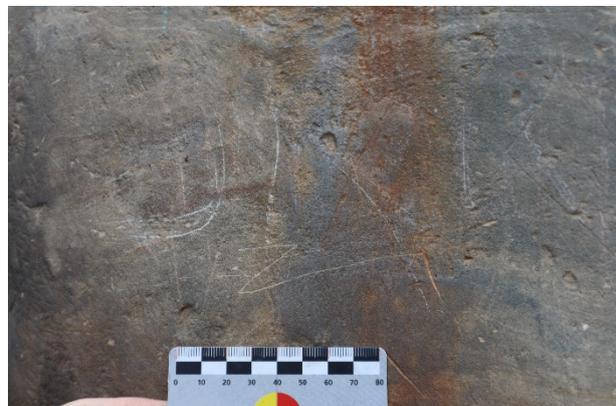
Scratches (vandalism) on the side of the right elephant (Fig.16)

Figure 16: Scratches, exemplary.
