## WALL PAINTINGS, SUNDARI CHOWK

Report of the Institute of Conservation (IoC), University of Applied Arts Vienna

## Data Sheet

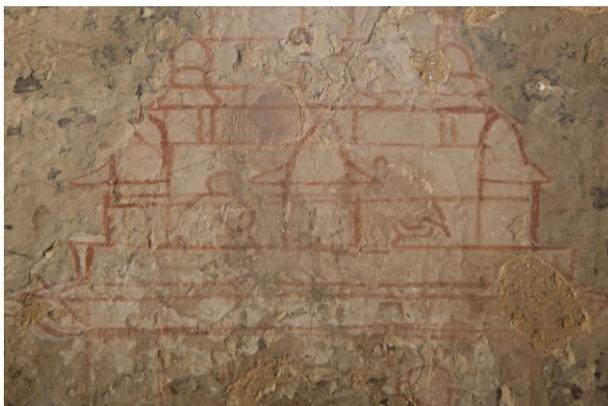
*Fig. 3: Underpainting with red ochre, 2013*

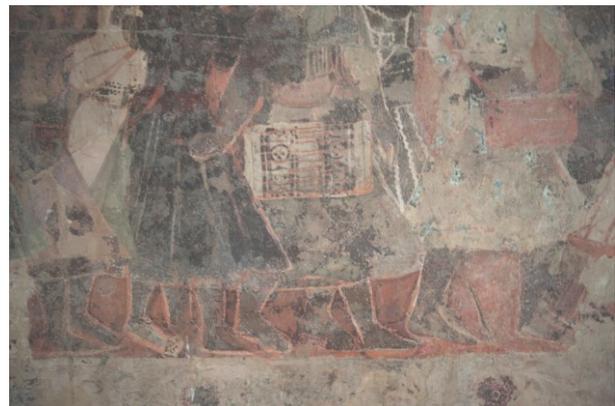
*Fig. 4: Detail of engraved lines (feet), 2013*

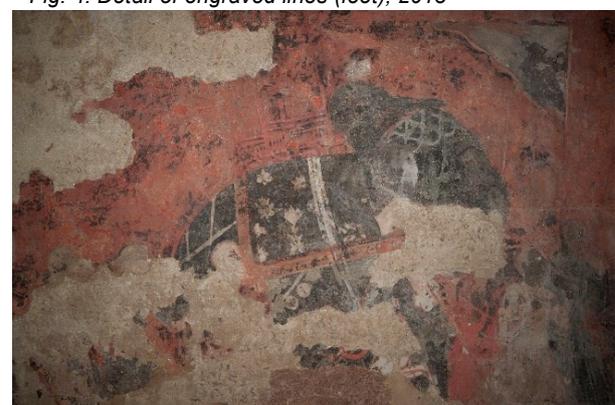
*Fig. 6: Detail of elephant with voids, 2013*

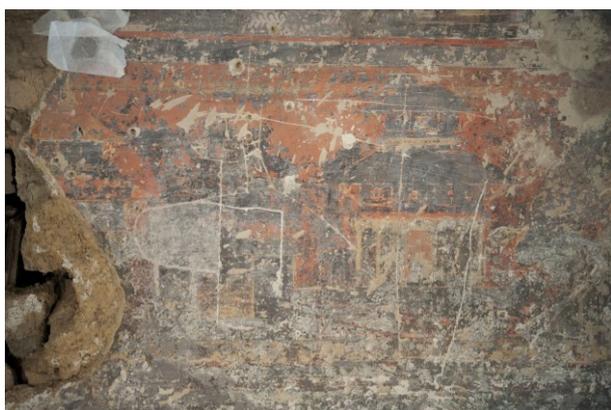
Fig. 7: Scratches within the painting, 2013

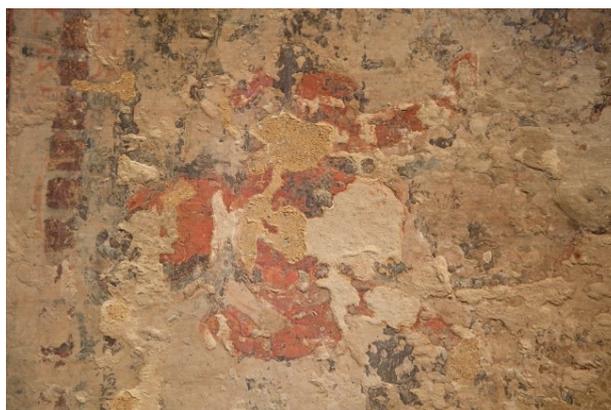
Fig. 8: Different kind of relining, 2013

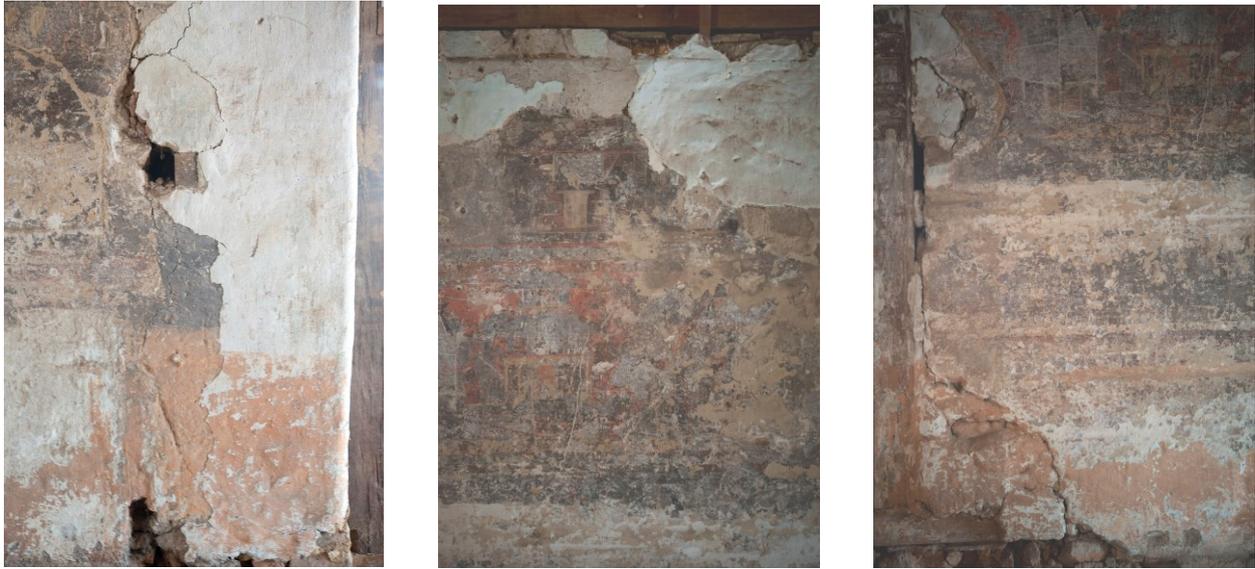
Fig. 9, 10 and 11: Details of plaster of Paris, cracks, hollow areas and insufficient completion, 2013

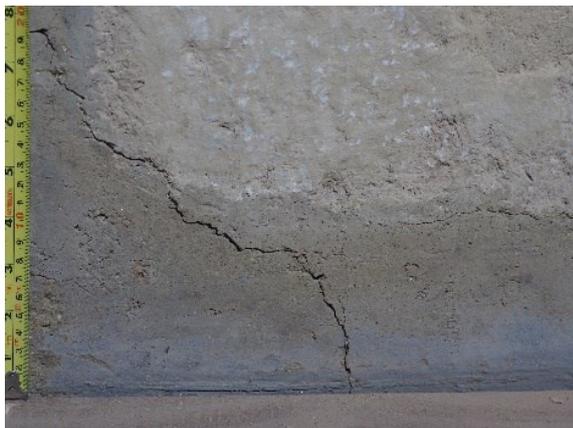
- Thick dust layer due to leaning wall (south wall) and protective glass screen open on both sides
- Cracks in the original and the secondary plaster applied by the IoC in 2013 due to earthquake 2015

Fig. 12: Cracks due to earthquake, 2022

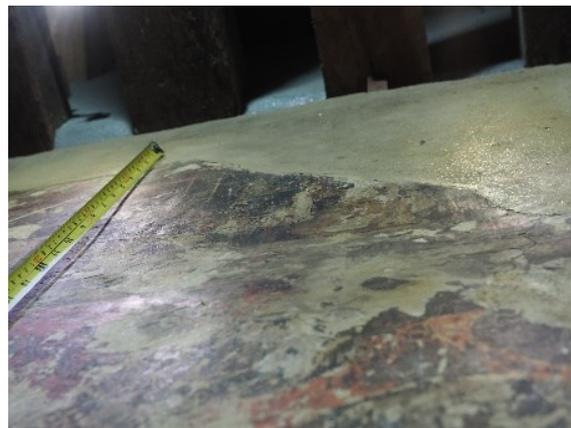
- Hairline cracks in plaster and paint layer
- Deformation of plaster (south wall only), elevated risk of loss of original material due to hollow area underneath; location of damage close to surrounding secondary plaster

- Hollow space, possibly caused by seismic vibrations (2015) and due to different properties of original plaster layers and surrounding secondary plaster leading to tensions within the structure

Fig. 13: Deformation, 2022

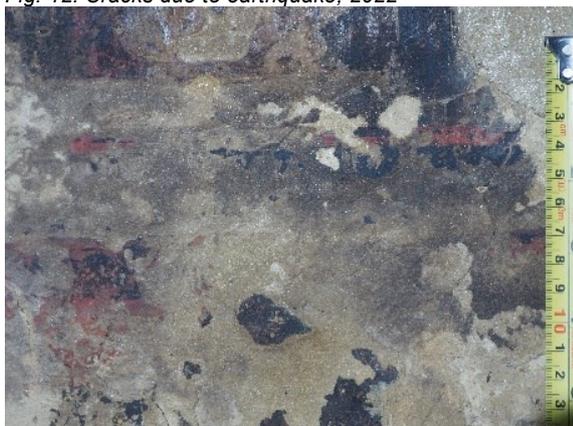
- Darkening: intense change in colour of surface, yellowing and browning of plaster and paint layer (depth of approx. 2 mm, sometimes more), no further investigation of causes (probably mould infestation or colour change of protective coating layers)

Fig. 14: Darkening, 2022

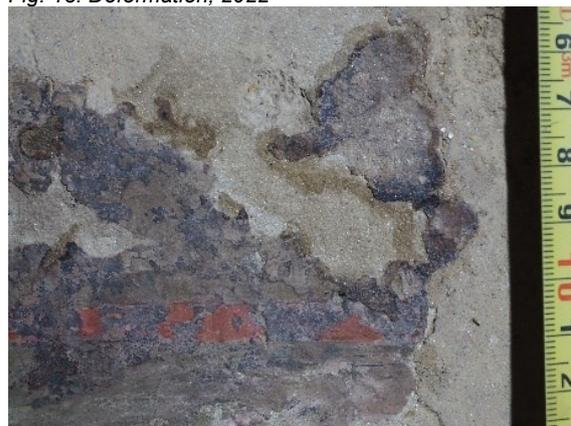
- Partial scaling: detachment of finishing plaster parallel to surface
- Loose edges of plaster and paint layer;
- Colour saturation: intensification of colour of a surface caused by humidity or by use of conservation materials (in the present case probably caused by aging consolidation media)

Fig. 15: Colour saturation of the fillings, 2022

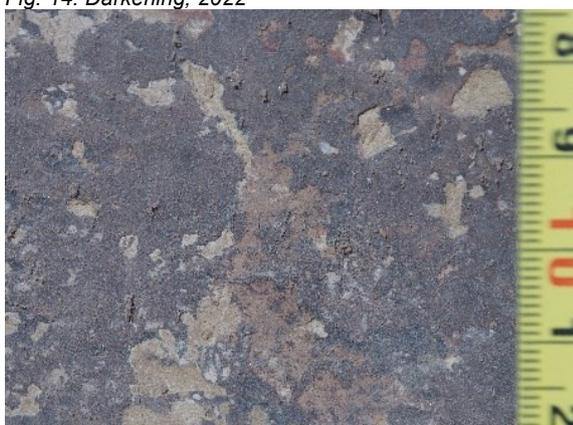
Fig. 16: Thick dust layer, 2022

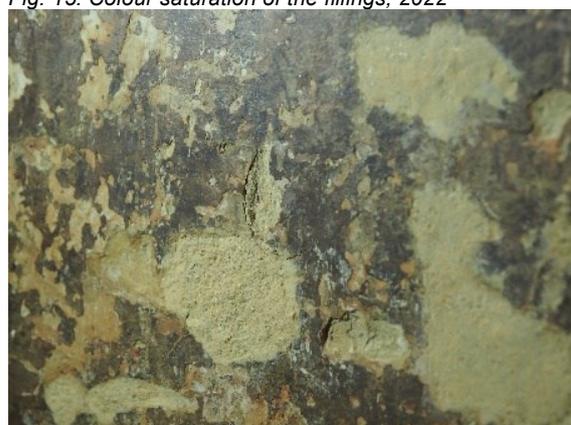
- Flaking: detachment of small amount of paint layer due to loss of adhesion (caused by physical influences e.g., humidity, possibly salt crystallization)

Fig. 17: Flaking of the edges (fillings and paint layers), 2022

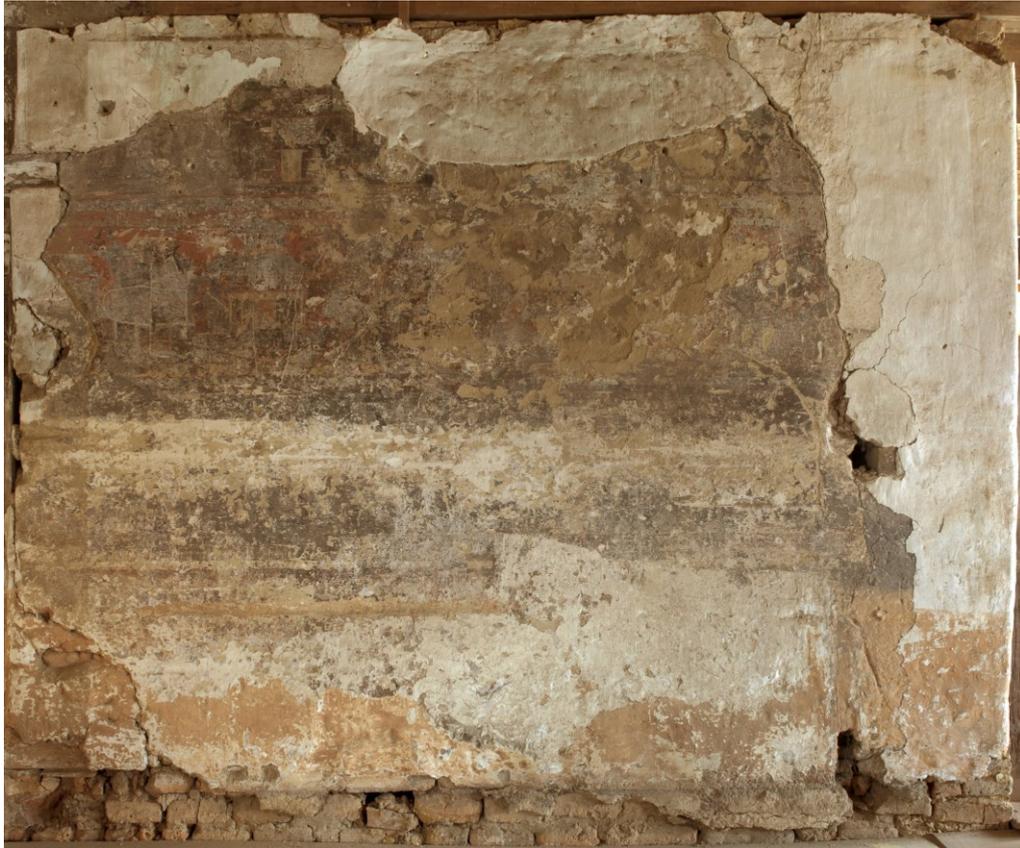
*Fig. 30: South wall before conservation, 2013*

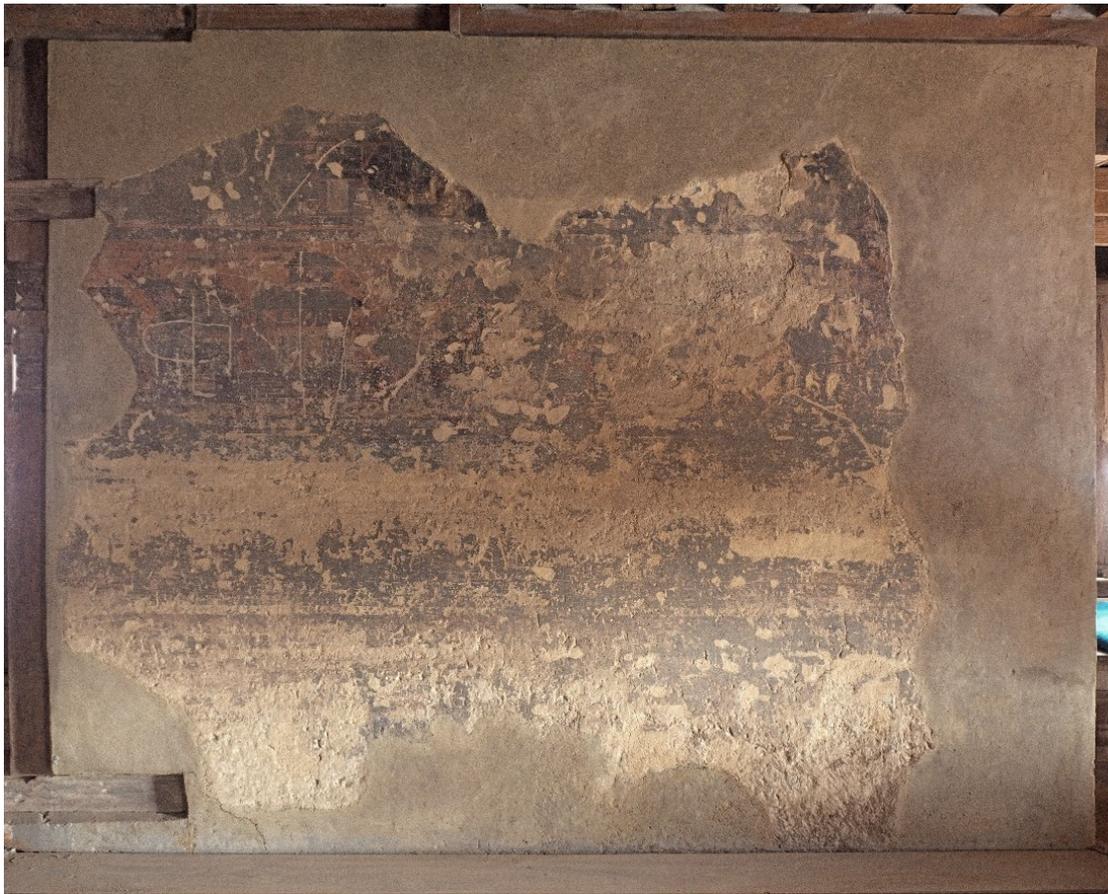
*Fig. 32: South wall before maintenance/conservation, 2022*

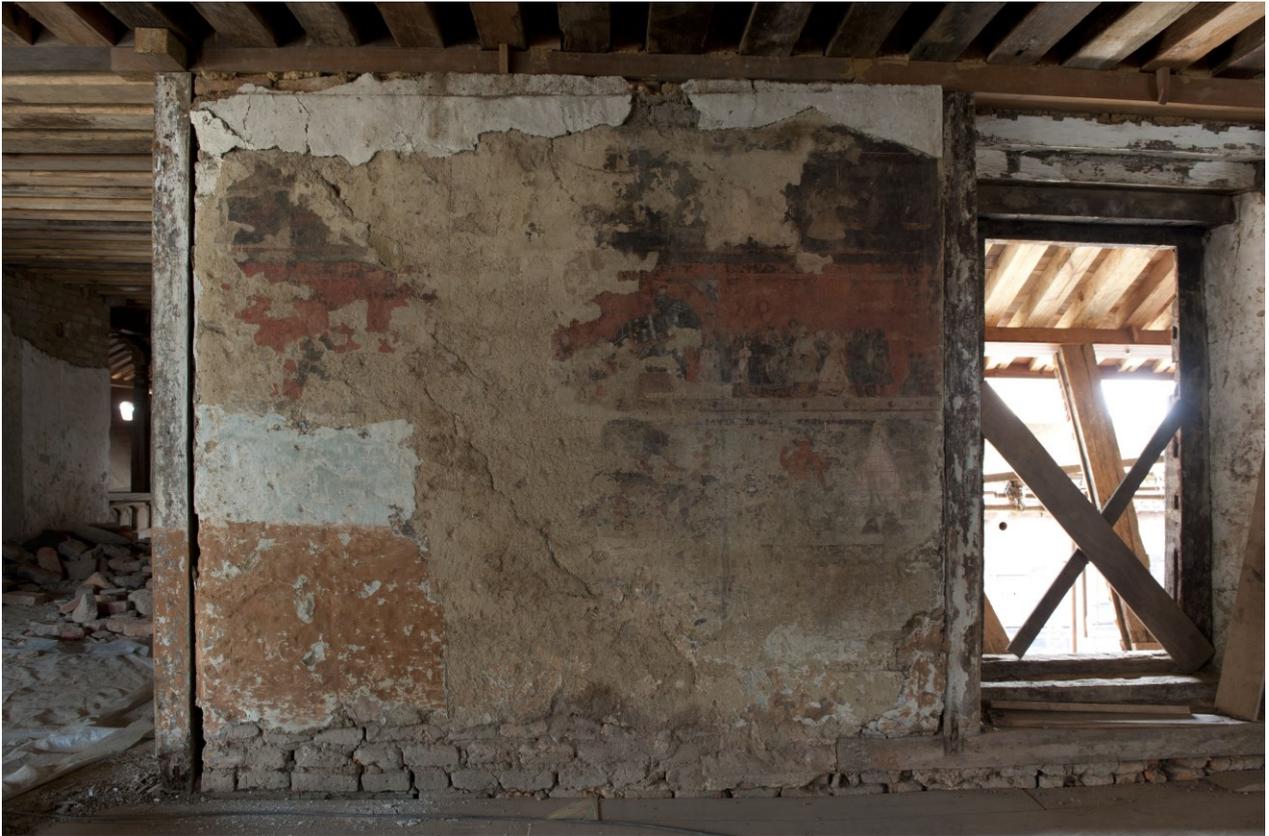
*Fig. 34: North wall before conservation, 2013*

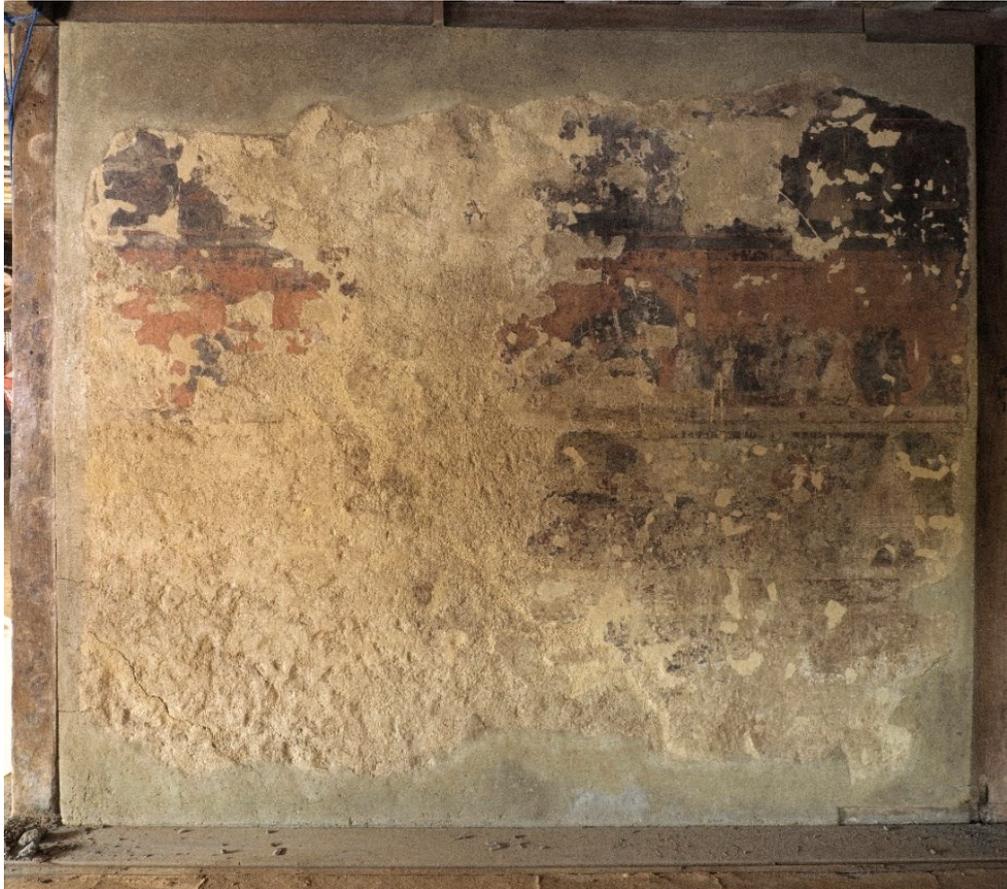
*Fig. 36: North wall before maintenance/conservation, 2022*

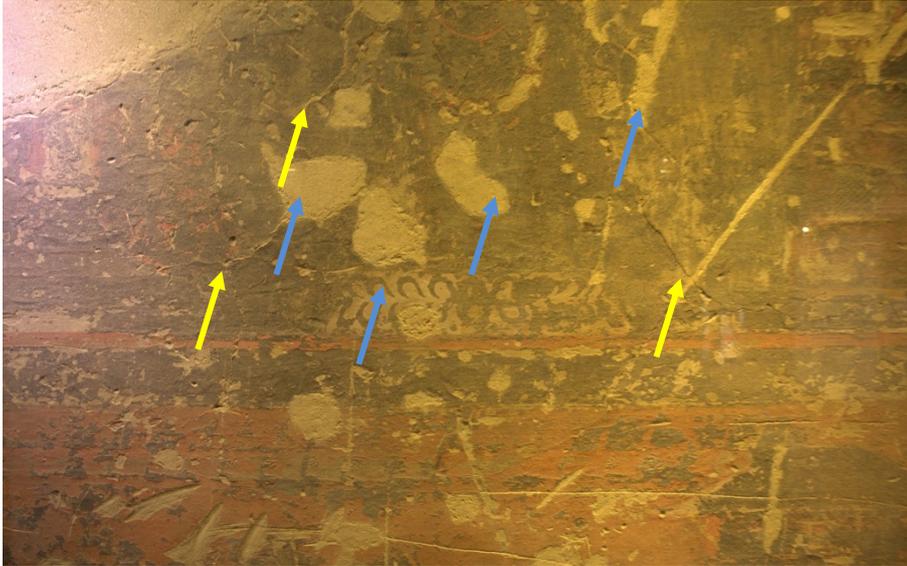
Comment:			
<input checked="" type="checkbox"/> Cracks in original plaster / in  <input type="checkbox"/> Not detected	<input type="checkbox"/> Many <input checked="" type="checkbox"/> Some <input type="checkbox"/> Few		
		Some of the cracks may be recent as they run through fillings that were - presumably - done in 2022

Fig. 5: South Wall, Detail with cracks and fillings (cracks-yellow arrow, fillings-blue arrow).

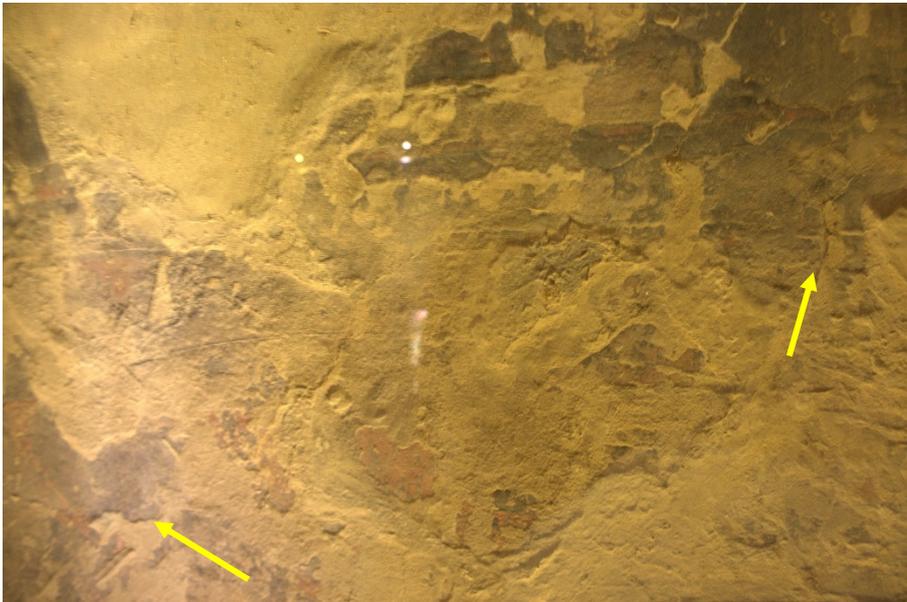
Fig. 4: South Wall, fragment surrounded by different fillings. Some cracks visible between wall and painting (arrows).
