## PILLAR OF YOGANARENDRA MALLA

Report of the Institute of Conservation (IoC), University of Applied Arts Vienna

**GENERAL INFORMATION**

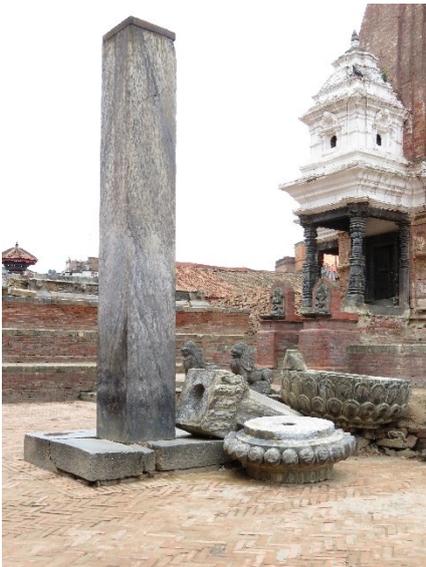
- Collapse during the earthquake in 2015, only the square shaft remained standing
- Cracks until a depth of 13 cm (due to ultrasonic pulse velocity measurements)
- Missing parts – only a small edge of the second element was smashed through the impact of collapsing;
- Soiling (pigeon droppings, dust and other deposits such as greasy layer, wax remnants)

Fig. 11: Partly collapsed stone pillar, 2016

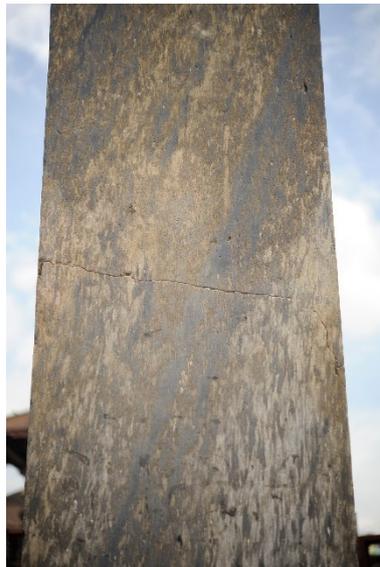
Fig. 12: Visible Crack, 2016

- Closing of cracks (pre-cleaning with scalpel and brushes in combination with water) with epoxy resin (EPO-TEK) injections by using syringes, repeated several times

- Pinning of two deeper cracks with four carbon fibre rods (diameter 10 mm, length 500 mm) fixed with injection mortar based on polymethyl methacrylate and three different methacrylates (Hilti injection hybrid mortar HFX)

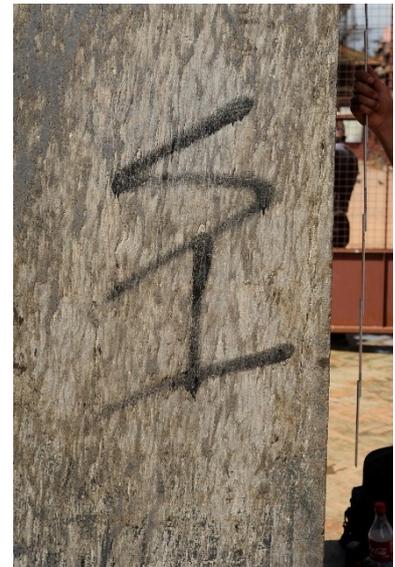
Fig. 13: Graffiti, 2016

- Removing of remnants of wax and oily residues of worshipping with white spirit
- Removing of graffiti with acetone poultices
- Mechanical reduction of crusts by hammer chisel and rasps

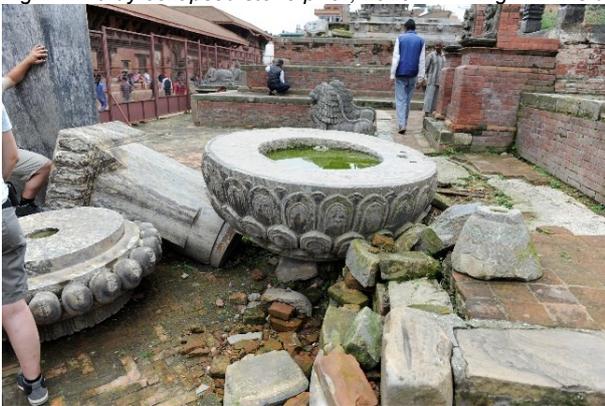
Fig. 14: Collapsed upper elements of pillar, 2016

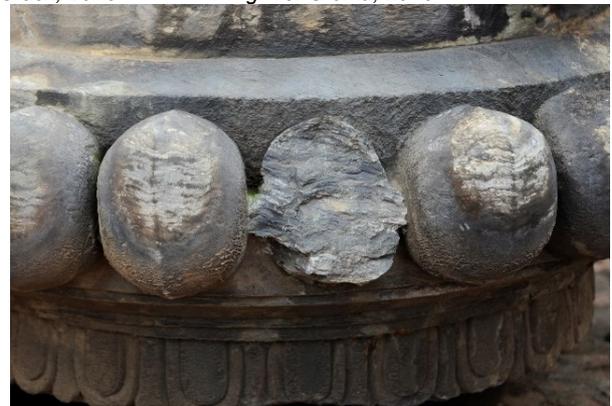
Fig. 15: Broken part (cylinder) due to collapse, 2016

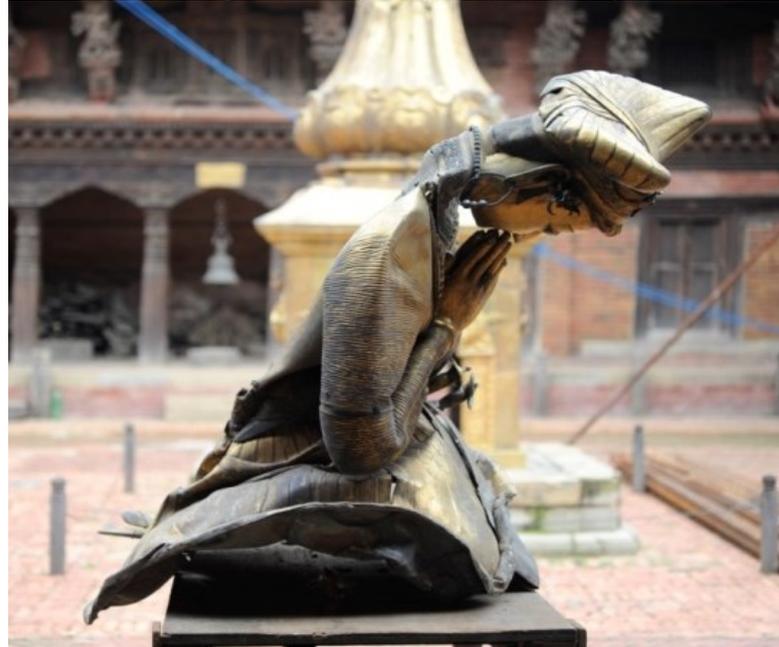
- Heavy deformations on all metal elements due to falling of the pillar during the earthquake 2015;
- Assembly connections partly loose or lost
- Voids and cracks due to falling during the earthquake
- Iron rods of the substructure connecting the sculpture with the stone pillar are highly corroded and deformed due to the earthquake
- Missing of original supporting construction
- Soiling (thick layers of dirt, dust and deposits)
- Partial corrosion
- Large areas without original fire-gilding (weathered) but only soiled copper

Fig. 17: Deformed sculpture of the king, 2016

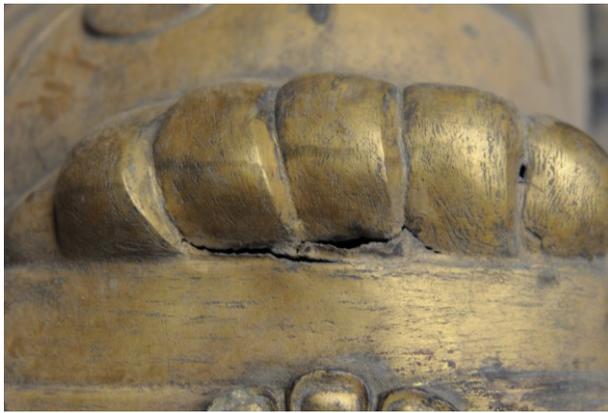
Fig. 18: Cracks, 2016

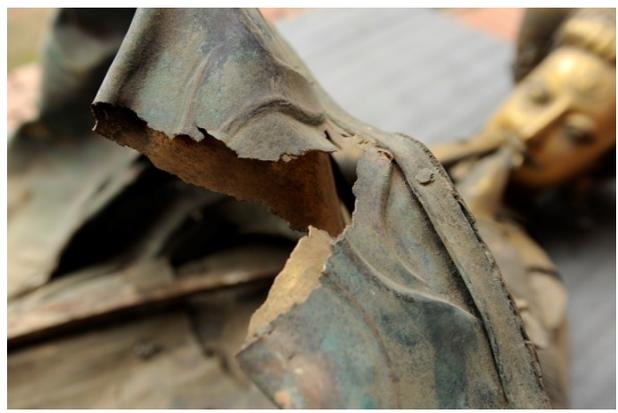
Fig. 19: Big crack, 2016

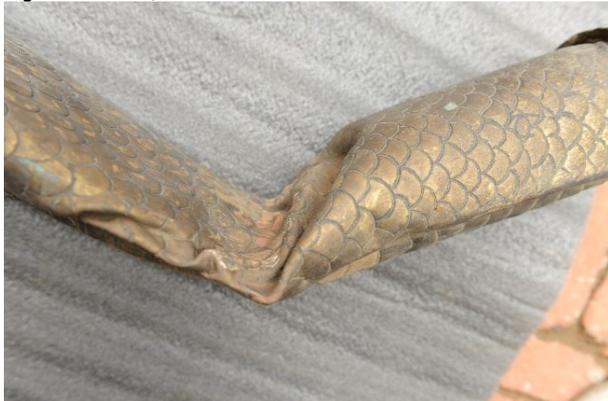
Fig. 20: Deformed naga and soiled surface, 2016

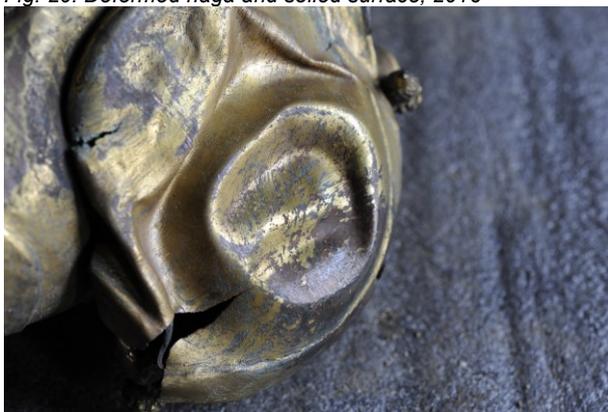
Fig. 22: Deformed back of the queen's head, 2016

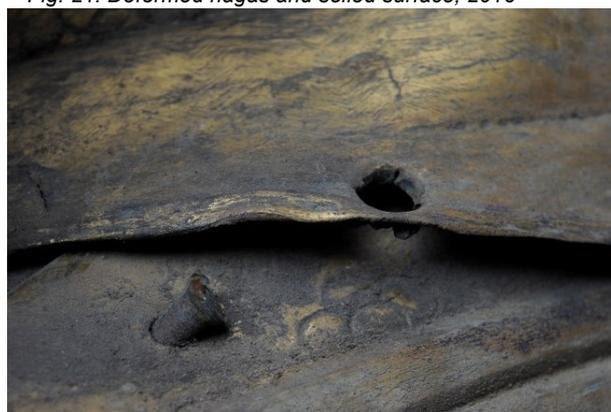
Fig. 23: Torn rivet and soiled surface, 2016

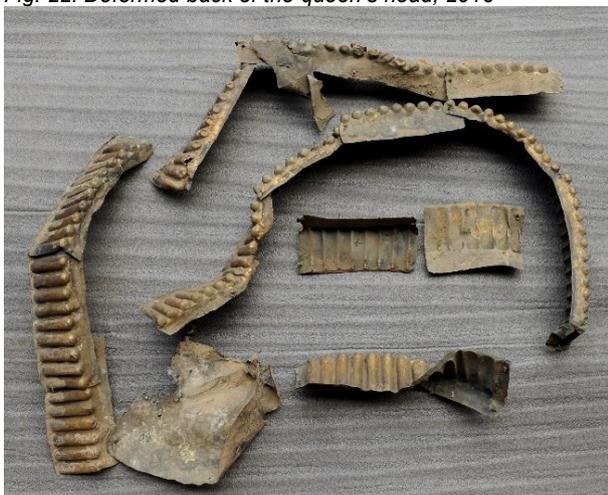
Fig. 24: Deformed elements of ornate frame, 2016

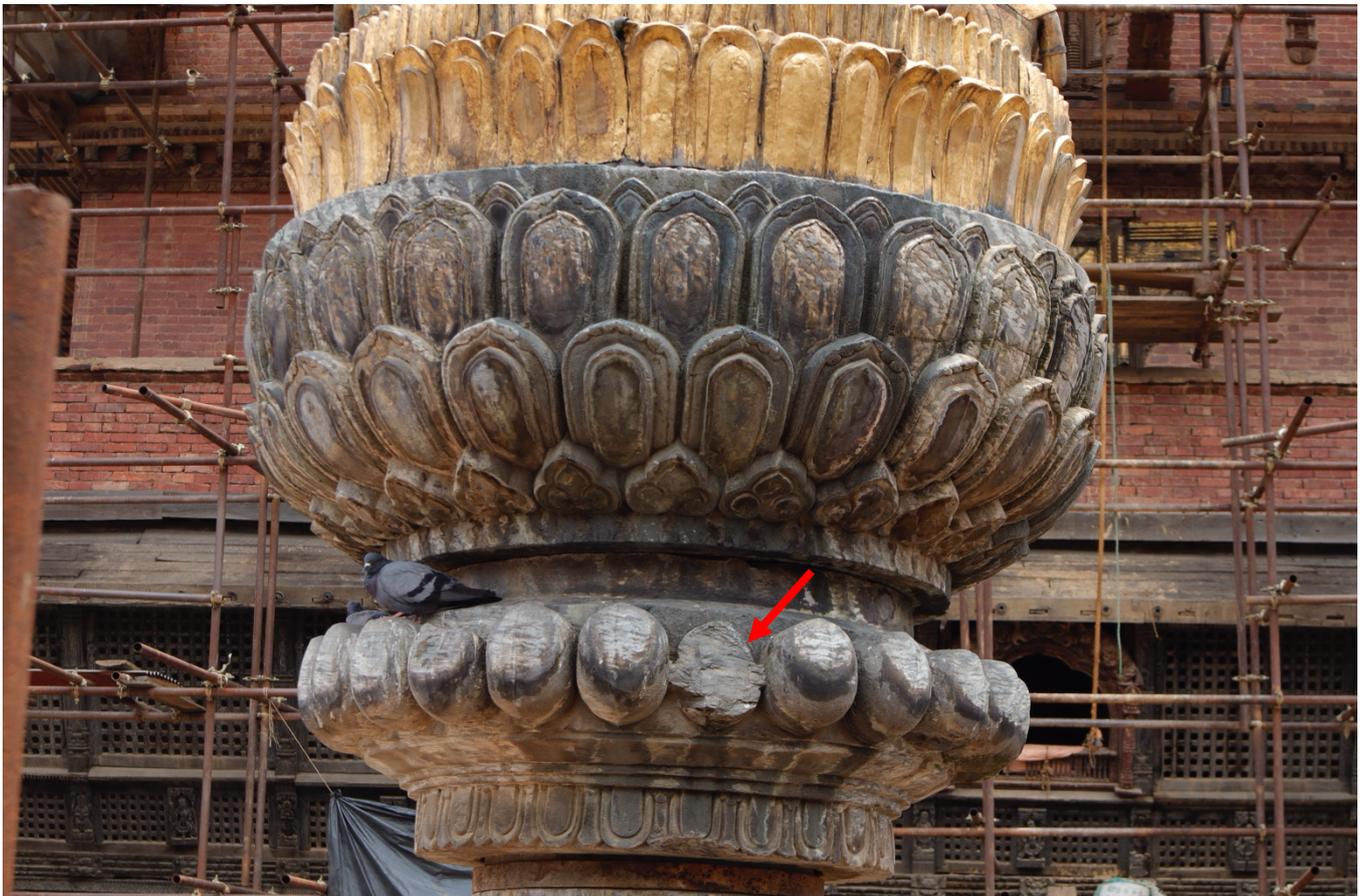
One of the lotus-rim elements is broken off (west side) (Fig. 1).

Fig. 1: Broken off lotus rim element.

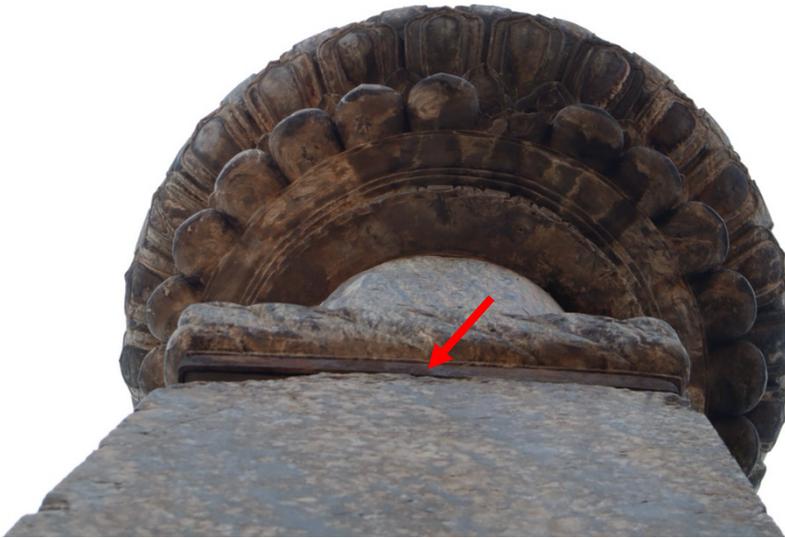
Scaling at pillar shaft was found under the square metal rim (Fig. 2).

Fig. 2: Scaling of the schist stone under the square iron rim.

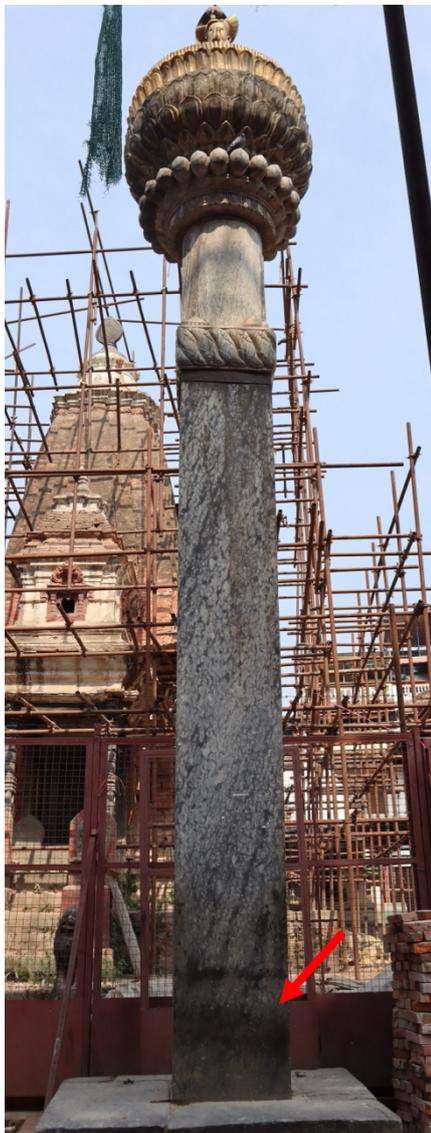
<input checked="" type="checkbox"/> Soiling <input type="checkbox"/> Not detected	<input type="checkbox"/> Heavy  <input type="checkbox"/> Medium  <input checked="" type="checkbox"/> Light	_____
		_____
		Typical human induced soiling in the lower area of the pillar (Fig. 3).

Fig. 3: Darkened area at the base of the pillar shaft.

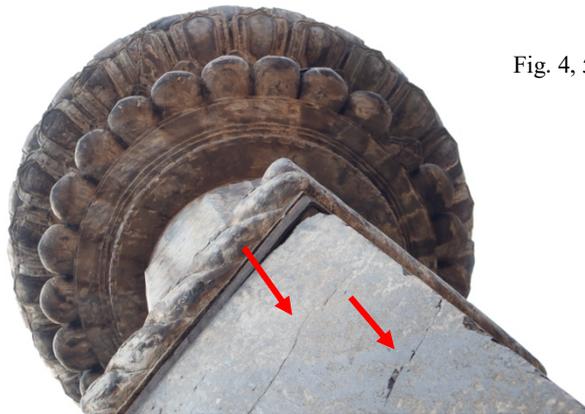
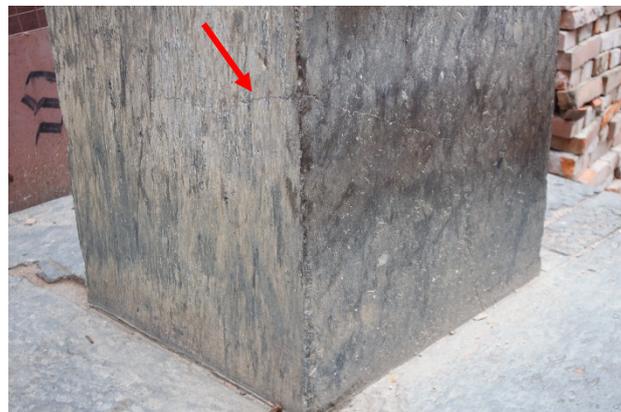
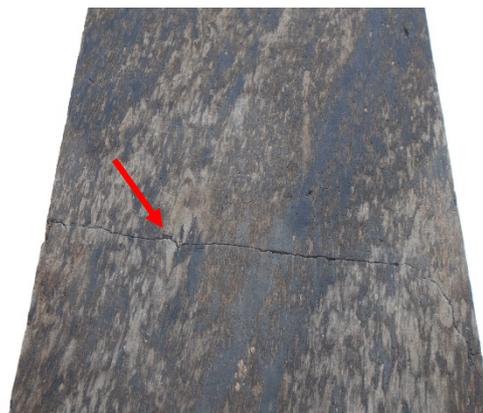
In general, the object is in good condition; the upper parts show dark crusts, with partial flaking of the crust, exposing the stone underneath. Loss of one and a half lotus rim element (recent?). Cracks seem unchanged since last treatment (Fig. 4, 5, 6), iron rim heavily rusted, causing rust stains on the stone.

Fig. 4, 5, 6: Cracks in the shaft.
