**Protection for Calcareous Stones in Times of Climate Change - Preventive and  
Interventive Conservation Measures**

Dissertation zur Erlangung des akademischen Grades  
einer Doktorin der Naturwissenschaften  
eingereicht an der Universität für angewandte Kunst Wien

**Marija Milchin**

Wien, im Februar 2026

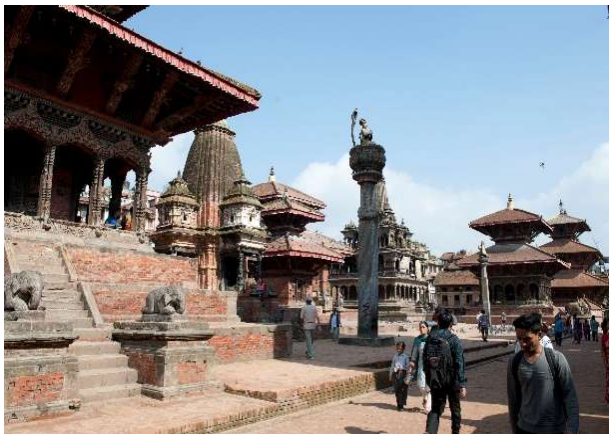
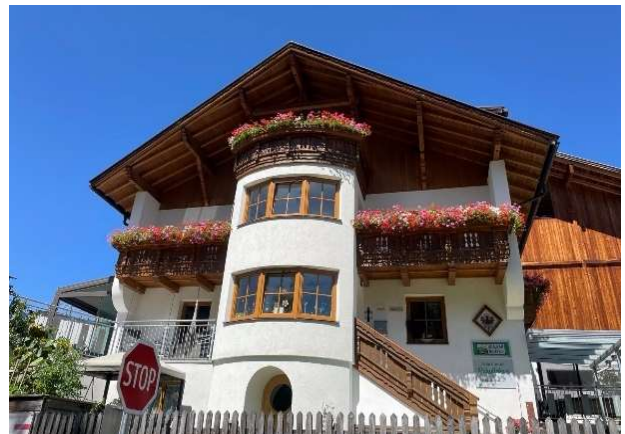
The design of (traditional) buildings often correlates with the needs deriving from certain types of climates. For example, the typical vernacular Newar buildings in the Kathmandu Valley, Nepal, feature projecting roofs and elevated 'ground floors' (Fig.1) designed to give protection against flooding and water ingress during monsoon rains (Bodach, Lang and Hamhaber 2014). In alpine regions, projecting roofs are also part of the traditional architecture (Fig.2), their task here being mostly to keep snow away from the direct vicinity of the walls.

Fig. 1 and 2: Vernacular architecture in Katmandu Valley, Nepal (left) and in Tyrol, Austria (right)

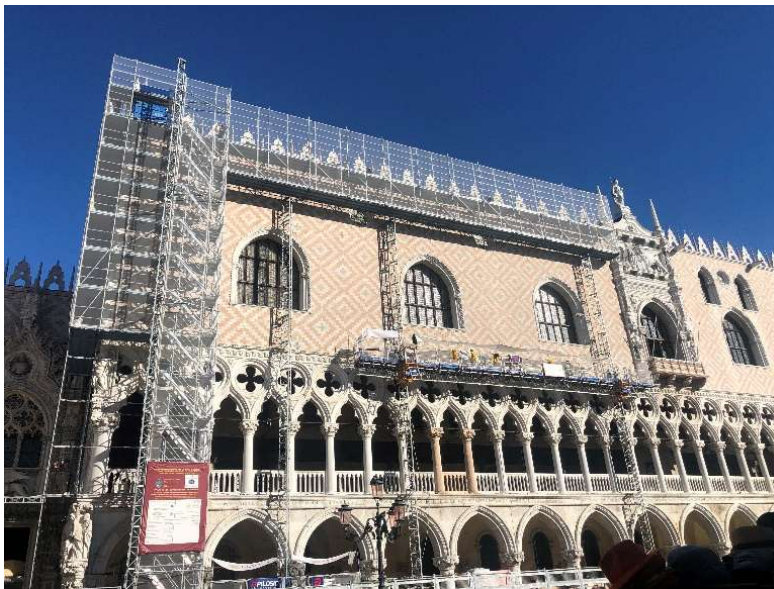
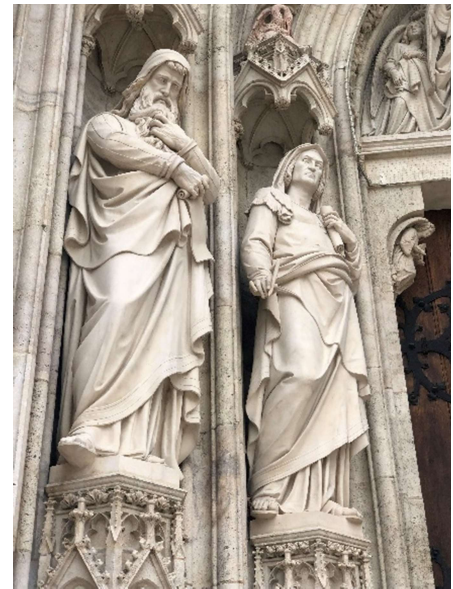
Fig.11 and 12: Istrian stone used on different façades; left: the façade of Palazzo Ducale in Venice (14<sup>th</sup> century), right: the sculptures on the façade of the Votivkirche in Vienna (19<sup>th</sup> century)

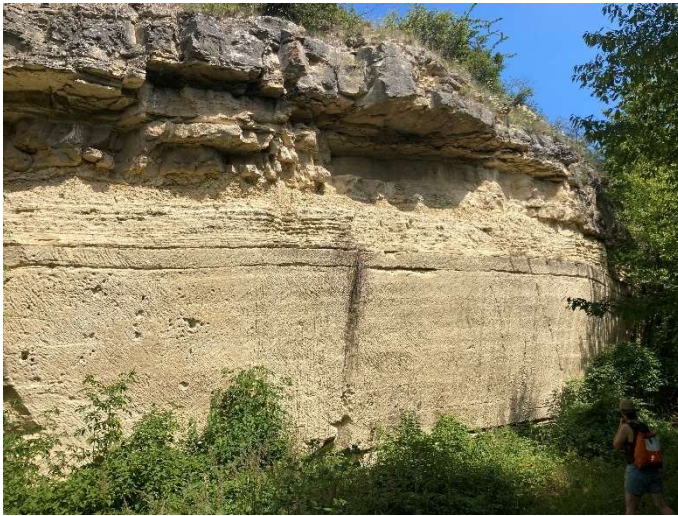
Fig. 13: Roman quarry of the porous limestone of Stotzing, "Leithagebirge", Austria (©Andrea Hackel)

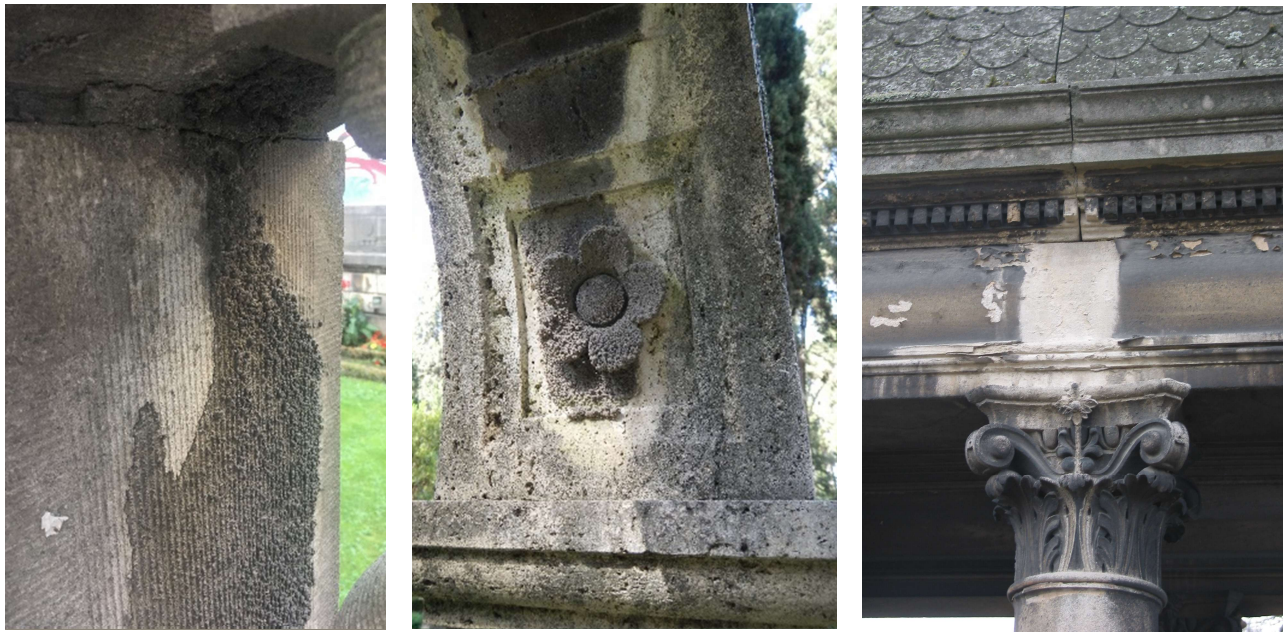
Fig. 18-20: “Black areas” or sulphation crusts, on monument surfaces in different European cities f.l.t.r.: Brussels, Rome and Vienna

The availability of  $\text{SO}_2$  necessary for this process is directly linked to the use of fossil fuels, particularly coal. Coal contains not only high concentrations of sulphur, but also generates significant amounts of soot and particulate matter when burned. The particulate pollutants can be embedded in the sulphation crusts and contribute to the well-known black colour of the same. The “black areas” (Camuffo et al. 1982) are only found on surfaces that are protected from direct rain but are wetted indirectly through capillary suction within the stone or condensation within the pores (Fig. 18-20).

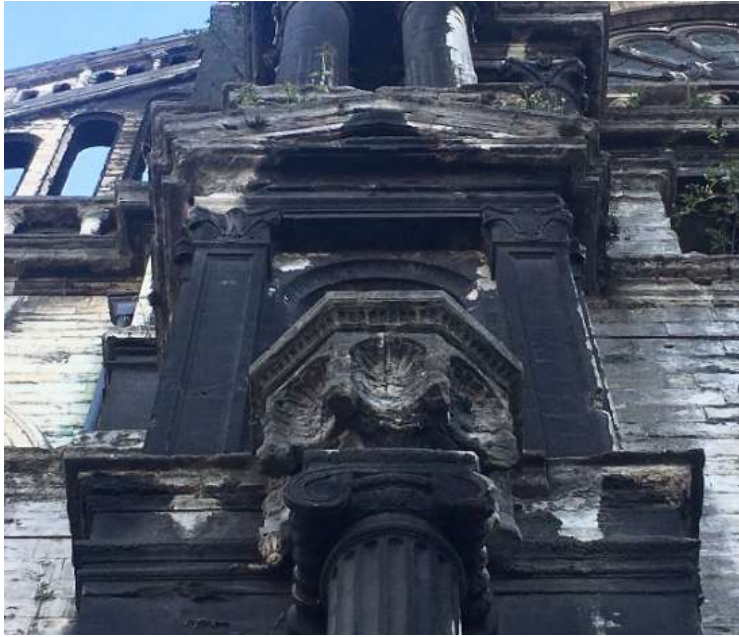
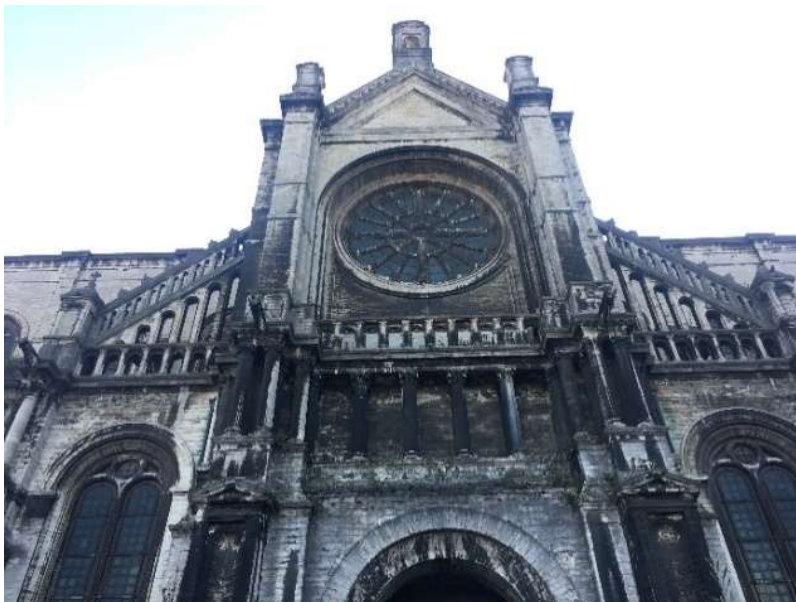
Fig. 21-23: St. Katherina church in Brussels: sulphation crusts (left up and down) and the half-cleaned façade (right)

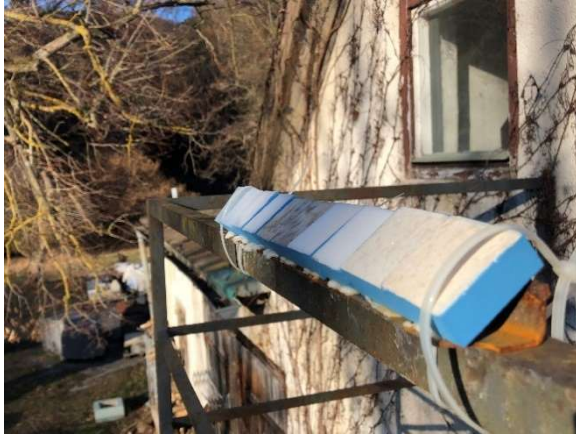
Fig. 31: first exposure of material sensors on a rack in Sattelbach, Lower Austria

The samples were placed on an exposure rack, in a rural area in Sattelbach<sup>27</sup>, Lower Austria, facing northwest (Fig.31), for defined periods of time (three and six months).

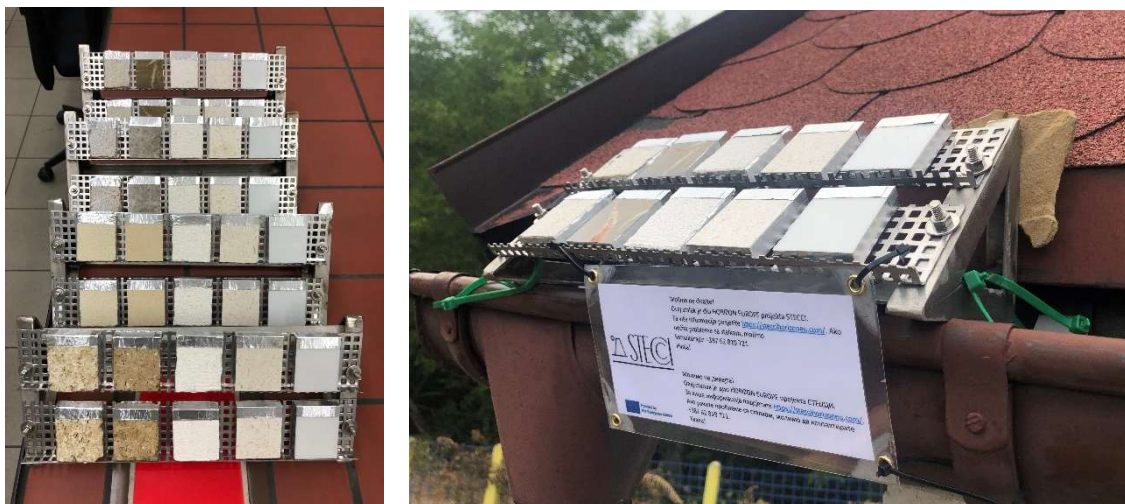
Fig. 44 and 45: The exposure racks for the STECCI project: four racks prepared for the installation (left) and the first installed rack (07.24) on the site of Kopošići in Bosnia and Herzegovina (right)

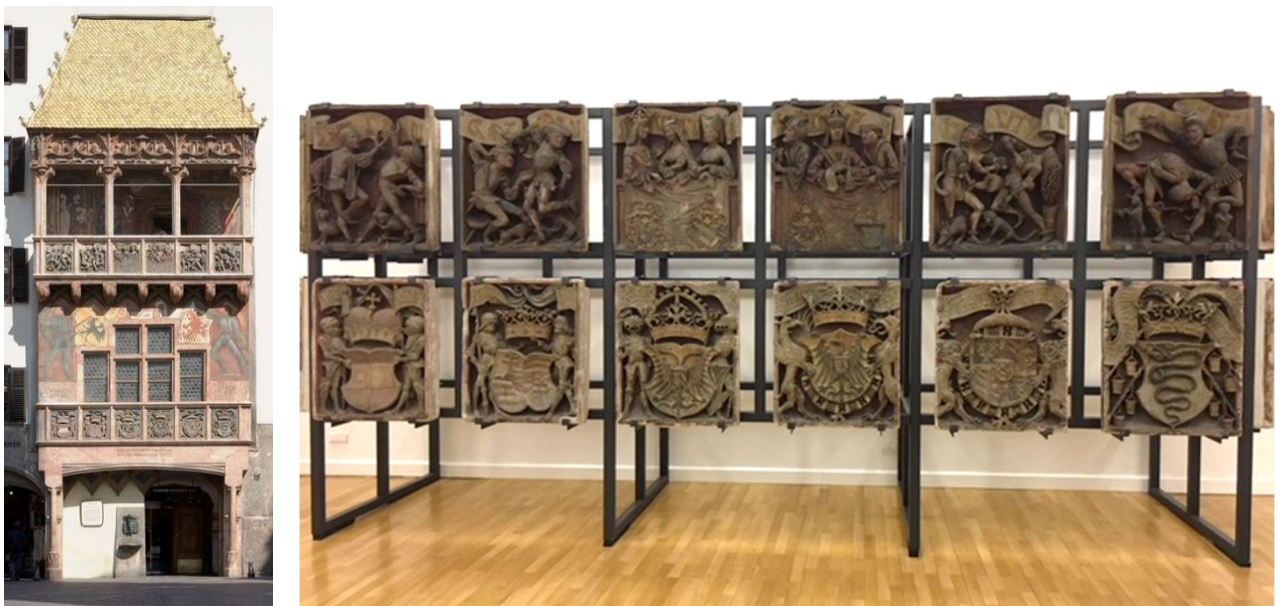
One of the most straightforward approaches to preventive conservation for “movable” outdoor stones is aiming at utilising the better circumstances in indoor environments. For “smaller” items, like singular sculptures, the possibility for a relocation of the same from the outdoor to an indoor environment is sometimes given. Depending on the relocated asset and its context, a copy might be placed to substitute the missing item; e.g. the reliefs of “Goldenes Dachl” (the Golden Roof) in Innsbruck, Tyrol, were substituted by polychrome stone copies on the façade (Fig. 46), while the originals were placed in a museum (Fig. 47) in the 1950s and 1960s (Milchin, Fuchs and Krist 2020).

Fig. 46 and 47: The reliefs of the “Goldenes Dachl” in Innsbruck, Tyrol, left: the façade displaying the stone copies of the reliefs (2018); right: the original stone reliefs from “Goldenes Dachl” on display in the Tyrolean Museum “Ferdinandeum” (2018)

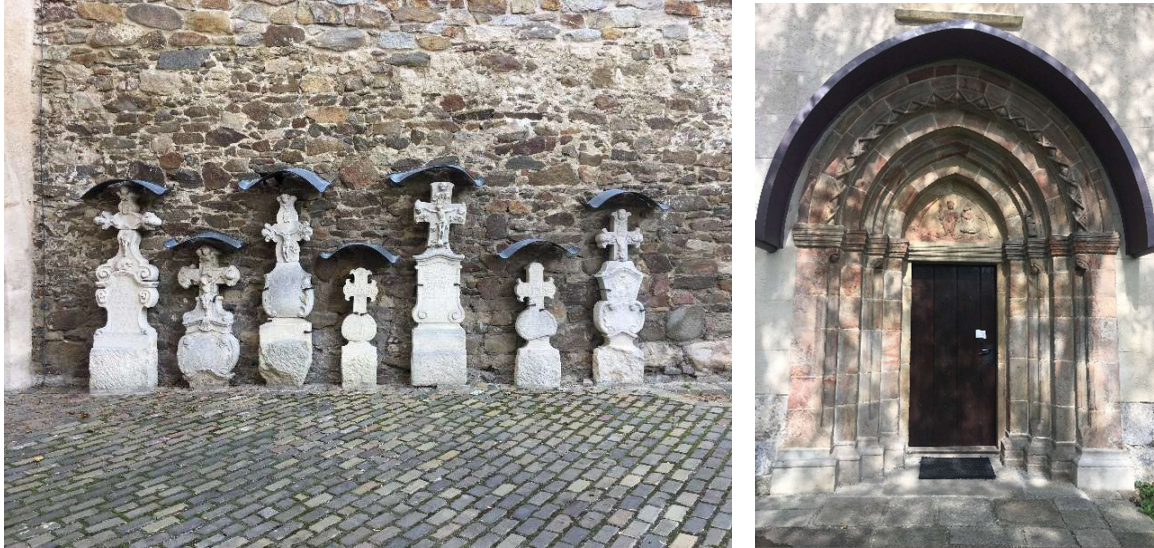
Fig. 48 and 49: permanent roofs as protection: left: historic roofs over gravestones on a church façade in Eggenburg, Lower Austria; right: a contemporary roof over a stone portal, St. Pantaleon-Erla, Lower Austria

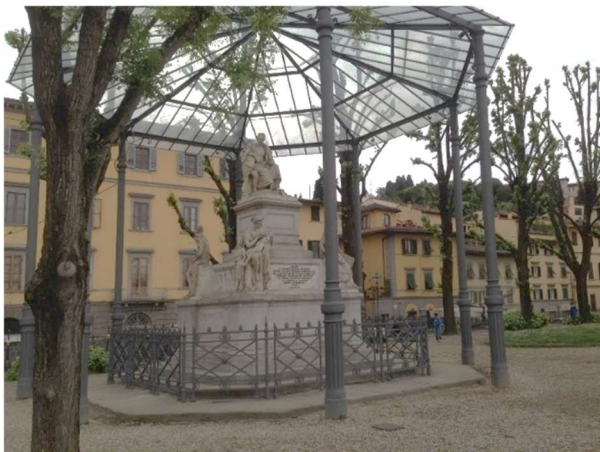
Fig. 50: historic permanent shelter over the monument to Nicola Demidoff (1870) in Florence, Italy

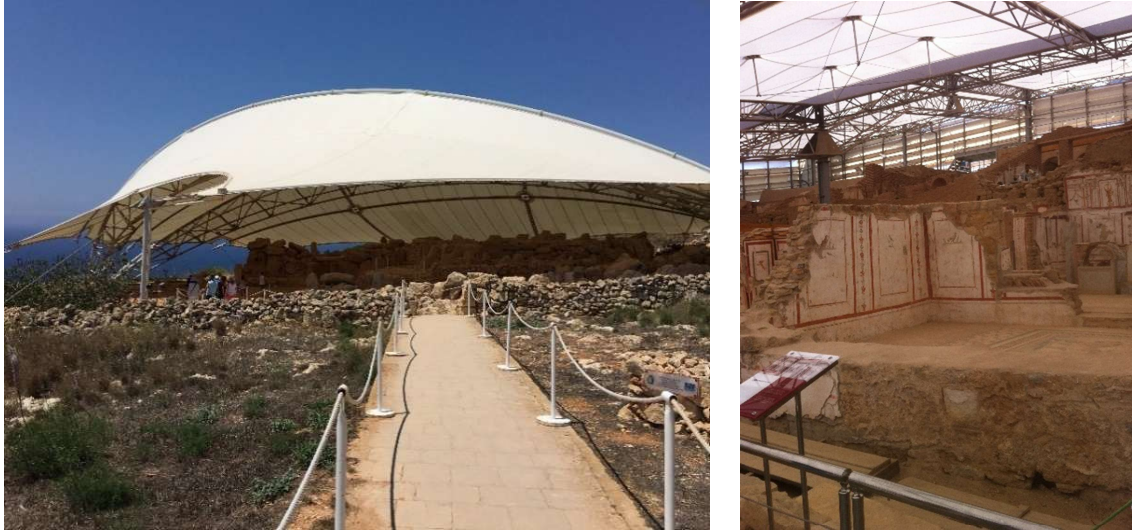
Permanent shelters are more commonly found in the context of archaeological sites (Schmidt 1995; Woolfitt 2007). More recent research on this topic was initiated with the implementation of the shelters for the megalithic sites of Ħaġar Qim, Mnajdra and Tarxien on Malta (Cassar et al. 2018) (Fig. 51). The shelter at Ħaġar Qim was evaluated in a thesis by Briones (2015).

Fig. 51 and 52: permanent shelter over archaeological sites: Ħaġar Qim, Malta (left) and Slope house II, Ephesus, Turkey

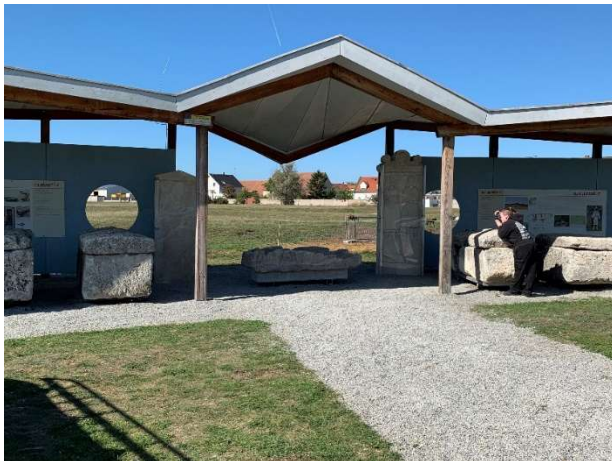
The permanent shelter for Roman gravestones and sarcophagi in Leithaprodersdorf, Lower Austria, was examined in a study (Milchin, Haselberger and Krist 2020) that can be found in the Appendix of this thesis. While the shelter protects by keeping rain and snow away from the assets exhibited underneath, it also has hint sides. The accumulation of dust and bird droppings, which are not washed away by rain due to the presence of the shelter, as well as the accumulation of litter, are among the associated issues. These problems are similar to those published in literature and noted elsewhere, e.g. the aforementioned shelters over the megalithic temples on Malta (Fig. 53 and 54). The changes in perception of the surroundings and context also seem important, but addressing the issue of bird droppings is probably the most crucial one, as it is the potentially most damaging change to the system in terms of materiality, after a permanent shelter is installed. Bird droppings are very acidic, contain salts and can therefore etch the surfaces and cause the accumulation of salts (Rubén 2022). Shelters also provide favourable conditions for the prolonged presence of birds, as they offer protection and numerous nesting opportunities. Dust accumulation on monument surfaces can also pose problems if no maintenance is conducted, as it is not washed away by rain.

Fig. 55: Permanent shelter in Leithaprodersdorf, Lower Austria

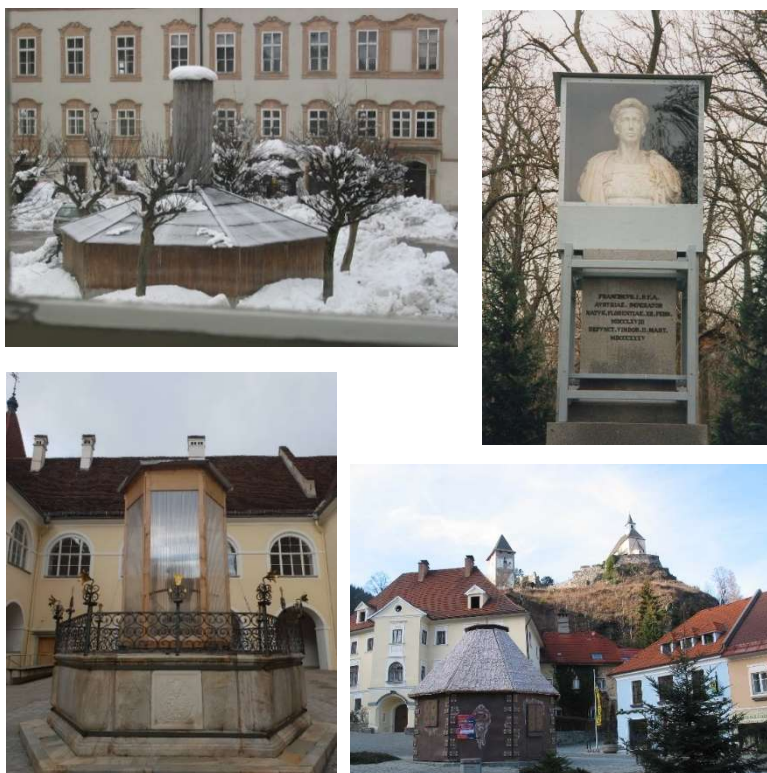
Fig. 57- 60: Different winter-shelter designs seen around Austria; f.l.t.r.: upper row: fountain in Monastery St. Peter, Salzburg, Bust of Leopold von Habsburg in the gardens of Laxenburg; lower row: Fountain in Monastery St. Paul in Lavantal, Fountain in Friesach (© Johann Nimmrichter and Marija Milchin)

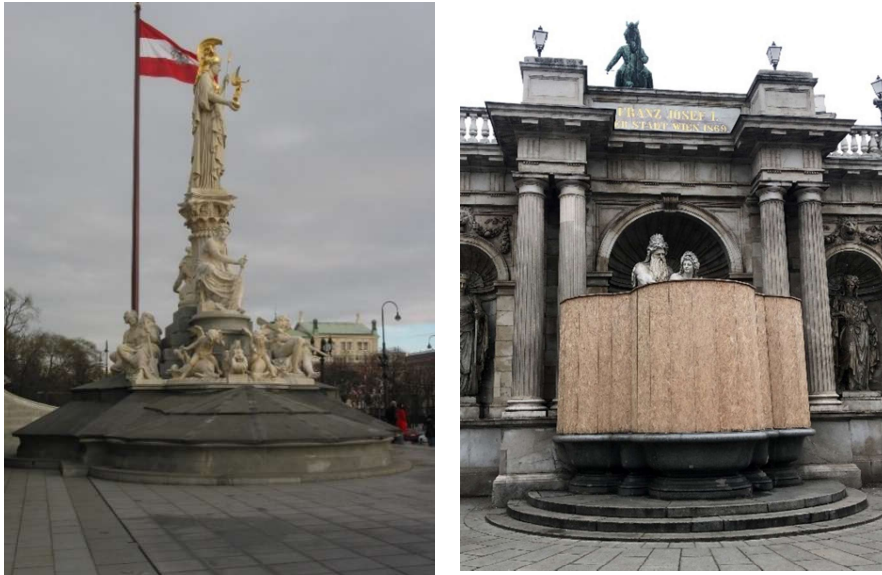
In the city of Vienna various small monuments are sheltered in winter. However, the majority of the winter shelters are simple covers for fountains, which often aim to protect only the basin of a fountain (Fig. 61

and 62). The concept is to ensure that the emptied basin remains devoid of rainwater and/or snow, preventing damage due to freeze-thaw cycling and to a lesser extent protecting surfaces from surface recession. The covers also only protect the basin and not the statuary of the fountain, which often stays exposed.

Fig. 61 and 62: Viennese fountains with winter covers for the fountain basin: Palais Athenna Fountain in front of the Austrian Parliament (left), Albrecht Fountain in front of the "Albertina" (right)

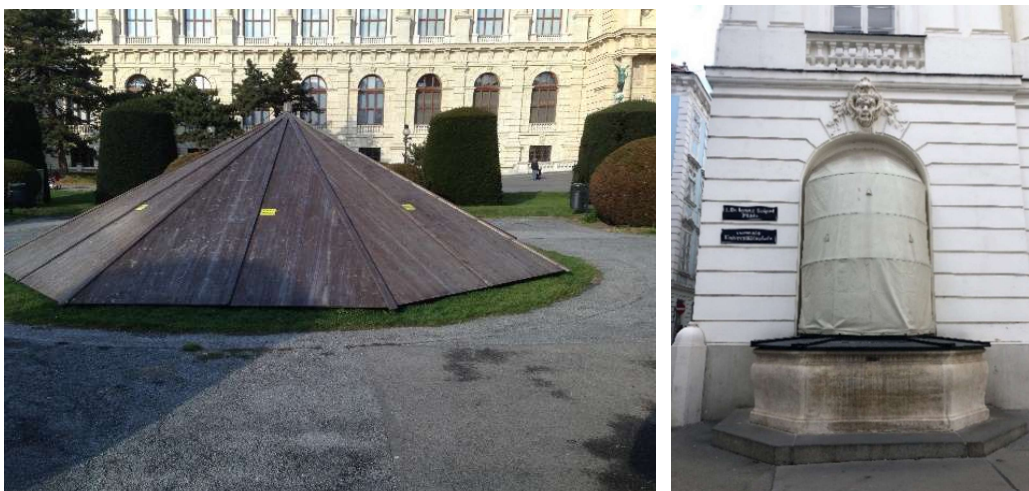
Few fountains in Vienna have winter shelters that cover both, the basin and the statuary (Fig. 63 and 64). Since many fountains are already being (semi-)sheltered, it can be suggested to extend the shelters to include the statuary as well. In doing so, the protection potential would be extended to the statuary and the whole fountain would profit.

Fig. 63 and 64.: Winter-sheltered fountains in Vienna: Maria-Theresien Platz (left) and Austrian Academy of Sciences (right)

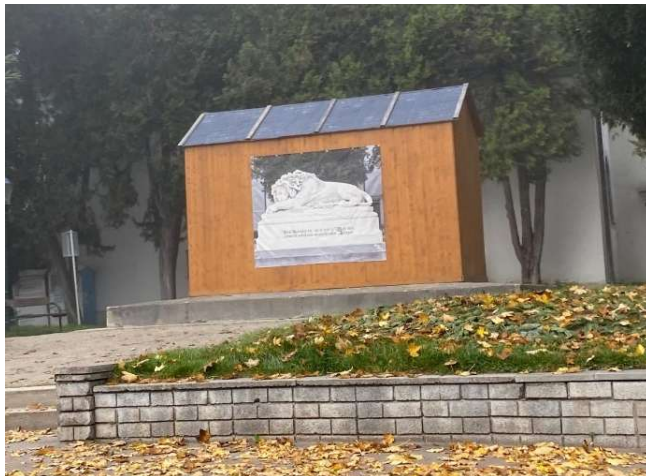
One of the very few examples of consequent use of winter shelters for a stone sculpture in Vienna is noted for the so-called "Lion of Aspern" by Anton Fernkorn (1858), a sculpture in the 22<sup>nd</sup> district of Vienna. The sculpture, made of porous limestone, has been protected for more than a decade by a wooden winter shelter bearing a photograph of the underlying sculpture during the winter months (Fig. 65).

Fig. 65: Winter shelter for the "Lion of Aspern" (2024)

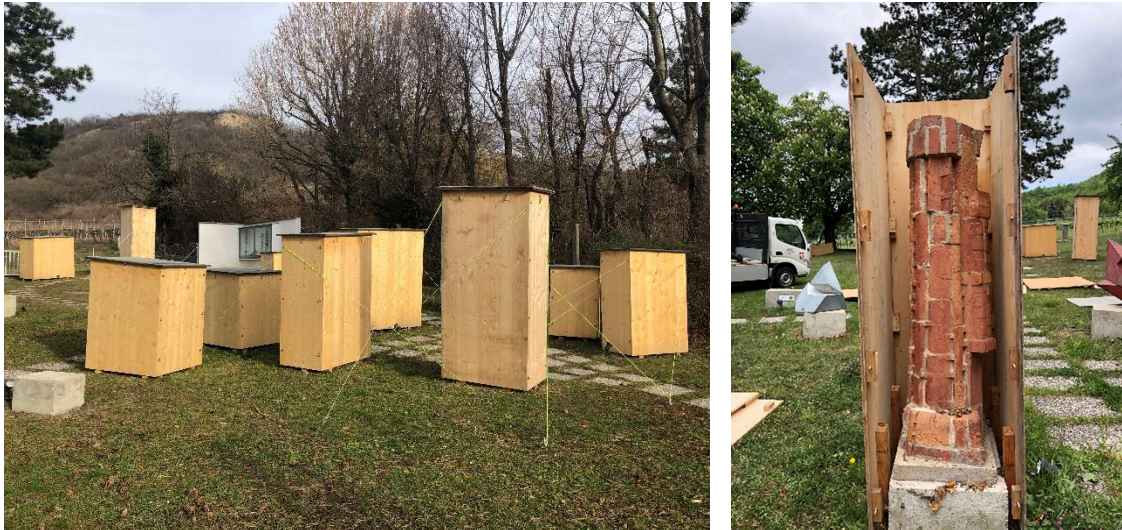
drawbacks include the required storage space in summer and the labour-intensive process of mounting and dismantling. When deciding upon the “traditional” version, it is important to think about a stable and firm fixation of the shelter (the problem of wind will be discussed further on in this chapter) and the possibility of air circulation.

Fig 66 and 67: “Traditional” wooden winter-shelters in the museum garden of LEMU in Langenzersdorf, Lower Austria (left), one of the shelters during dismantling (right)

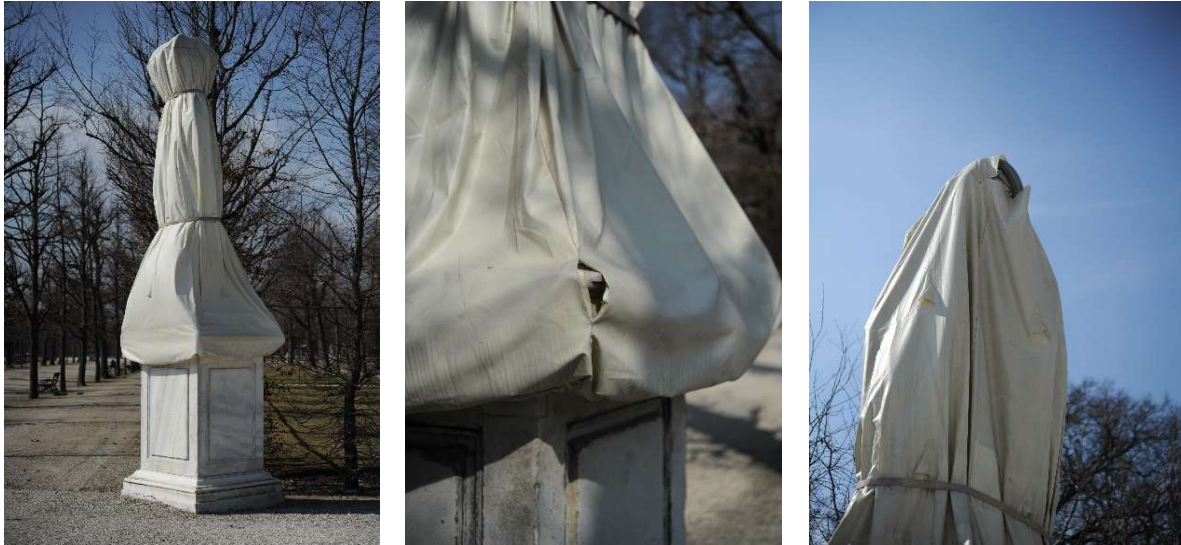
Fig. 68 – 70: soft winter-shelters in the Schönbrunn Gardens (left), prominent problems and damage (middle and right)

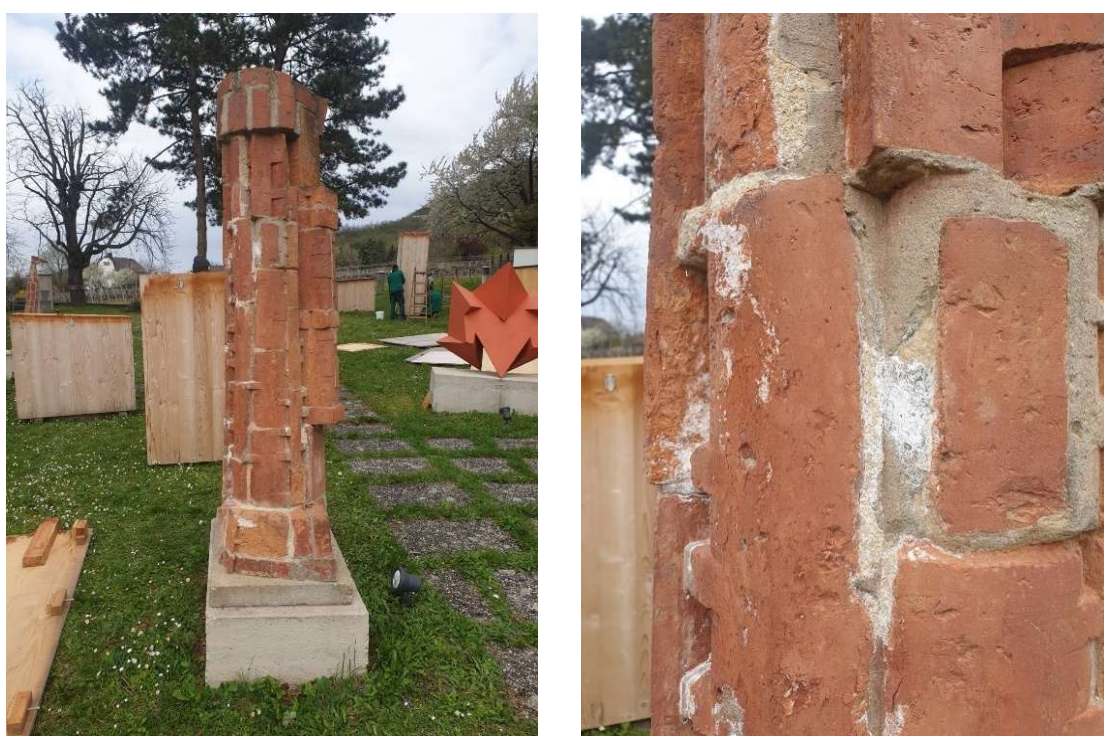
Fig. 72 and 73: Salt efflorescence visible after the dismantling of the winter shelters in spring, LEMU (© Katharina Breunhölter)

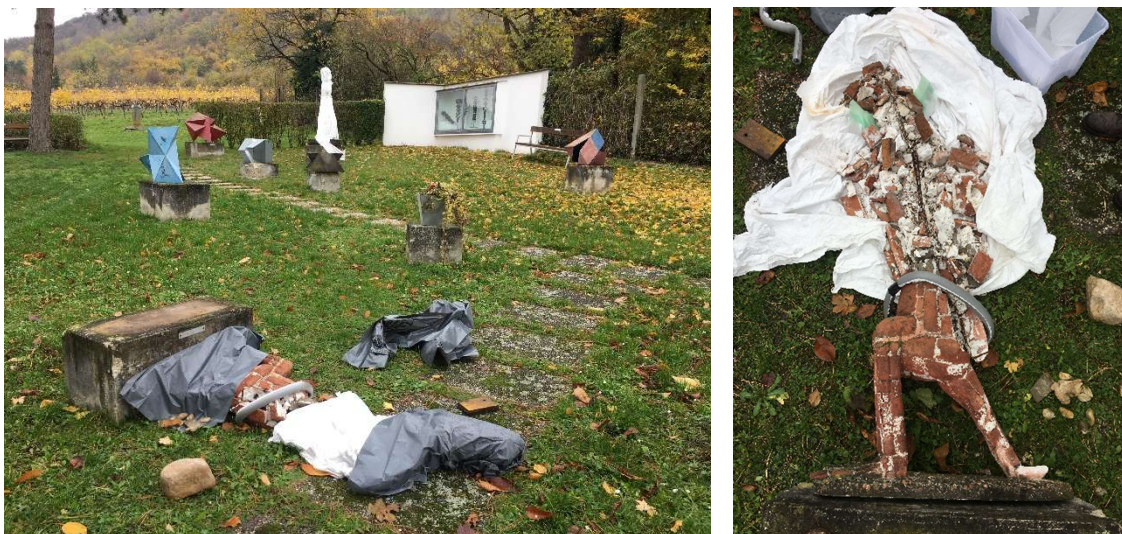
Fig. 75 and 76: Damage to the sculpture “Kangaroo” after a storm in the winter 2017/18, Langenzersdorf, Lower Austria

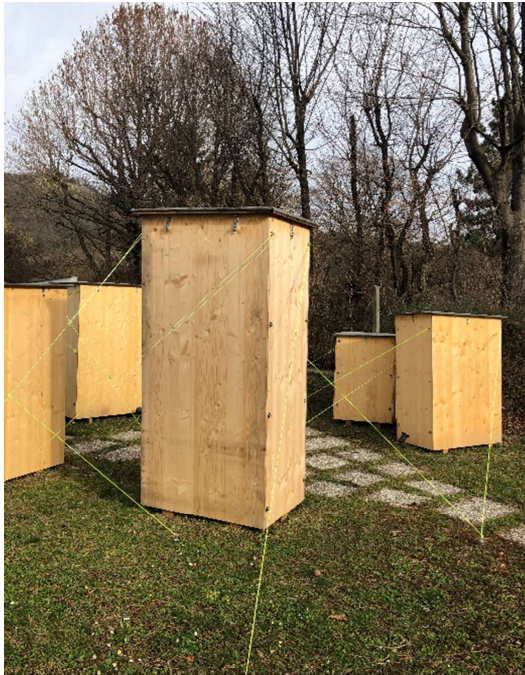
Fig. 77: Wooden shelters stabilised by tension ropes

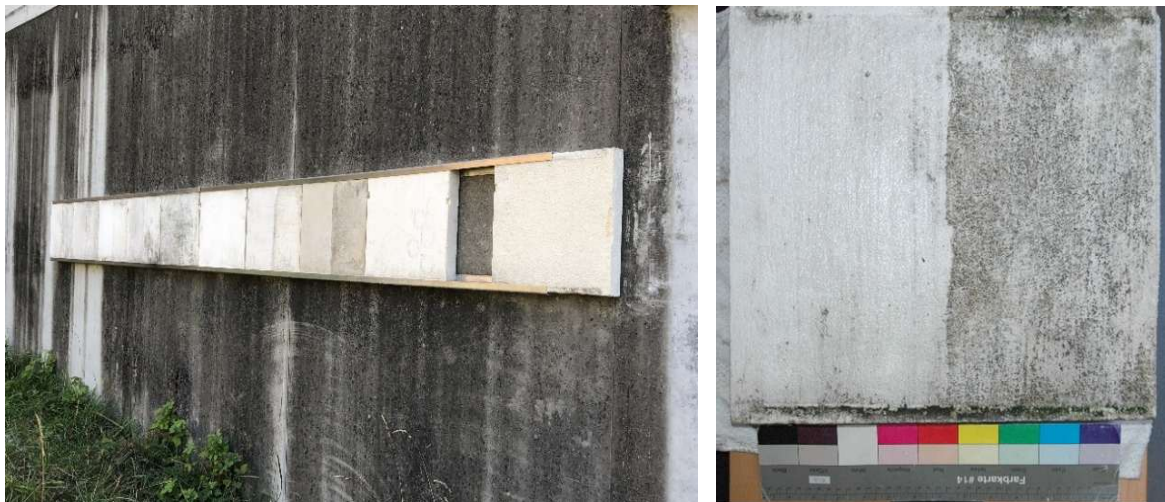
Fig. 78 and 79: Exposure of stone slabs with different shelter coats in Mauerbach, Lower Austria (left) and slab I (lime shelter coat) after 12 months of exposure, the right side of the slab is additionally treated with hydro repellent

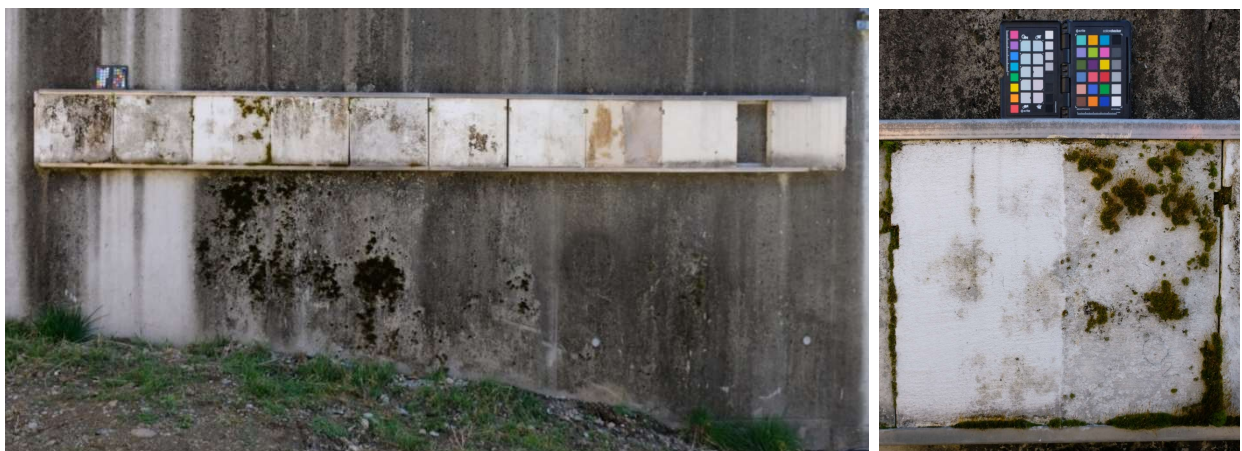
Fig. 80 and 81: after 8 years of exposure: stone slabs with different shelter coats (left) and slab III - lime shelter coat with white cement addition (right) (© Katharina Fuchs)

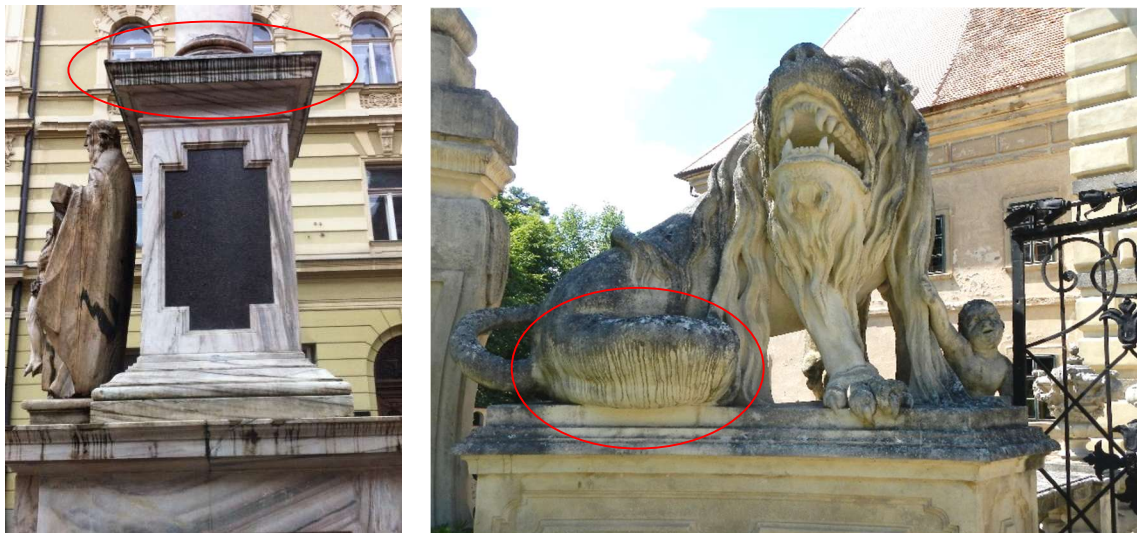
Fig. 88 and 89: Extreme soiling patterns due to a water repellent treatment documented on monuments in Austria: Klagenfurt (left) and Greillenstein (right)

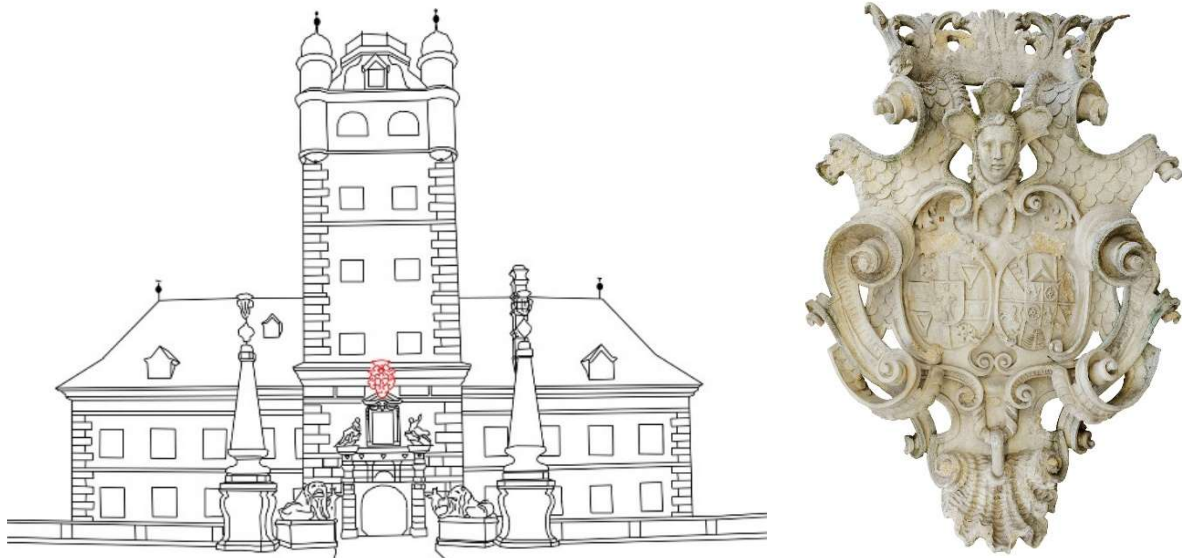
Here, the case of the coat of arms from Greillenstein Castle in Lower Austria should be mentioned. The monolithic Baroque object (Fig. 91) was mounted above the castle's main entrance (Fig. 90), tilted toward the ground to provide better visibility for anyone passing through the portal. The piece is made of *Zogelsdorfer Stein*, a porous limestone from northern Austria that was frequently used for sculptural work in Baroque times (Breunhölder et al. 2018).

Fig. 90 and 91: The position of the coat of arms on the south façade of the Greillenstein castle, Lower Austria (left) and an overview of the dismantled coat of arms before the conservation treatment in 2016 (right) (©Katharina Breunhölder)

By the 1980s, the coat of arms was in very poor condition and therefore treated by a stone conservation company under the supervision of the Federal Monuments Authority Austria. The asset was cleaned, the effects of sulphation were treated, and the stone was consolidated using ethyl silicate (Wacker OH) and acrylates (Paraloid B72, 7%). At the end of the treatment, the coat of arms was painted with a silicon resin paint and a water repellent (Wacker 190) was applied on top (Breunhölder et al. 2018).

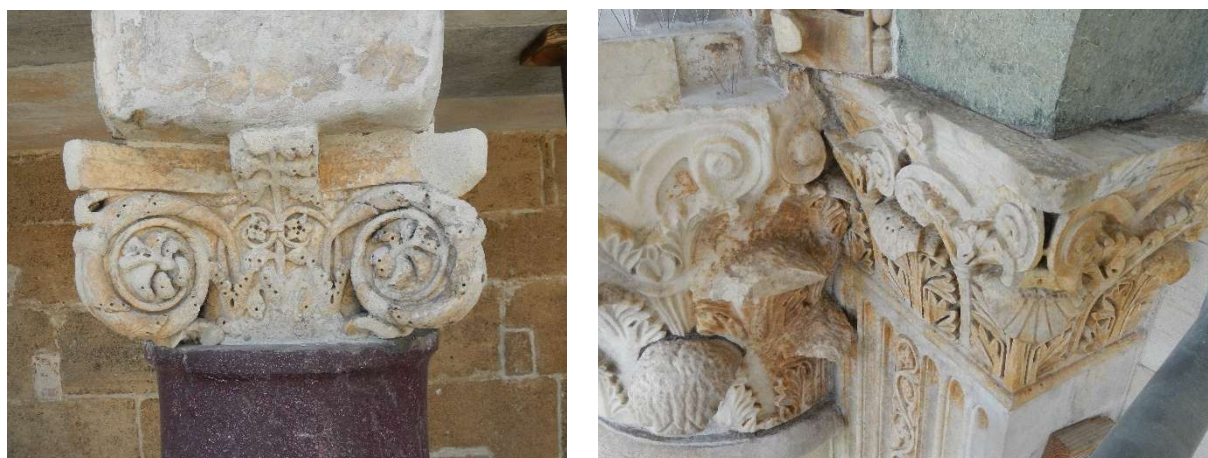
Fig. 93 and 94: Visible orange layers of natural oxalate patina on façade elements on the Cathedral of Pisa

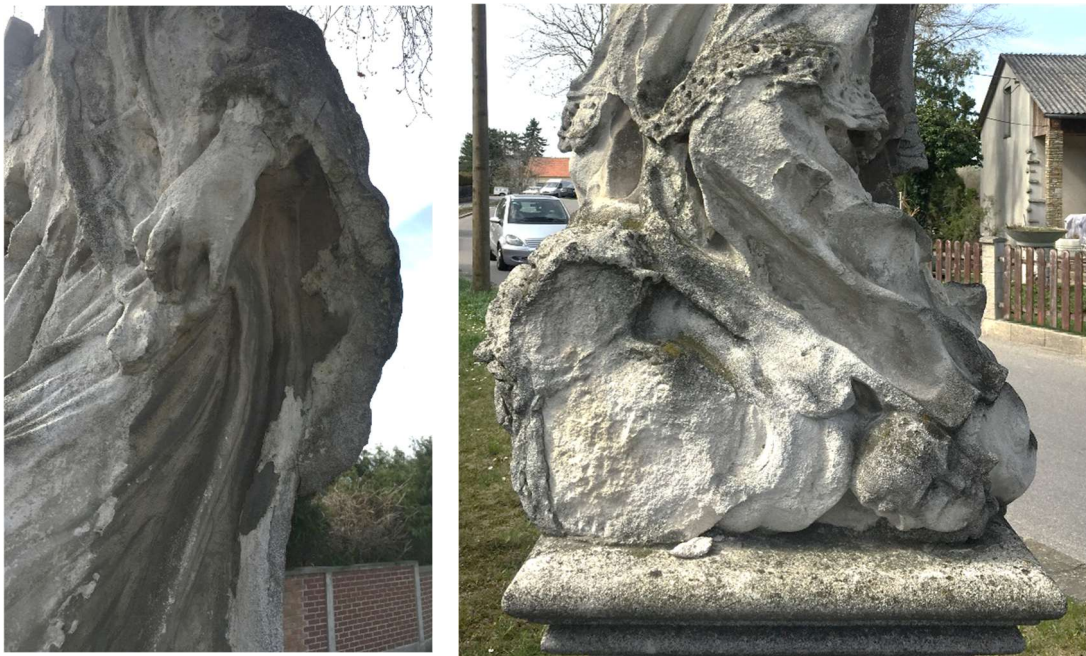
Fig. 95 and 96: Condition of the sculpture of St. Johannes von Nepomuk, before conservation (2018)

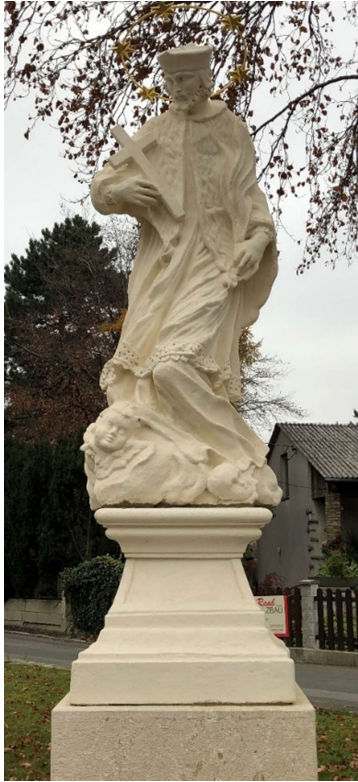
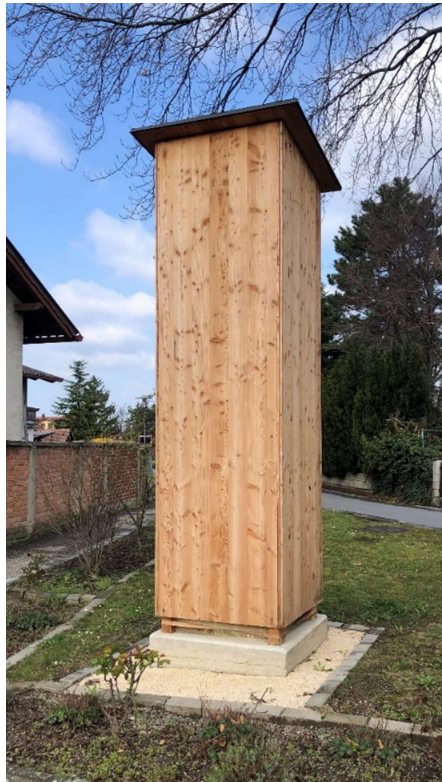
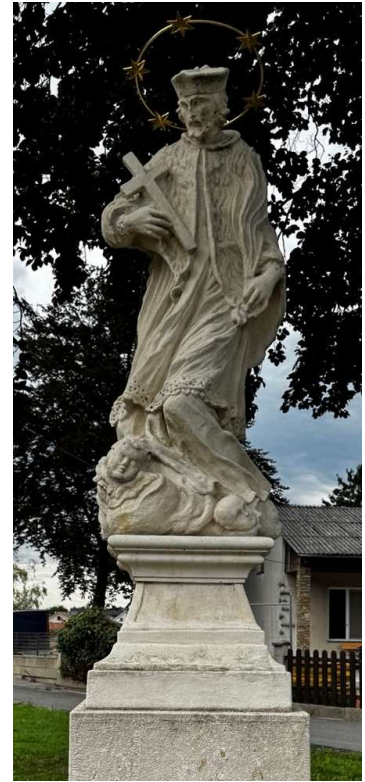
Fig. 100, 101 and 102: The sculpture of St. Johannes von Nepomuk, Königstetten, Lower Austria: after conservation 2019 (left), winter sheltered February 2024 (middle) and six years after the conservation treatment in 2025 (right)

In February 2024 while winter sheltered (Fig. 101), and July 2025 without winter shelter (Fig. 102), the situation was evaluated. The temporary shelter is still employed and the sculpture presents itself in a well-preserved state. Only some initial staining (mostly where black crusts were present before conservation) and some starting soiling can be noted (Fig. 103).

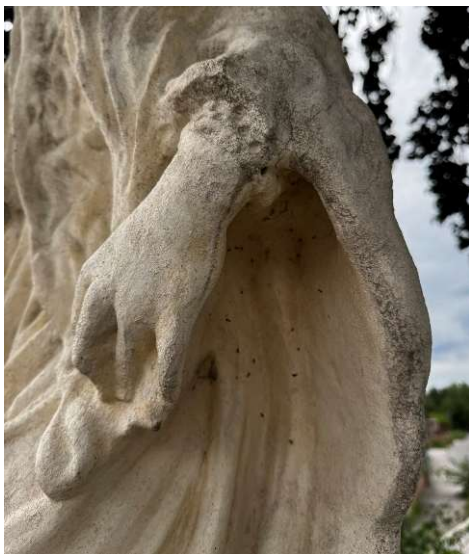
Fig. 103: Initial soiling visible on the sculpture after more than 5 years of exposure after treatment (2025)

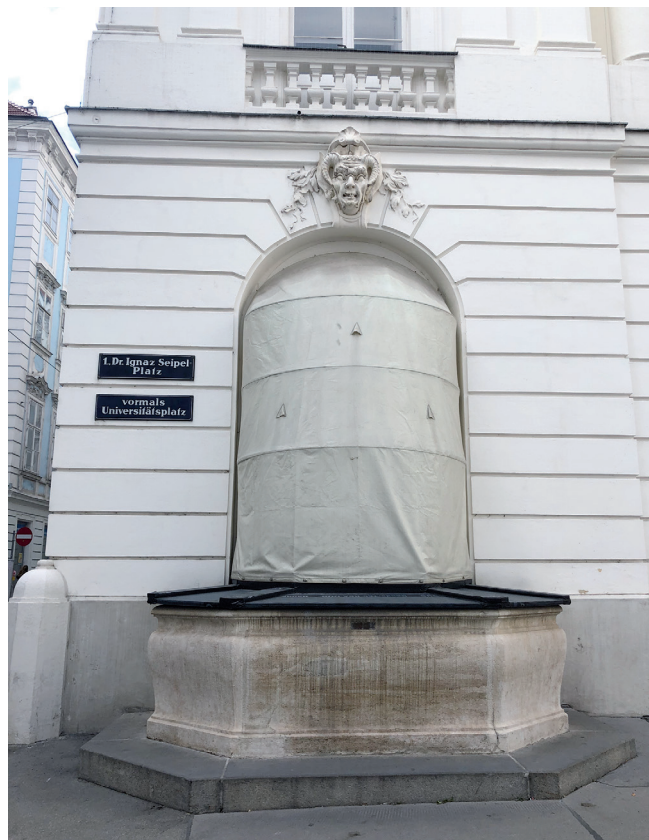
Abb. 5: Wintereinhausung von Wandbrunnen, Akademie der Wissenschaften, 1010 Wien; © Marija Milchin.

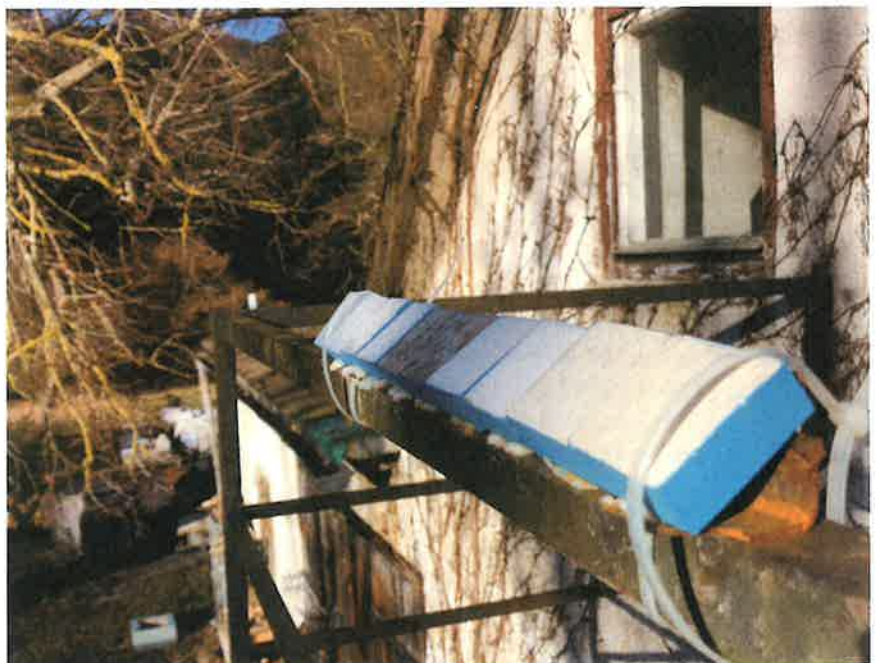
Abb. 1: Testreihe, exponierte mineralische Material-Sensoren (Marmor, Kalkstein und Alabaster)  
Fig. 1: Test series, exposed mineral material sensors (marble, limestone and alabaster)

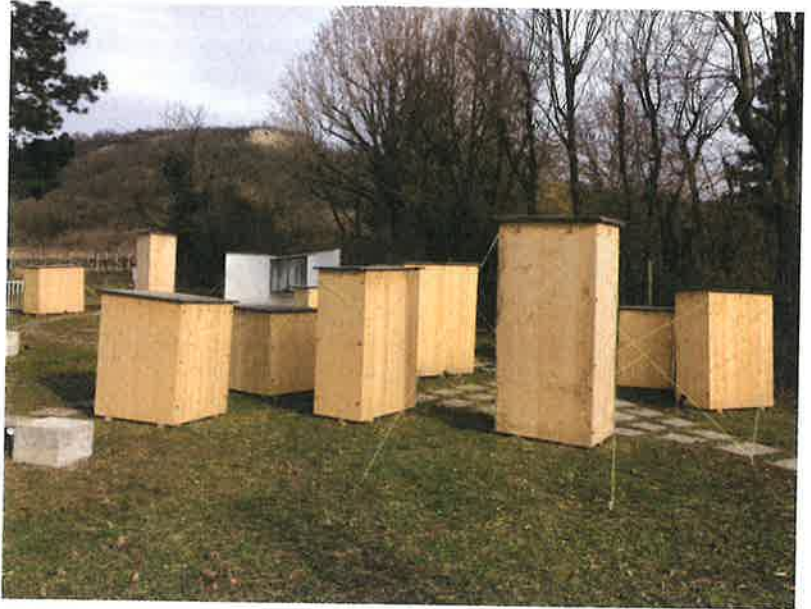
Abb. 2: Holz-Wintereinhausungen von Skulpturen und Plastiken, Langenzersdorf Museum, Niederösterreich

Fig. 2: Wooden winter shelters for sculptures, Langenzersdorf Museum, Lower Austria

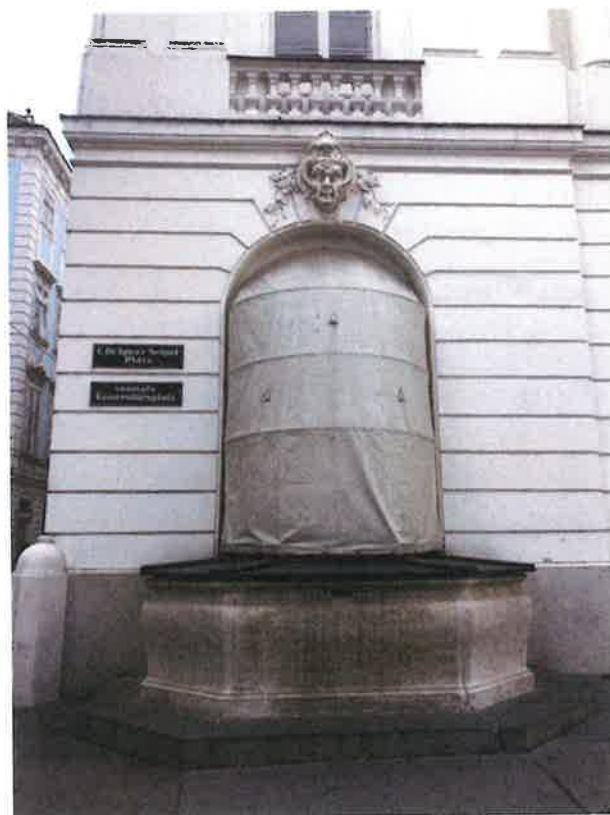
Abb. 3: Textile Wintereinhausung von Wandbrunnen, Akademie der Wissenschaften, Wien

Fig. 3: Textile winter shelter of wall fountains, Academy of Sciences, Vienna

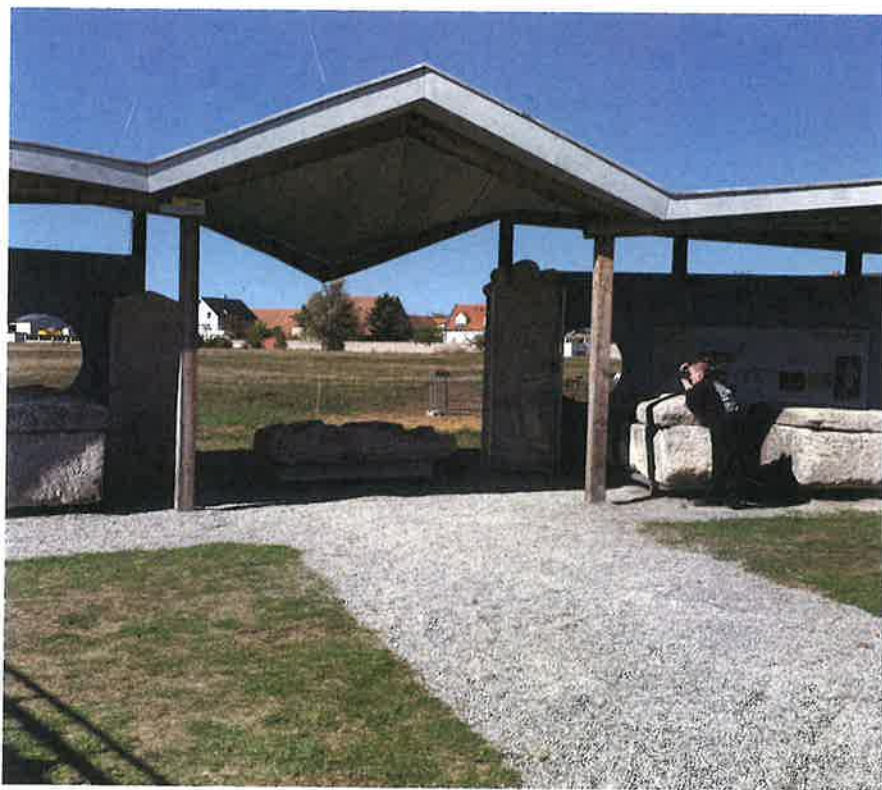
Abb. 4: Dachkonstruktion über römischen Grabsteinen und Sarkophagen, Leithaprodersdorf, Burgenland  
Fig. 4: Roof construction over Roman gravestones and sarcophagi, Leithaprodersdorf, Burgenland, Austria

Überdachungen können, sofern sie richtig dimensioniert und positioniert sind, Objekte und Fassaden ganzjährig vor direktem Niederschlag schützen (Abb. 4). Jedoch ist es aus konservatorischen (Eingriff in Originalsubstanz) aber auch denkmalpflegerischen und ästhetischen Gründen nicht überall möglich, derartige Konstruktionen (im Nachhinein) anzubringen.
