**Protection for Calcareous Stones in Times of Climate Change - Preventive and  
Interventive Conservation Measures**

Dissertation zur Erlangung des akademischen Grades  
einer Doktorin der Naturwissenschaften  
eingereicht an der Universität für angewandte Kunst Wien

**Marija Milchin**

Wien, im Februar 2026

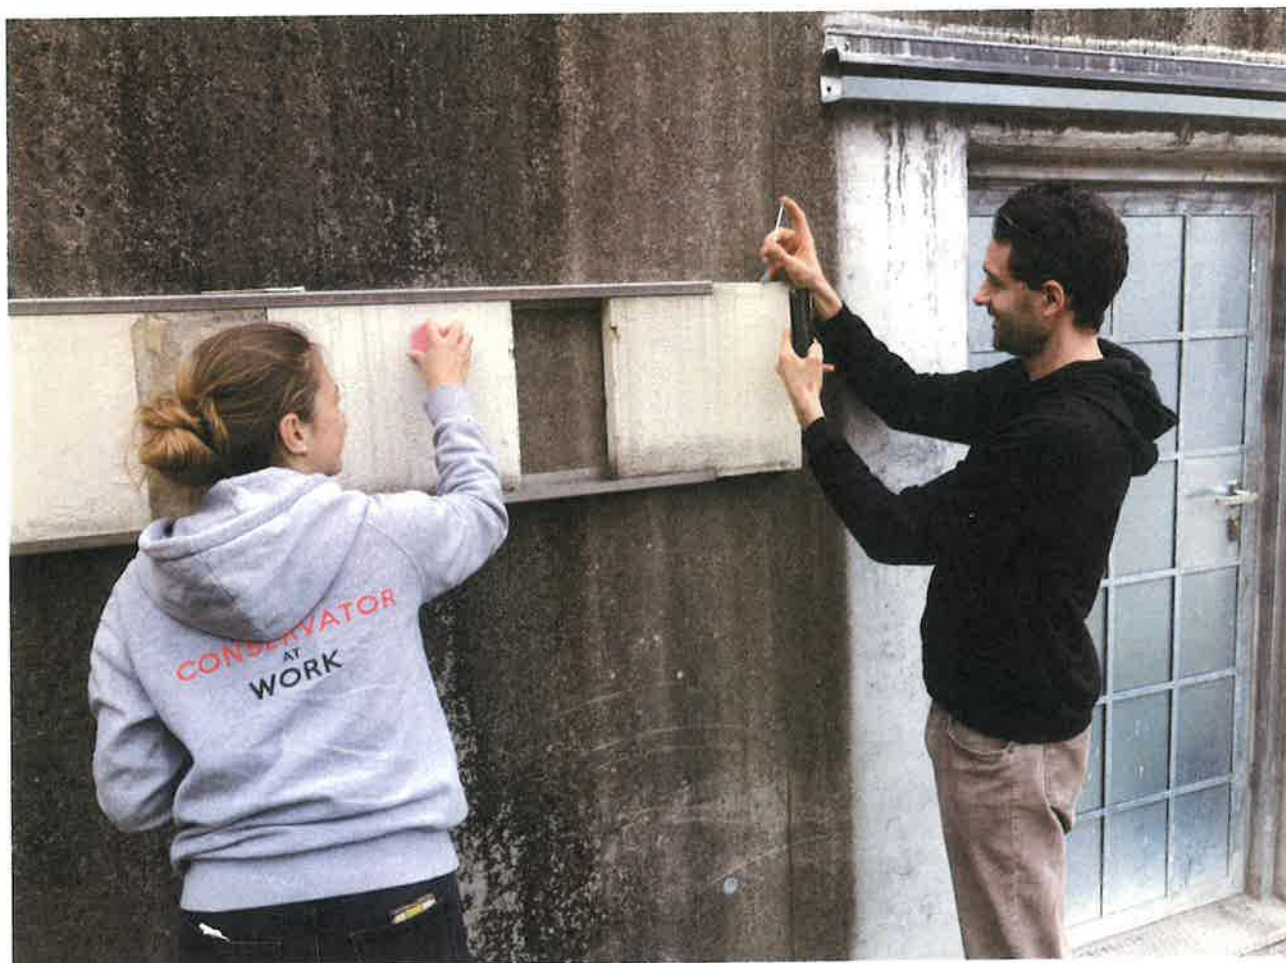
Abb. 5: Evaluierung der Freiluftbewitterungsanlage von Schlammplatten, Mauerbach, NÖ

Fig. 5: Evaluation of the outdoor weathering system of slabs with sacrificial layers, Mauerbach, Lower Austria

troversy' in monument conservation in Austria, in turn resulting in closer examination of sacrificial layers within the framework of a working group set up by the Federal Monuments Office. After seven years of intensive work, guidelines on sacrificial layers were published and an outdoor weathering facility for stone slabs with sacrificial layers was installed in Mauerbach (Lower Austria), and is regularly evaluated (Fig. 5).

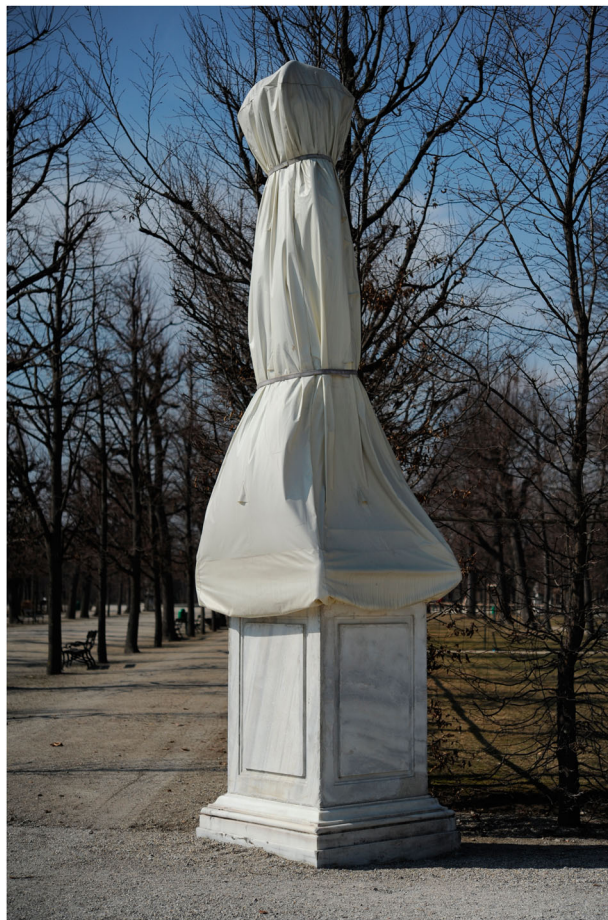
**Figure 1.** Soft wrap with spacers, Schönbrunn gardens.

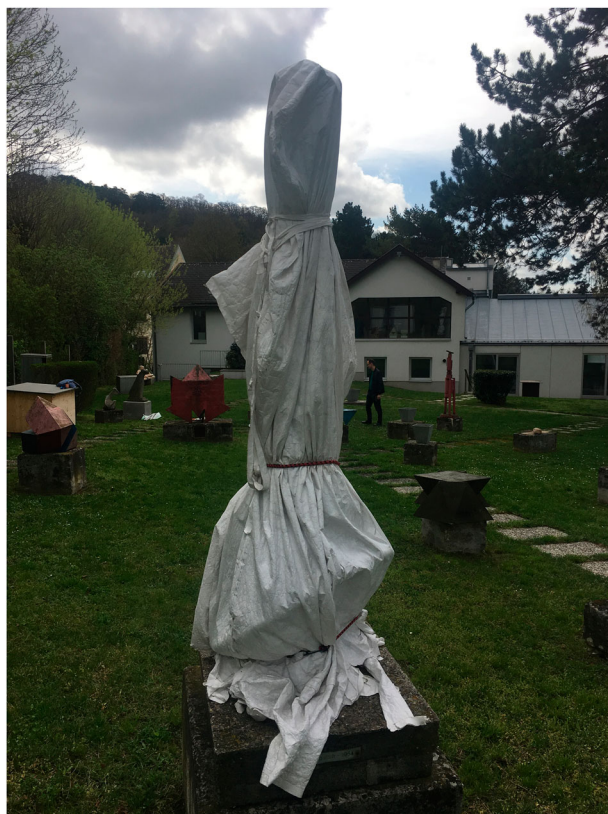
**Figure 2.** Front: damaged Tyvek® soft wrap after one season of exposure; back, on the left, the prototype for a wooden shelter.

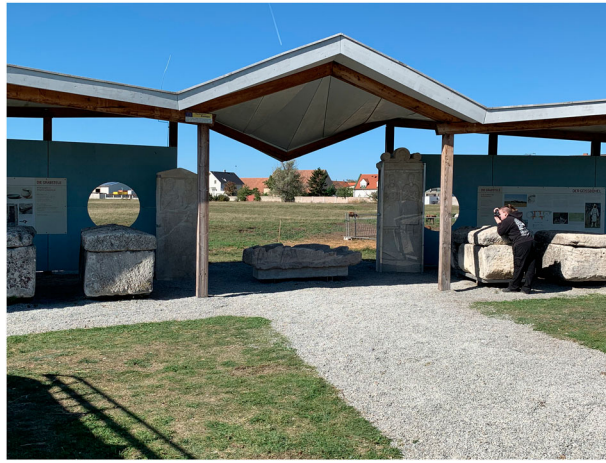
**Figure 3.** The permanent shelter in Leithaprodersdorf protects Roman sarcophagi and gravestones.
