GOLDEN DOORWAY ENSEMBLE

Report of the Institute of Conservation (IoC), University of Applied Arts Vienna

EVALUATION	
Date of Evaluation May 2024	Evaluation done by Meral Hietz, Katharina Mendl

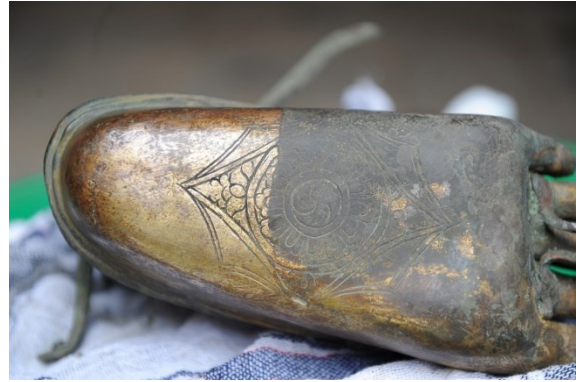
Fig. 19: Cleaned (left) and untreated (right) surface, 2012

- Mechanical removing of corrosion products and strongly adhering dirt (excrements and clay) with scalpel, knives and bone cleanser
 - Removing of further corrosion products/dirt with citric acid (complexing agent) in combination with brushes and poultices, immediate subsequent cleaning with drinking water and brushes
