## HARISHANKARA TEMPLE – BASE AND SCULPTURE

Report of the Institute of Conservation (IoC), University of Applied Arts Vienna

## Data Sheet

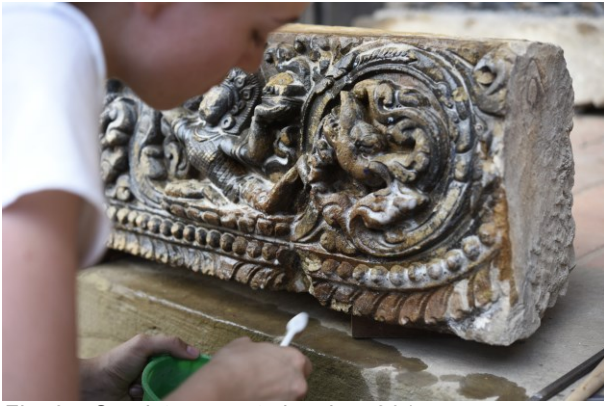
*Fig. 27: Sandstone, wet cleaning, 2017*

- Biocide treatment (QUATS, 2% in water, one application); subsequent cleaning with water
- Backfilling of cracks with acrylic resin (Paraloid B72, first 10% in Acetone for deep penetration, second 30% in Acetone for filling)
- Gluing and pinning of broken blocks with epoxy resin (Akepox 2010) and carbon fibre rods
- Micro-pointing of breakage joints and splitting areas with mortar based on natural hydraulic lime (depending on the stone colour either yellow or dark sand was chosen)

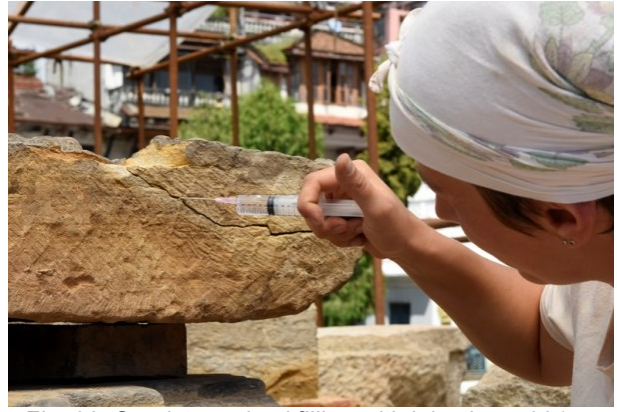
*Fig. 28: Sandstone, backfilling with injections, 2017*

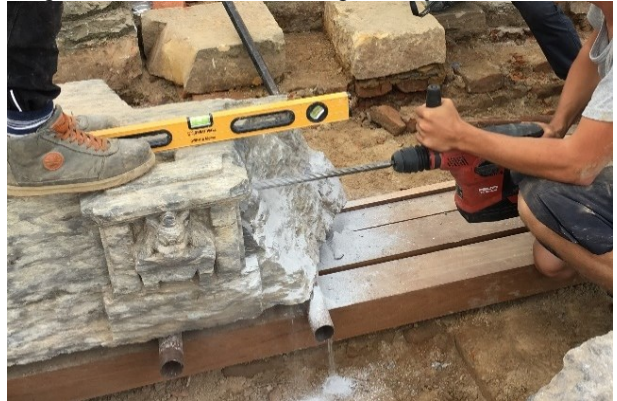
*Fig. 30: Schist, drilling of holes for pinning, 2017*

- One broken base cornerstone glued with epoxy resin (Akepox 2010) and pinned with stainless steel reinforcements
- One heavily damaged base cornerstone equipped with stone indent; core was removed and indent inserted
- Broken threshold block (south) was glued with epoxy resin (Akepox 2010) and pinned with two stainless steel reinforcements (diameter 1.6 cm, length 60 cm)

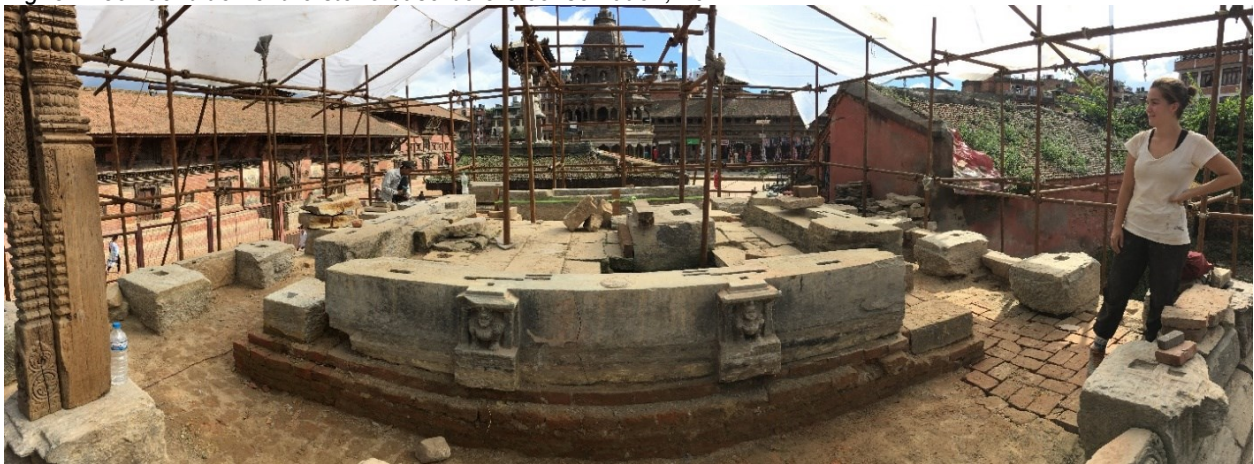
Fig. 36: Condition of the stone base during conservation, 2017
