GOLDEN DOORWAY ENSEMBLE

Report of the Institute of Conservation (IoC), University of Applied Arts Vienna

EVALUATION	
Date of Evaluation May 2024	Evaluation done by Meral Hietz, Katharina Mendl

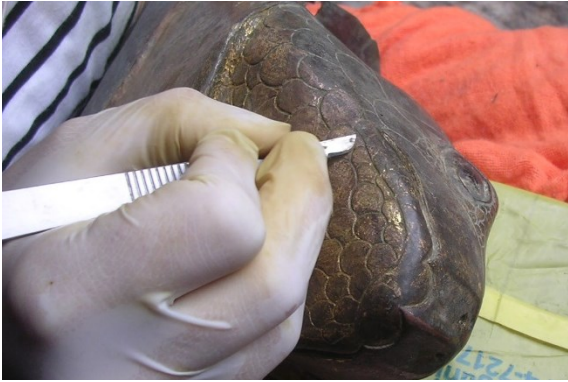
Fig. 18: Mechanical Cleaning, 2012

- Mechanical removing of corrosion products and strongly adhering dirt (excrements and clay) with scalpel, knives and bone cleanser
 - Removing of further corrosion products/dirt with citric acid (complexing agent) in combination with brushes and poultices, immediate subsequent cleaning with drinking water and brushes

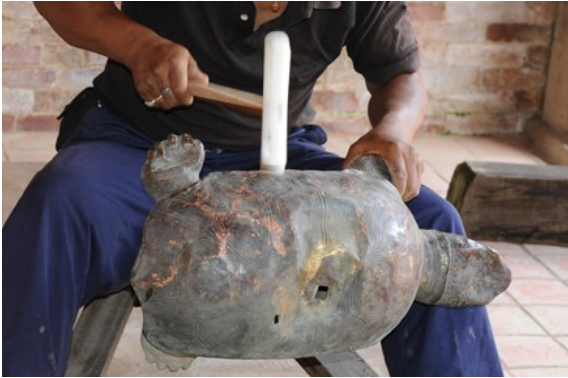
Fig. 20: Reducing the deformations, 2012

- Reshaping of deformations by hammering with rubber or skin-hammer/wooden ones (done by local artisans)
 - Cracks either underlaid with copper strips and fixed with copper rivets (Ganga's left leg, Makara's head) or closed with brass solder (crook of Yamuna's arm, Makara's head)

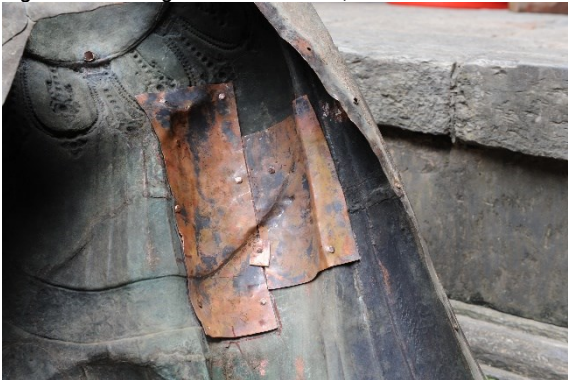
Fig. 22: Supporting inlay copper sheets, 2012

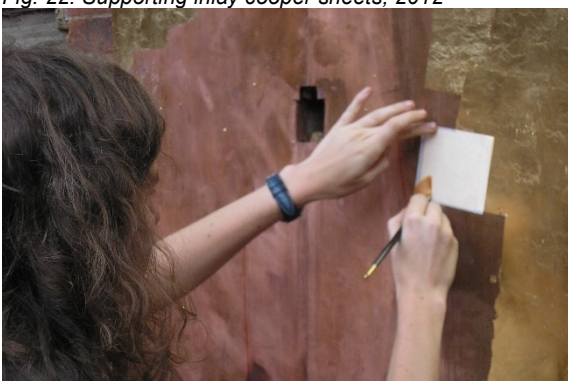
Fig. 24: Regilding with gold leaves, 2012

- Wooden back panels of the sculptures were repaired covered with three new plain copper sheets; regilding with gold leaves (Dukaten-Doppelgold) using Mixtion

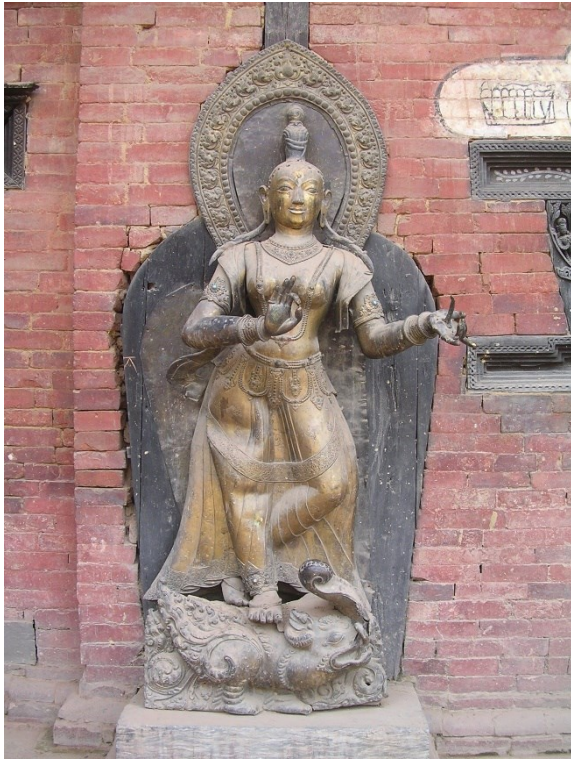
Fig. 26: Ganga before conservation, 2011

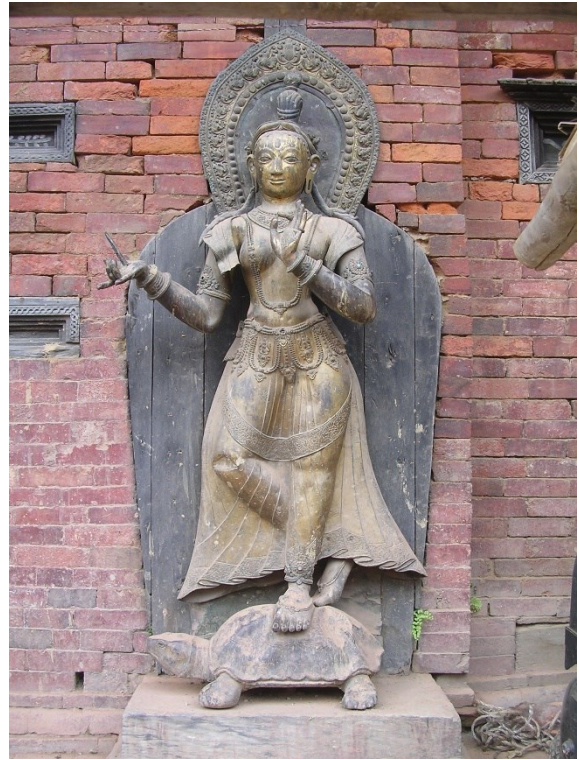
Fig. 27: Yamuna before conservation, 2011

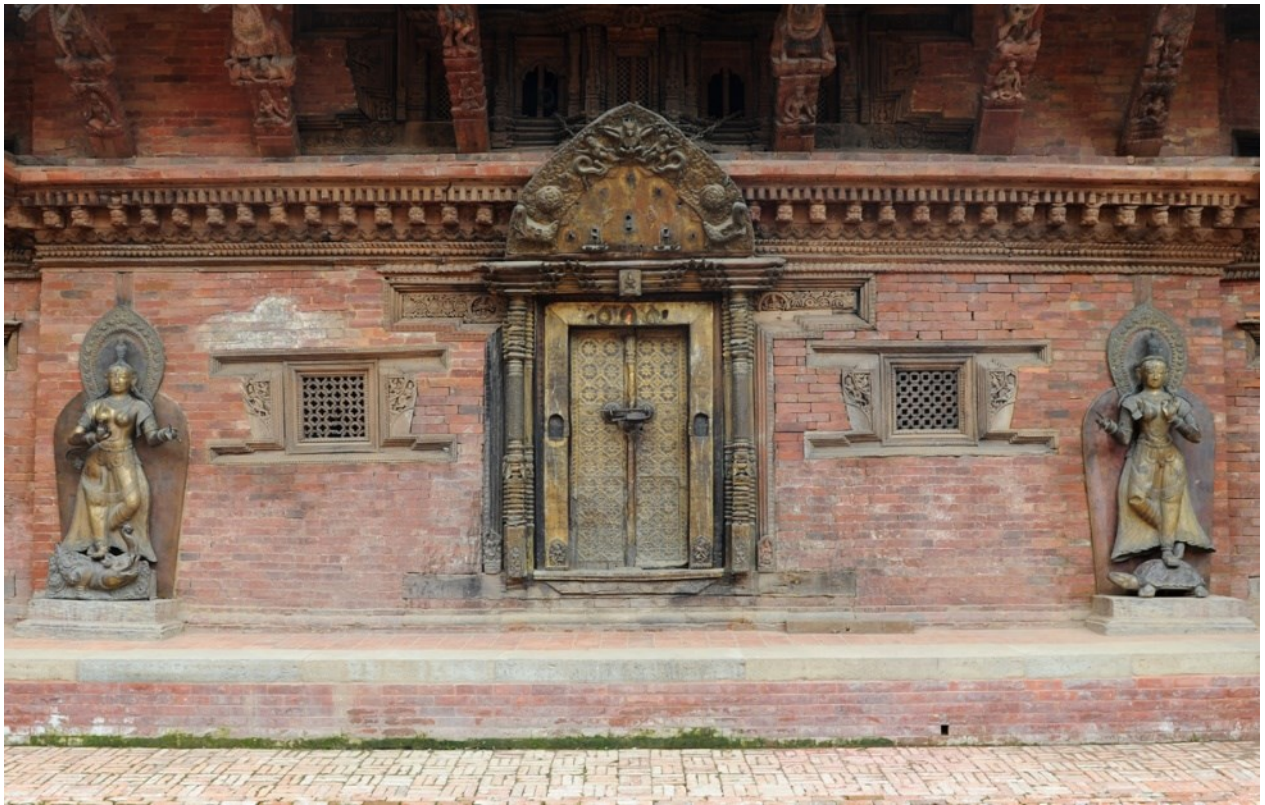
Fig. 34: Golden Doorway Ensemble before conservation, 2012

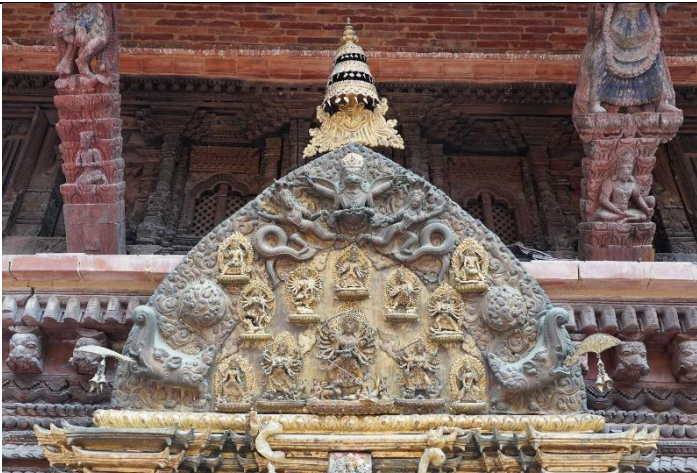
Fig. 11: Torana with umbrella on top, in May 2024

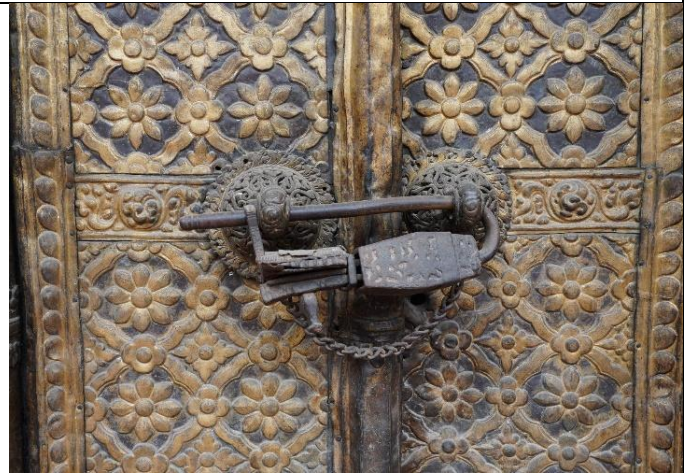
Fig. 12: Iron lock of the Golden Door, in May 2024
