## HARISHANKARA TEMPLE – BASE AND SCULPTURE

Report of the Institute of Conservation (IoC), University of Applied Arts Vienna

## Data Sheet

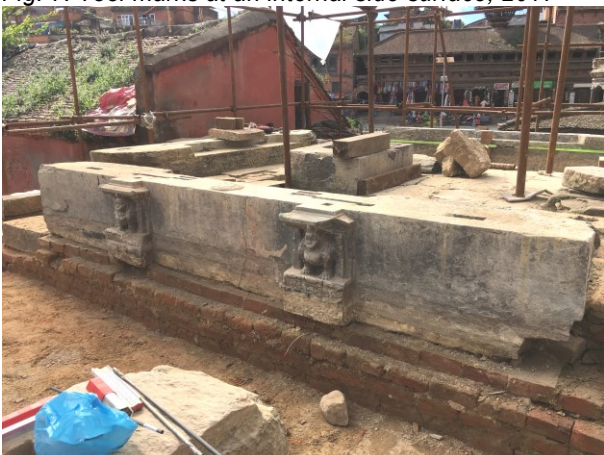
Fig. 9: Threshold of the sanctum with lion busts, during conservation, 2017

- Broken threshold block (north) was reinforced with carbon fibre rods glued into four holes drilled across the crack with hybrid mortar (HFX)
- Micro-pointing of breakage joints and splitting areas with mortar based on natural hydraulic lime

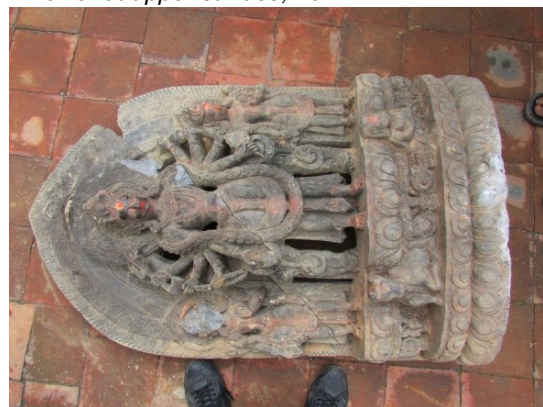
After having survived the major earthquakes of 1809, 1833 and 1934, the temple of Harishankara collapsed completely during the 2015 earthquake. Only the base of the outer ambulatory and the threshold level of the sanctum stayed in place. The sculpture split into two pieces and small parts broke off.

Fig. 12: Sculpture recovered from the debris, © KVPT

- Two broken parts were re-adhered; reinforcement with two stainless steel pins (diameter 0.8 cm, length 10 cm) glued in drilled holed on both sides with hybrid mortar (HFX); dashes of epoxy resin (Akepox 2020) applied to the fractured surfaces
- Gluing of broken of head of Parvati with epoxy resin (Akepox 2010)
- Mechanical removing of deposits (spatulas, scapels)
- Reduction of residues with different solvents (Acetone, white spirit, ethanol and ammonium hydroxide) applied with brushes and cotton buds; oily components were reduced with additional lime putty poultice was applied; subsequent cleaning of all surfaces with water
- Reconstruction of missing attribute (stone indent) adhered to sculpture with epoxy resin (Akepox 2010)
- Pointing of breakage joints and filling of losses with mortar (in this way, the integrity and meaning of the sculpture could be fully restored)

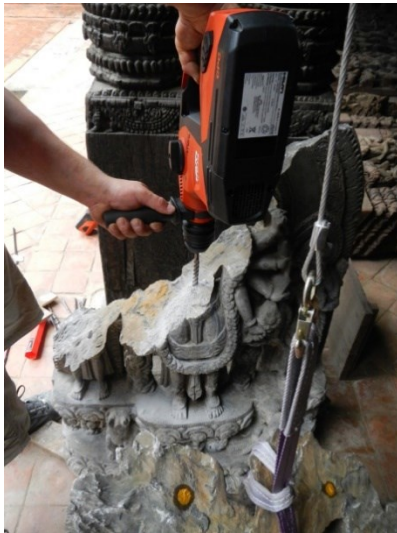
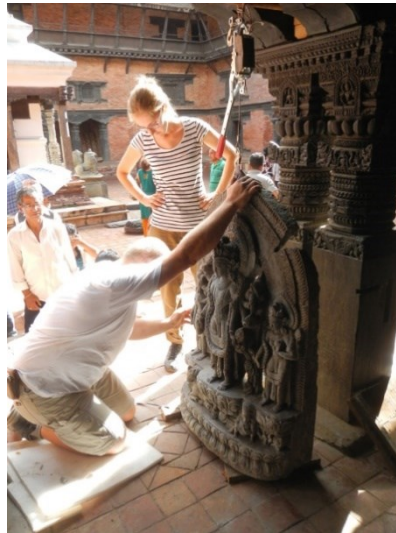
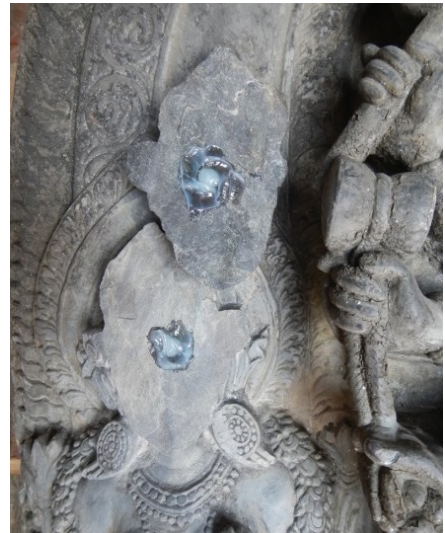
Fig. 22 - 23: Drilling of holes for pins and re-adhering, 2015

Fig. 24: Re-adhering broken head, 2015

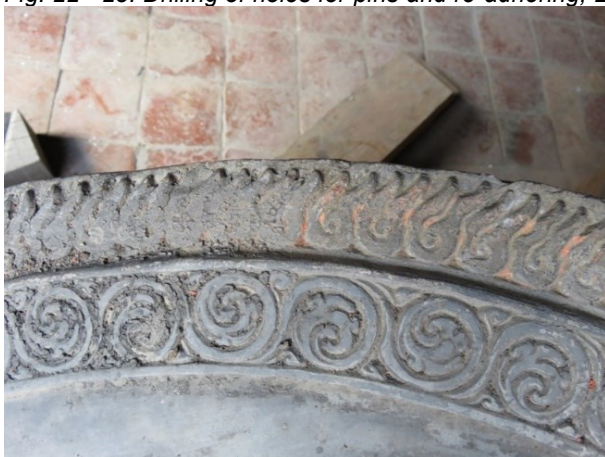
Fig. 25: Reduction of deposits, 2015

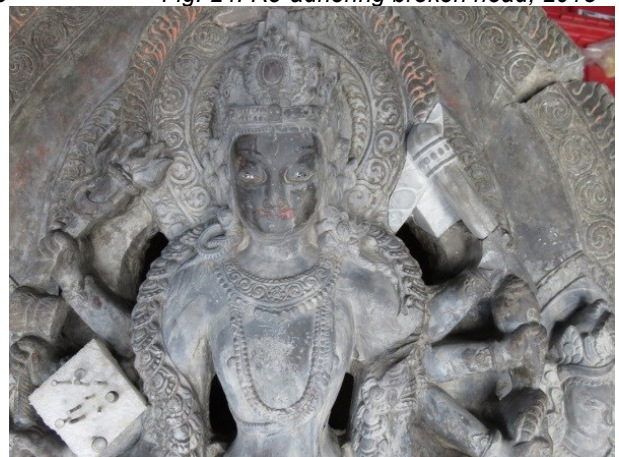
Fig. 26: Reconstruction of attribute, 2015

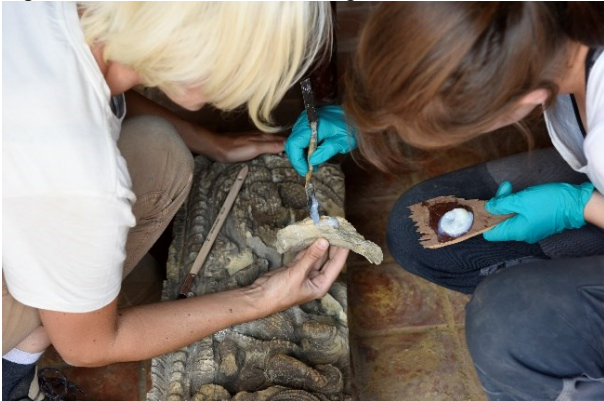
*Fig. 29: Sandstone, gluing of broken parts, 2017*

- Biocide treatment (QUATS, 2% in water, one application); subsequent cleaning with water
- Backfilling of cracks with acrylic resin (Paraloid B72, first 10% in Acetone for deep penetration, second 30% in Acetone for filling)
- Gluing and pinning of broken blocks with epoxy resin (Akepox 2010) and carbon fibre rods
- Micro-pointing of breakage joints and splitting areas with mortar based on natural hydraulic lime (depending on the stone colour either yellow or dark sand was chosen)

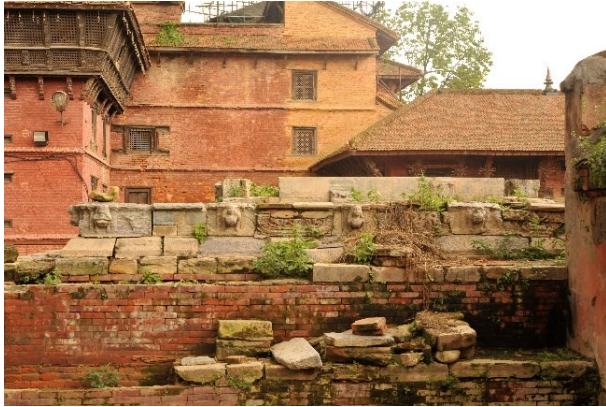
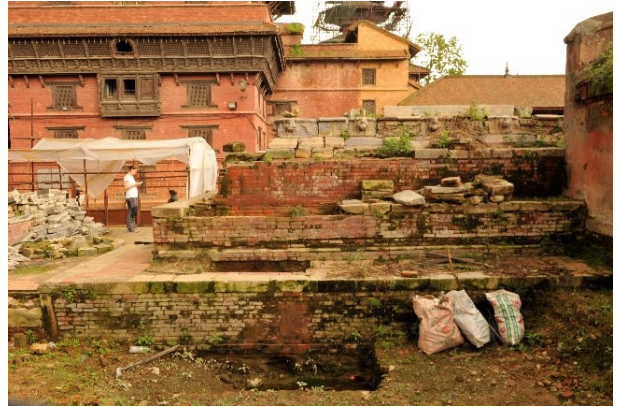
- Some stone blocks show fractures; cracks in the form of fissures on all stone blocks
- Building collapsed towards the South – therefore, stone blocks at this side suffered most (fractures, broken parts, and chipping)

- Losses and missing parts (also on carved surfaces)
- Heavy soiling and deposits on all surfaces
- Blocks made of schist show splitting (vertically oriented lamination) and delamination

Fig. 34 - 35: Condition of the stone base before conservation, 2017

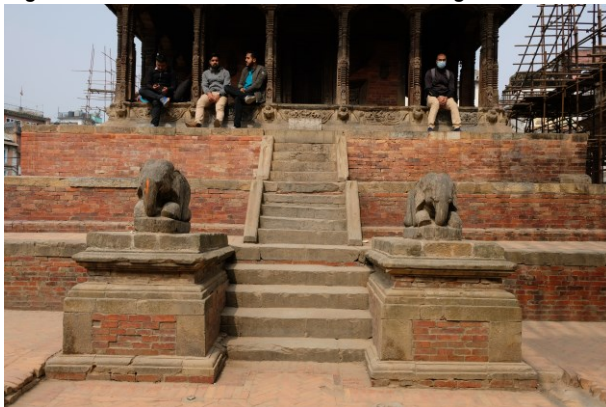
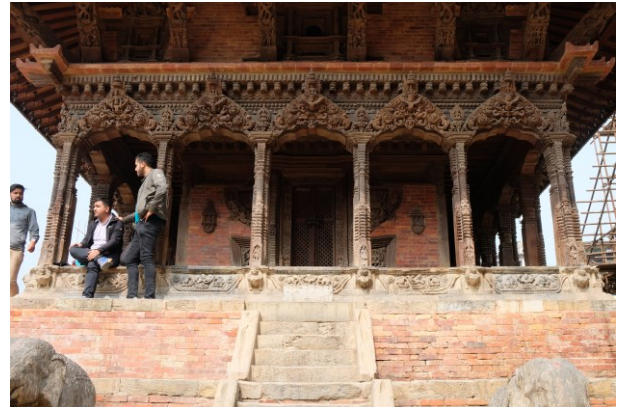
Fig. 37 - 38: Condition of the base after conservation, 2022

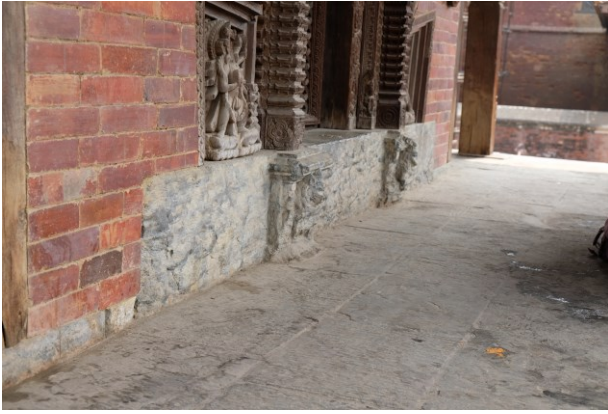
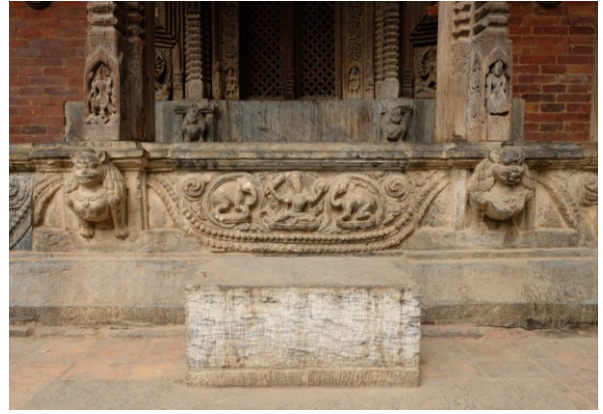
Fig. 39 - Fig. 40: Details of the stone base after conservation, 2022

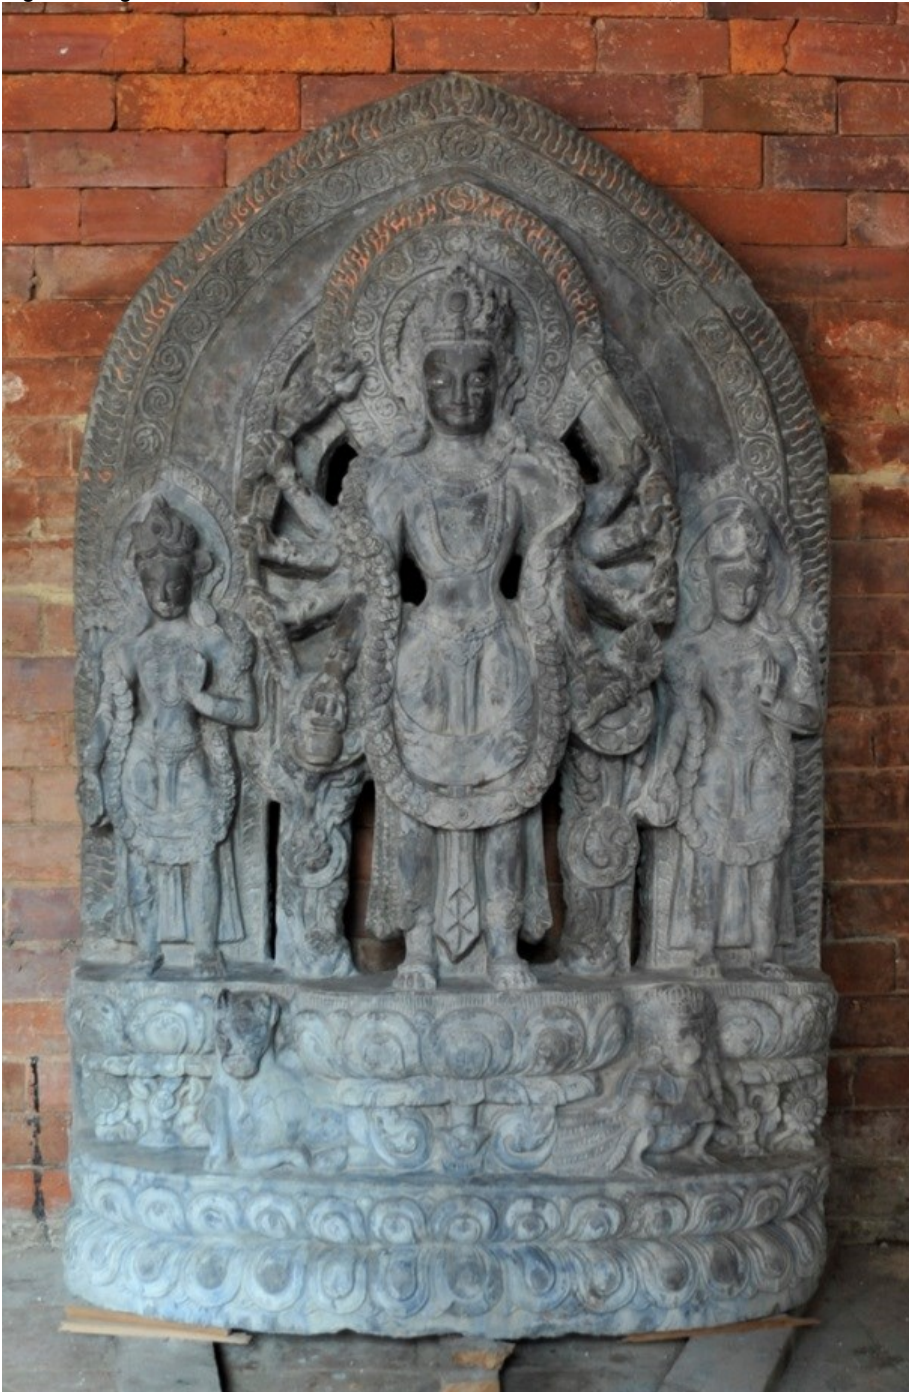
Fig. 41: Sculpture after conservation, 2015
