NARASIMHA TEMPLE

Report of the Institute of Conservation (IoC), University of Applied Arts Vienna

Condition Assessment

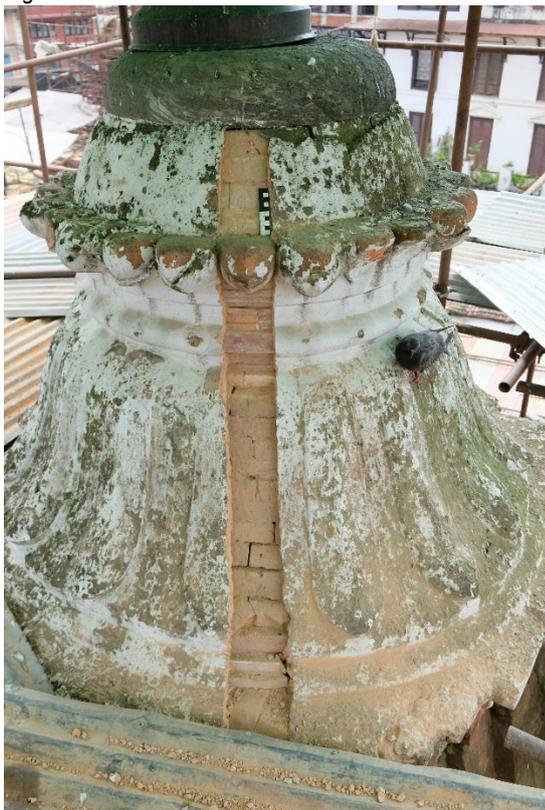
Fig. 7: Uncovering trench at the top pinnacle

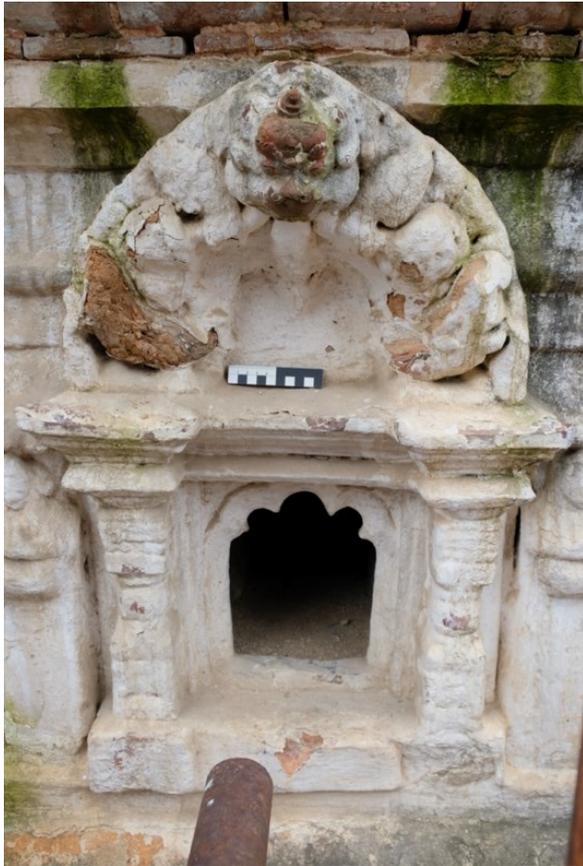
Fig. 14: Lime layers

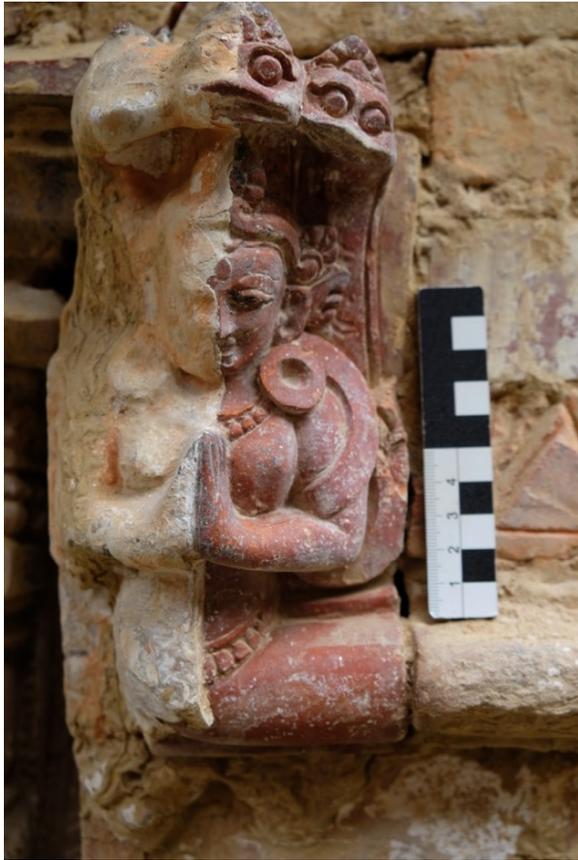
Fig. 17: Partly uncovered terracotta element

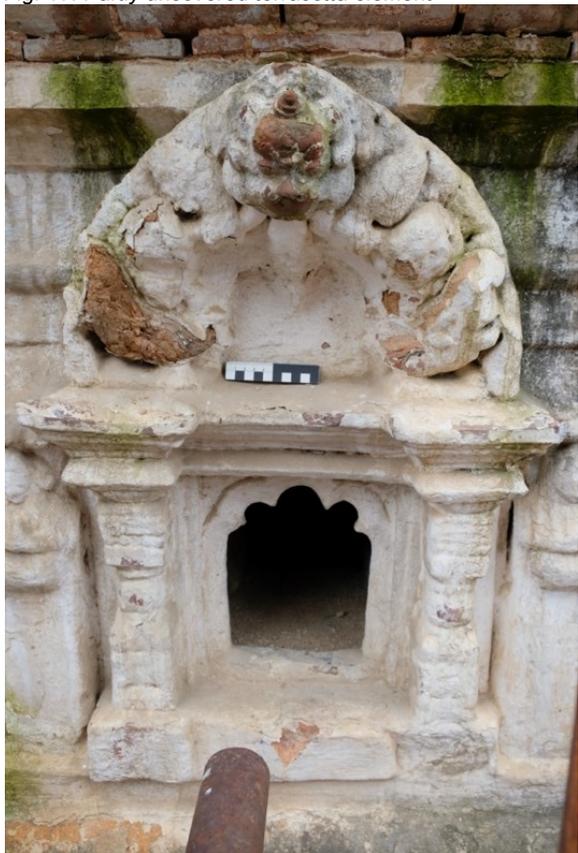
Fig. 19: Torana before uncovering

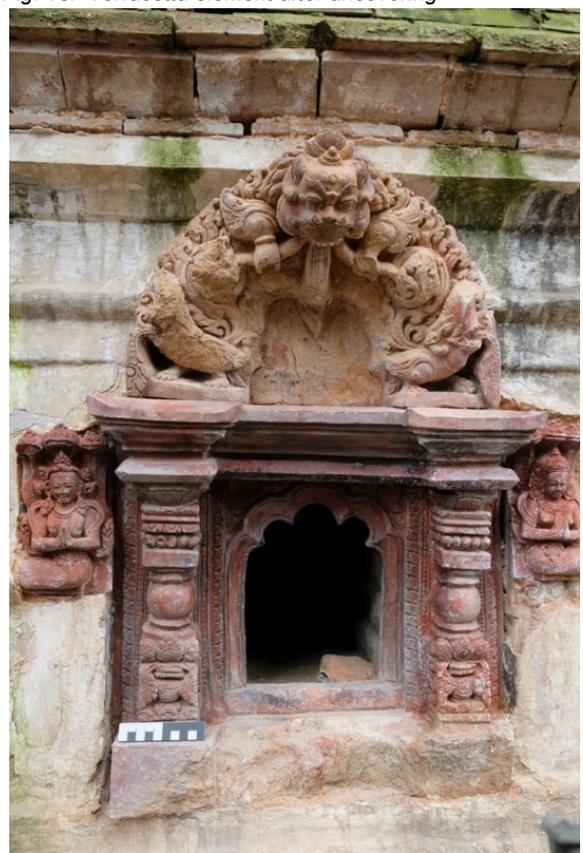
Fig. 20: Torana after uncovering

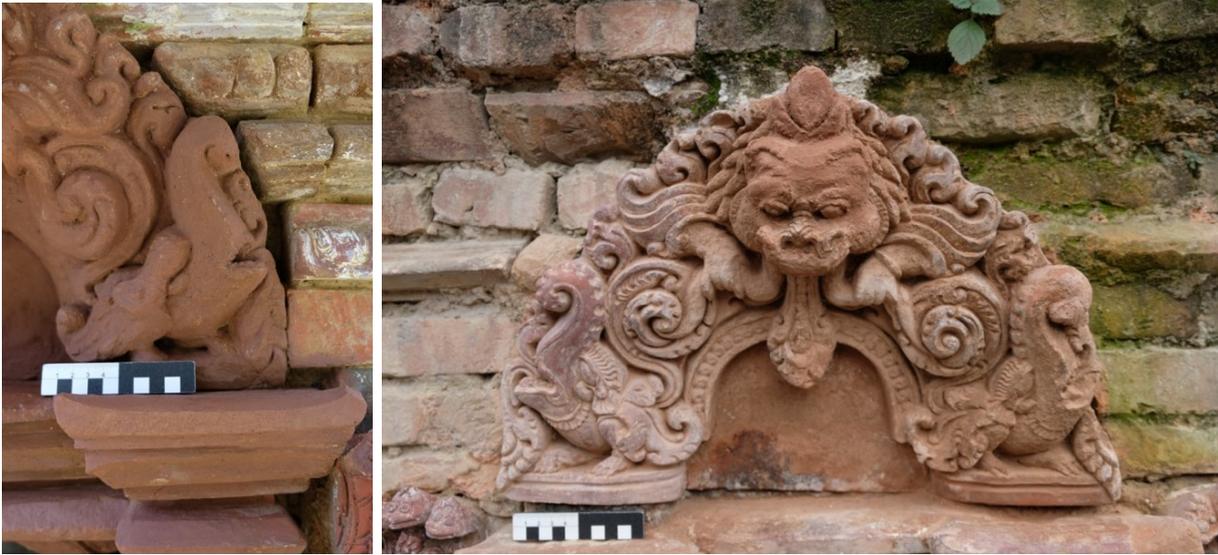
Fig. 21 - 22: Reconstruction with coarse mortar (left) and fine mortar (right)

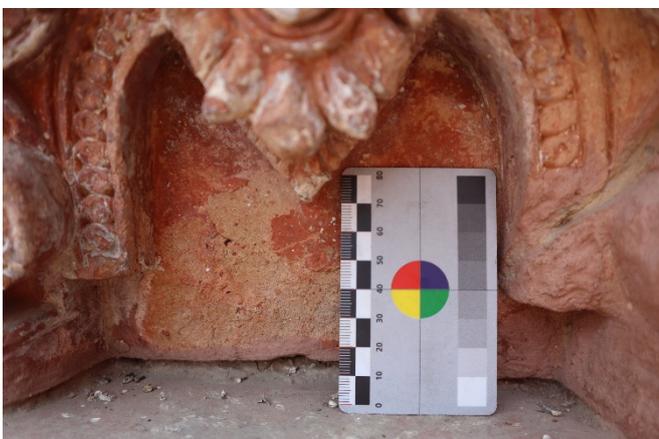
WS Scaling in the middle of the Torana (recent?), Small cracks in the coarse mortar, no powdering or sanding of the protective coating.

Figure 6: Detail, scaling in the middle of the WS Window, Torana.

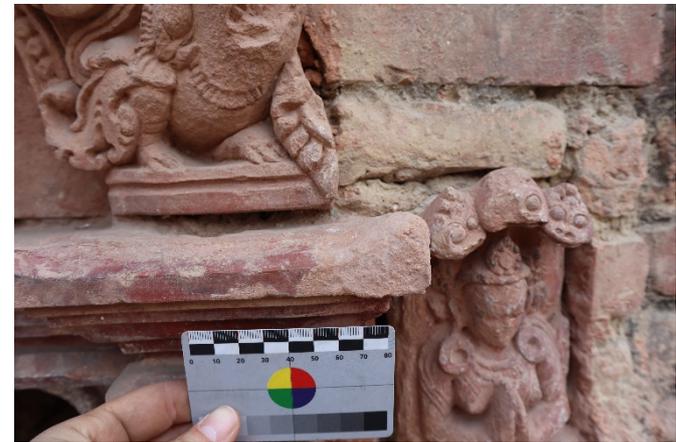
W Cracks (detachment of coarse mortar due to manufacturing errors), no powdering of the protective coating.

Figure 13: W-Window, Corner of Window, Mortar-replacement.

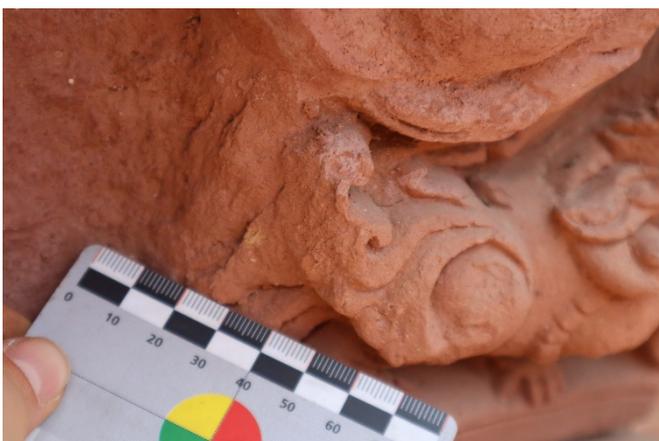
EN Cracks in the coarse mortar, rough/inappropriate application (regarding formal reconstruction), no powdering of the surface coating.

Abbildung 10: EN-Window, Detail Torana, Scaling at the Tail of the left Makara.

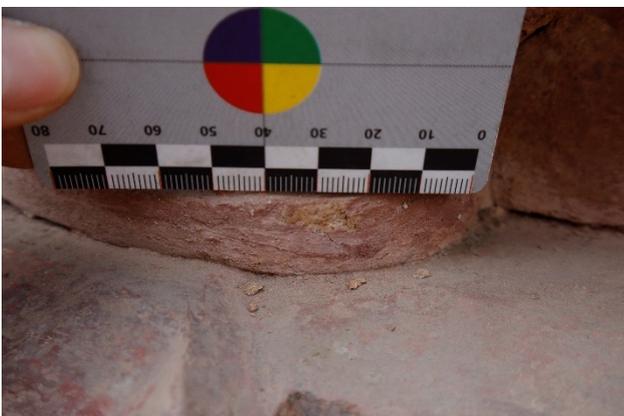
Figure 24: E-Window, Detail Torana, scaling at the bottom of the right Makara.

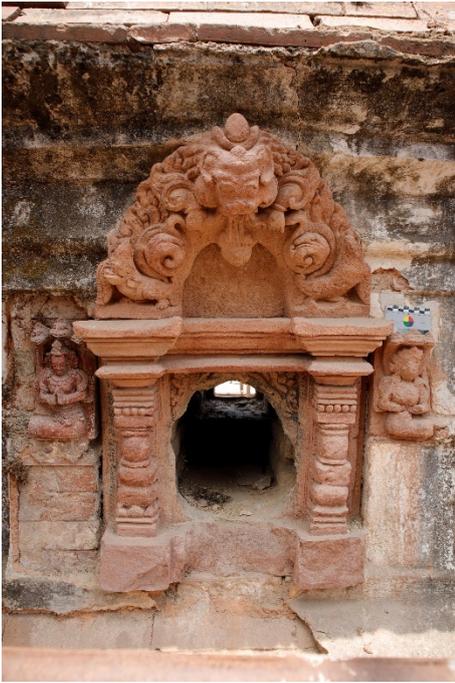
Figure 26: East-Fudja, ES-Window.

ES Crack at the boarder of mortar and terracota, a bit of powdering of the surface coating, cracks in the terracotta (recent?)

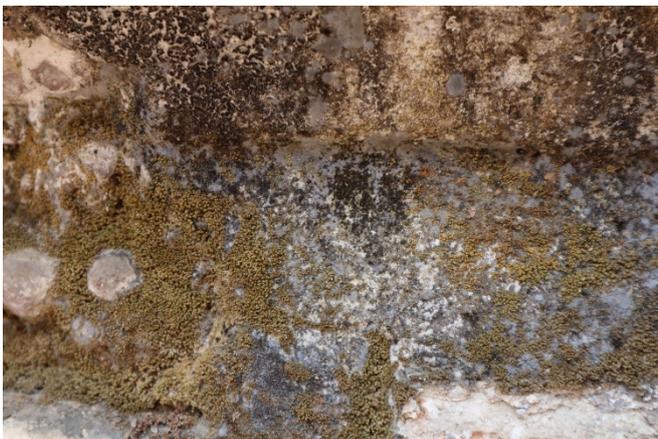
Figure 39: SO-Window, Detail of the biological infestation around the window. Mosses and microbiology.

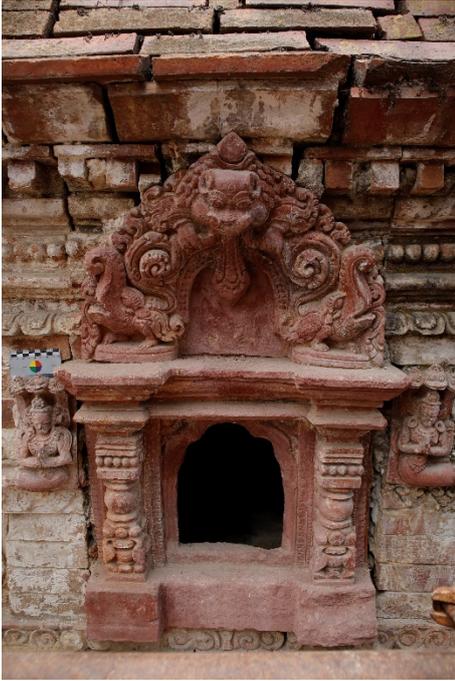
Figure 41:South-Fudja, S-Window.

S Mortar is soft and crumbling (not cured properly, can be easily scratched off), protective coating is powdering, colour a bit too pinkish, cracks at boarder of mortar and terracotta.

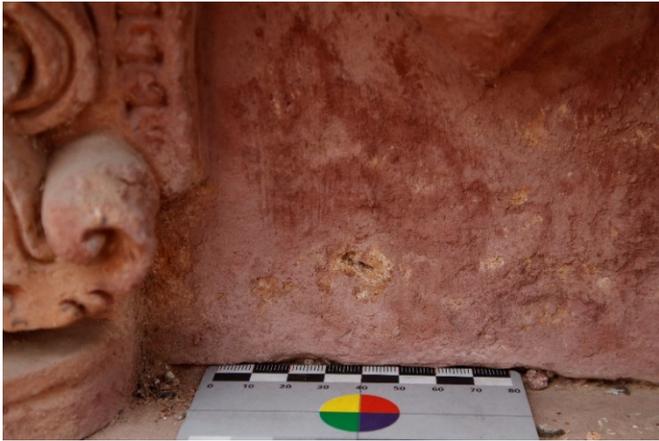
Figure 45: S-Window, Detail Torana, scaling.
