## STONE GATES

Report of the Institute of Conservation (IoC), University of Applied Arts Vienna

GENERAL INFORMATION		
<b>Monument</b> Stone Gates (Gate A)	<b>Orientation</b> -	<b>Size (H x L x W)</b> -
<b>Date of Production</b> 1640-1734	<b>Location</b> Flanking Degutale Temple	
<b>Date of the last Treatment</b> Conservation 2012-2014	<b>Institutions of the last Treatment</b> IoC

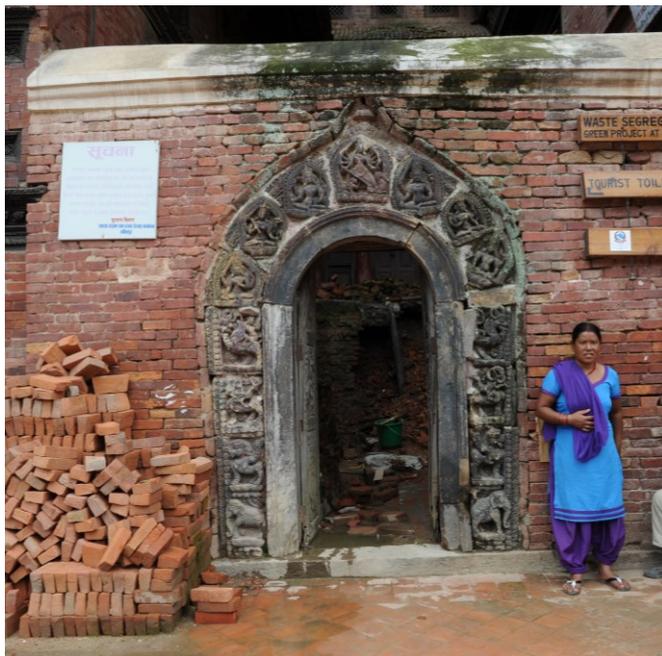
Fig. 1: Gate A before conservation, 2010

Both gates collapsed in the 1934 earthquake and were then reassembled, unfortunately disarranged. Later, they suffered from inadequate restoration efforts and were covered with a bituminous coating, which caused damage to the stone matrix. The courtyards behind were closed to the public and either filled with debris or used as garbage dump and latrine.

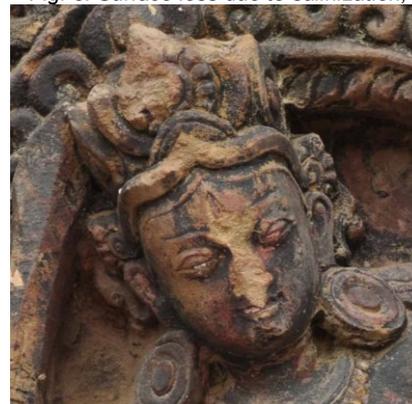
- Missing parts
- Bursted parts at exposed areas
- Salt deterioration appearing as surface loss through sanding, flaking and scaling of the first stone grain layers; salt crystallization beneath the water repellent layer (bituminous coating)
- Cement joints and infills and partial cement layer over surfaces
- Biological colonisation
- Soiling
- Most of damage (e.g., sanding, scaling, flaking, biological colonisation) accelerated by impaired drying behaviour and retention of water mainly caused by too dense joint mortar and bituminous coating

Fig. 10: Losses on exposed parts, 2012

- Re-construction of missing parts (done by the stonemason of the KVPT); one element (pinnacle) was made completely new, at other blocks missing parts were replaced in stone and glued with a local two-component adhesive glue

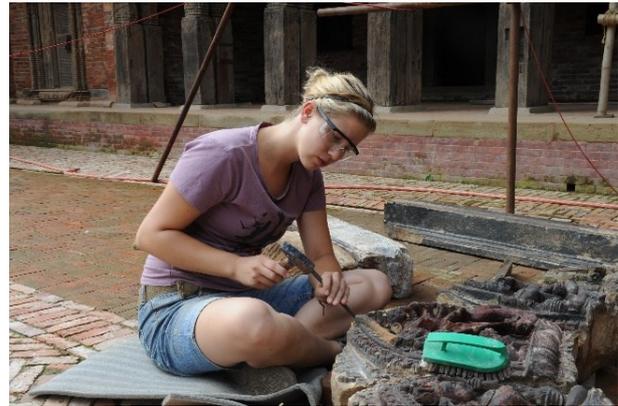
Fig. 16: Removal of cement with hammer and chisel, 2012

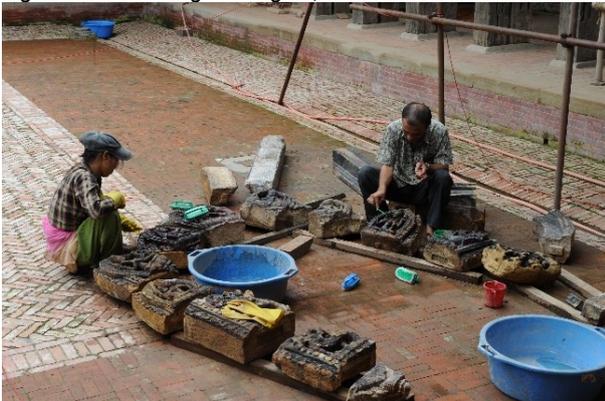
Fig. 17: Wet cleaning with collected rain water, 2012

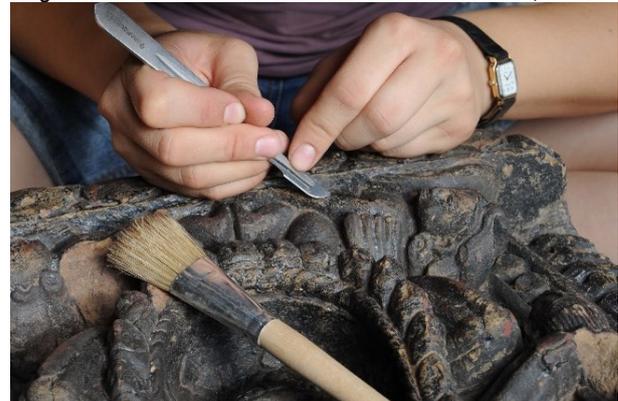
Fig. 18: Removal of thick bitumen layers with scalpel, 2012

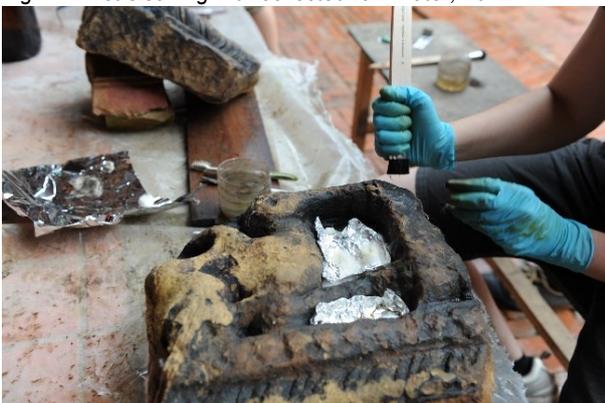
Fig. 19: Removal of bitumen by using acetone /-poultices, 2012

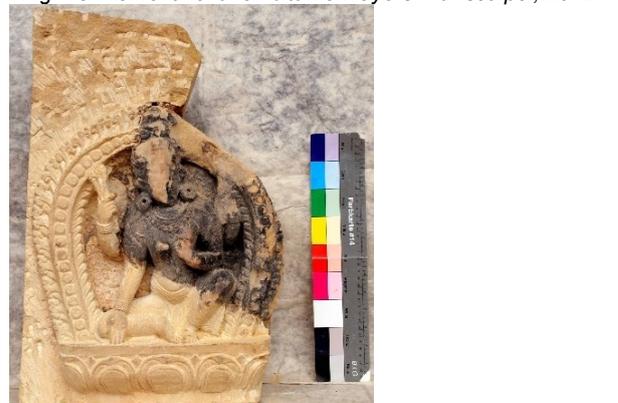
Fig. 20: Missing half replaced in stone (bright area), 2012

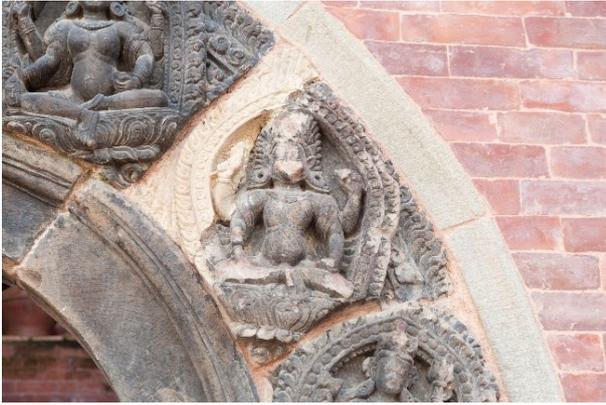
Fig. 21: Missing part replaced in stone (bright area), 2013

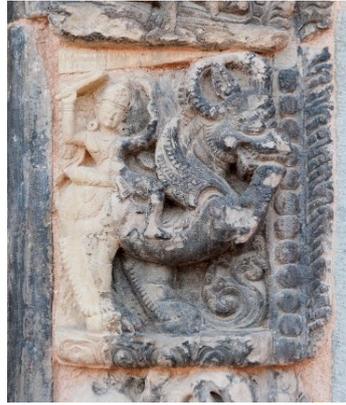
Fig. 22: Missing part replaced in stone (bright area), 2013

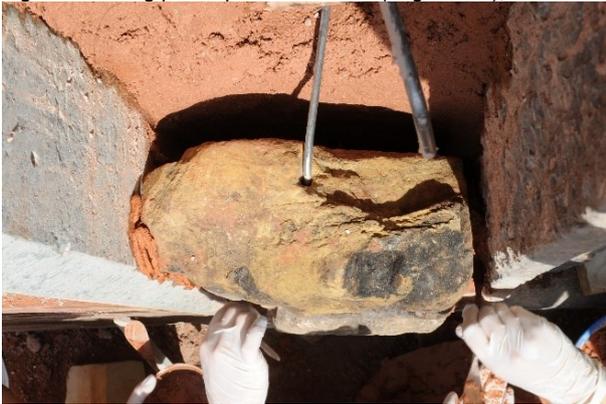
Fig. 23: Air gap and cramps during re-assembling, 2012

- Gluing of loose parts with a local two-component adhesive glue
  - Re-assembling with inox cramps within the masonry structure while leaving an air gap for faster drying of the stone blocks

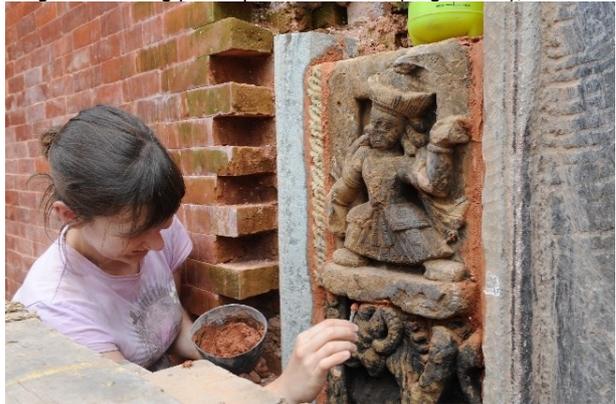
Fig. 24: Pointing joints with lime-brick dust mortar, 2012

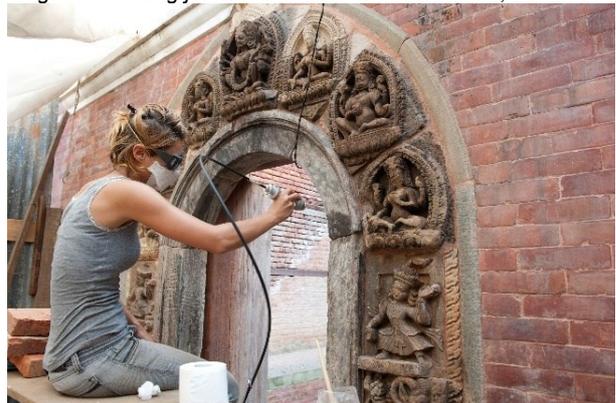
Fig. 26: Laser cleaning, 2013

- 2013
- South Gate:**
- Cleaning with Acetone and brushes
  - Laser cleaning with modified Laser Eos 1000 LQS (in cooperation with Dr. Alessandro Zanini, El.En group) to reduce bituminous coating
  - Biocide treatment of joints with QUATS (solved 3% in water)
  - Re-pointing of joints with cracked or porous mortar
  - Retouching of stone blocks in low area (which could not be cleaned to a satisfactory level) with pigmented silicate paint
  - Retouching of joints with pigmented silicate paint
  - Retouching of newly made stone blocks (2012) with pigments dispersed in ethanol and fixed with Ethylsilicate (Funcosil)

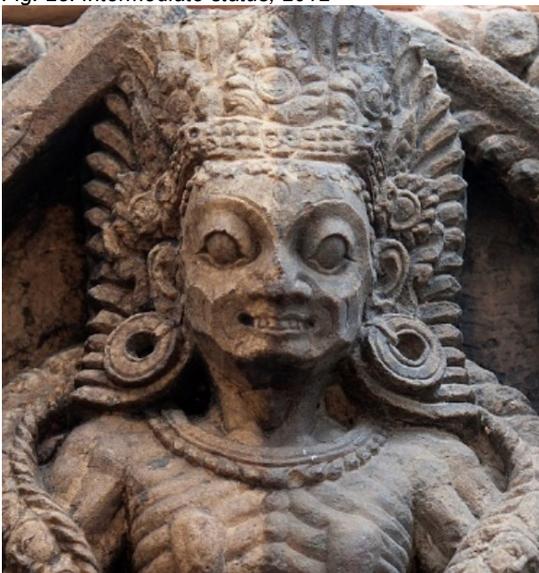
Fig. 27: Detail laser cleaning before (r.) and after (l.), 2013

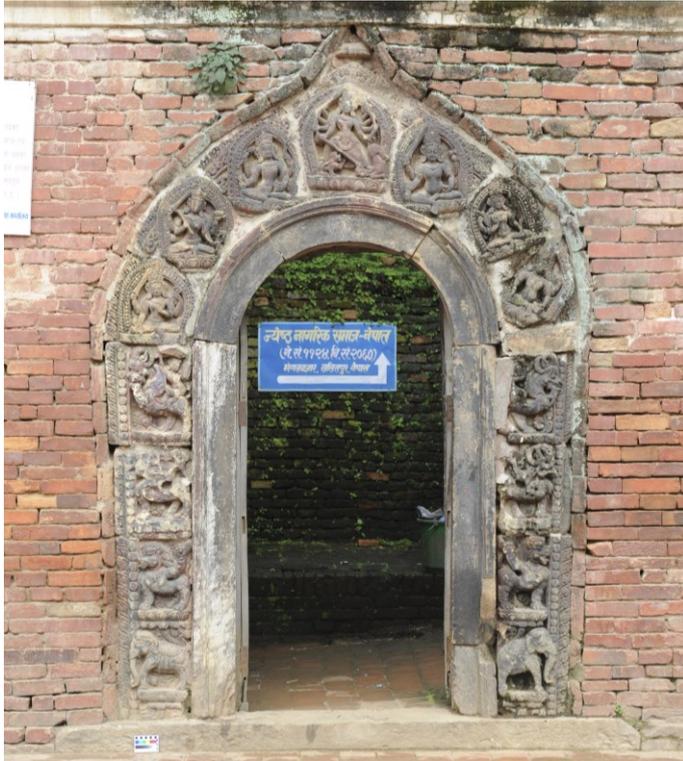
Fig. 28: Gate A before conservation, 2010

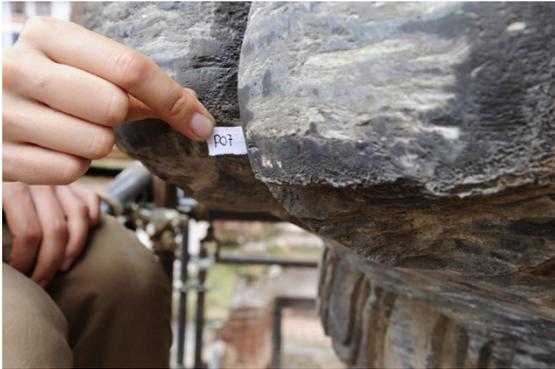
Fig. 9: Sample P07 taken in 2016, Lotus ring, Pillar of Yoganarendra Malla, Kaipf 2017.

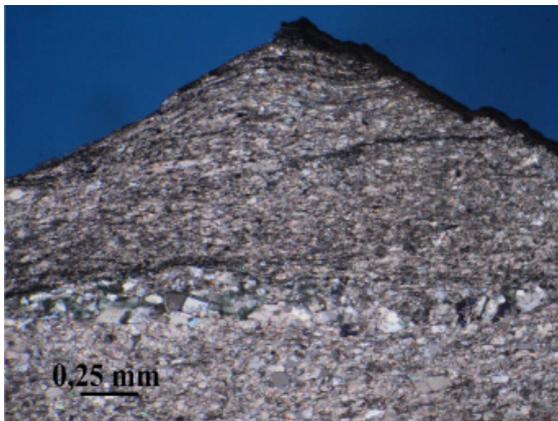
Fig. 10: Sample P07, thin section, x72. Fabric with relatively homogenous matrix and slightly developed banding.

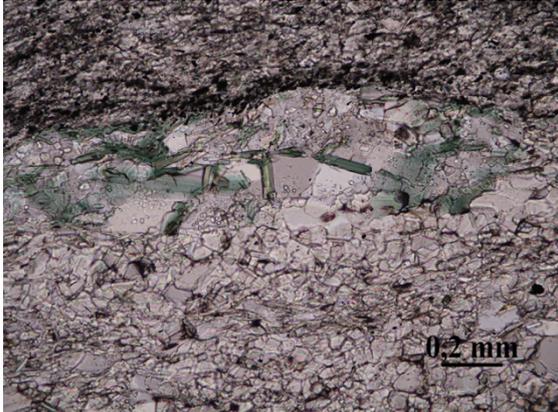
Fig. 14: Sample P07, thin section, x100; Phlogopite.

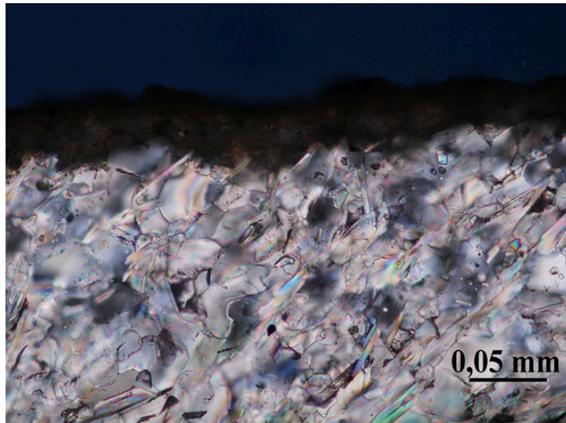
Fig. 16: Sample P07, thin section, x500. Equigranular grain aggregate with mainly polygonal grain forms.

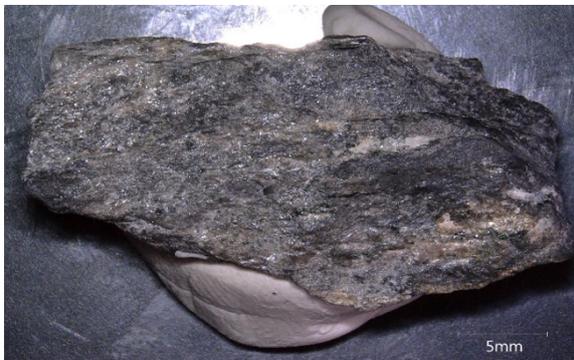
Fig. 17: Sample NEP\_ST\_1.

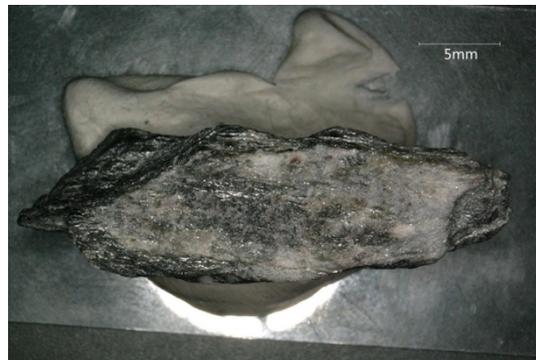
Fig. 18: Sample NEP\_ST\_1.

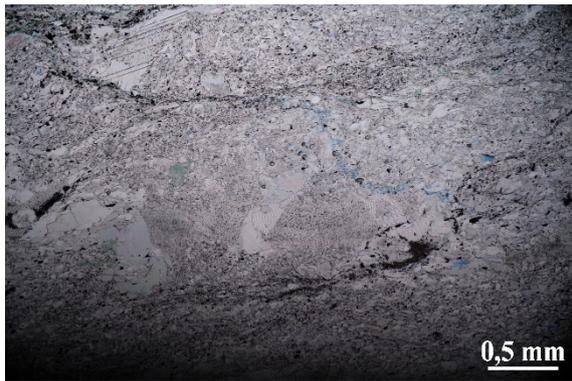
Fig. 19: Sample NEP\_ST\_1, Nikon SMZ 500, transmitted light, crossed polarizers. Overview of the rock matrix with coarser and finer layers.

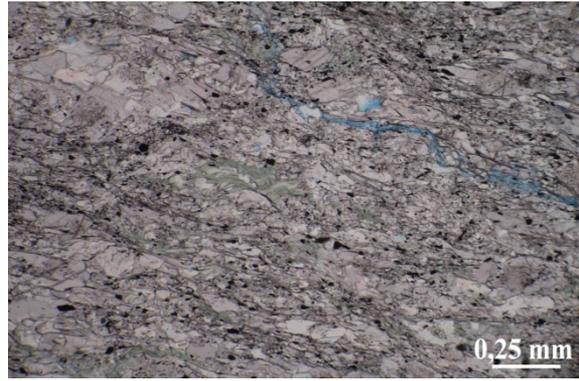
Fig. 20: Sample NEP\_ST\_1, Nikon SMZ 500, transmitted light, parallel polarizers. Detailed view of the matrix.

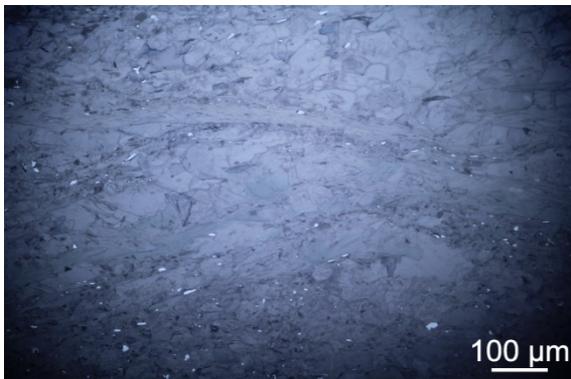
Fig. 21: Sample NEP\_ST\_1, Olympus BX40, incident light, bright field. Overview of mica inclusions (whitish spots).
