## VISHVESHVARA TEMPLE BASE AND ELEPHANTS

Report of the Institute of Conservation (IoC), University of Applied Arts Vienna

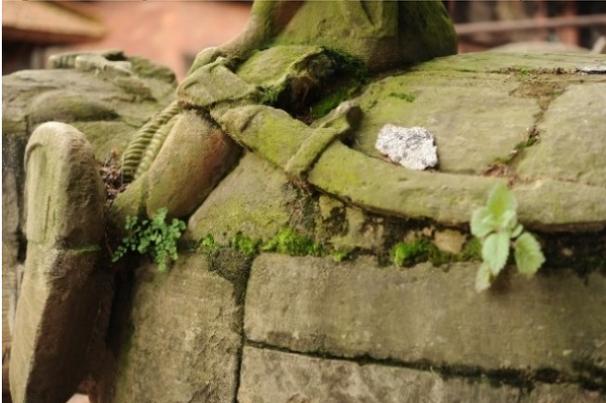
*Fig. 14: Elephant: Biological colonization, 2018*

Present on joints, fillings and upper areas where water is allowed to accumulate, as well as on the heads of the elephants (Fig. 14 and 15)

Fig. 28: Elephant: removal of microbiological growth

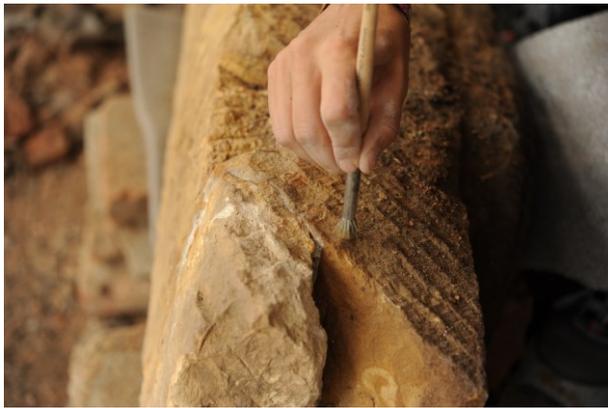
Fig. 18: Dry cleaning of stone block, 2018

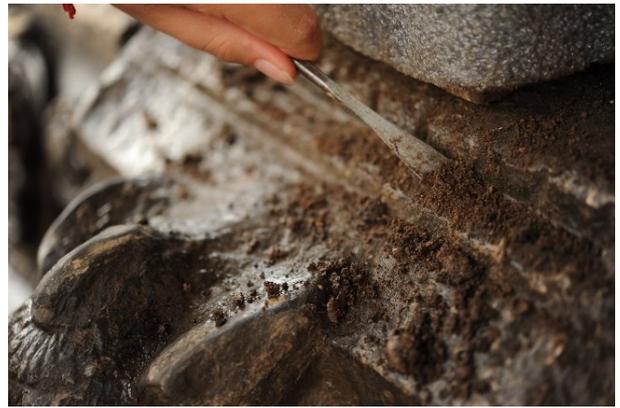
Fig. 19: Removing earth within the joints, 2018

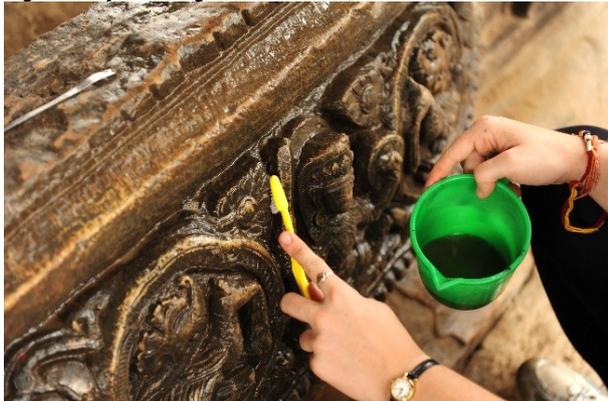
Fig. 20: Wet cleaning with water of carved stones, 2018

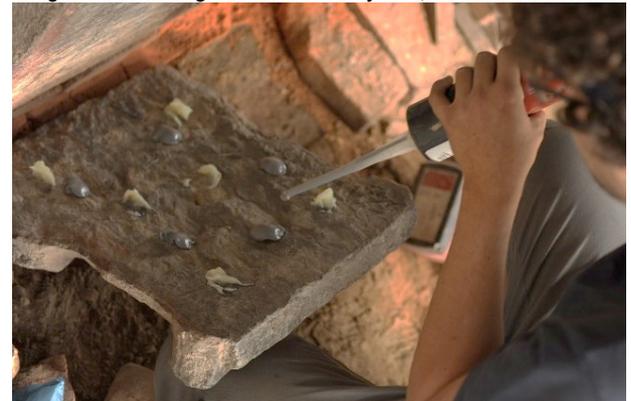
Fig. 21: Gluing of displaced elements, 2018

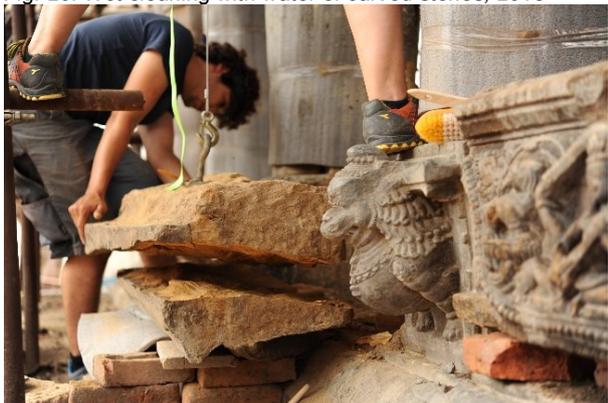
Fig. 22: Applying the setting mortar for a replaced stone, 2018

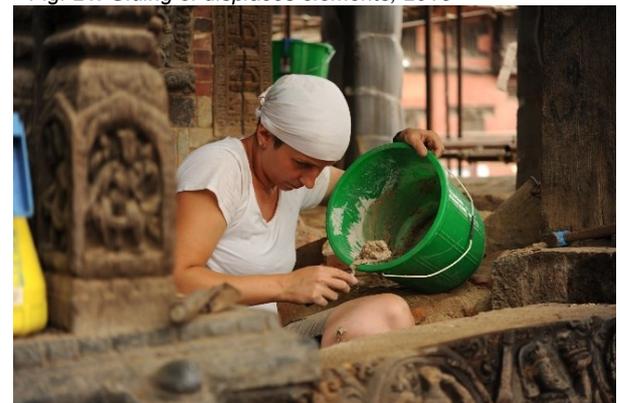
Fig. 23: Gluing and replacing stone blocks, 2018

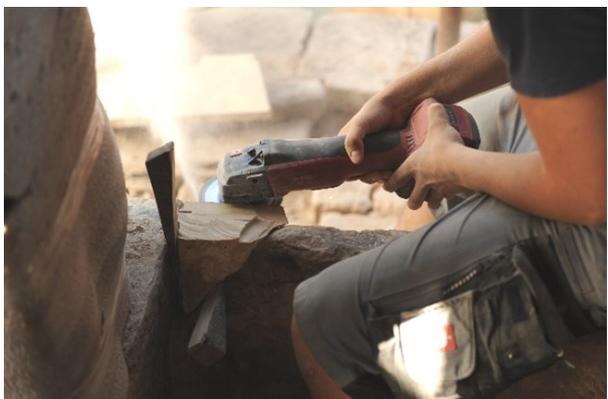
Fig. 24: Preparing the fitting stone completion, 2018

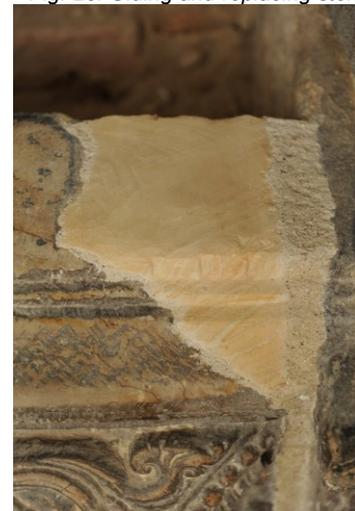
Fig. 25: Detail of a fitted completion without retouching, 2018

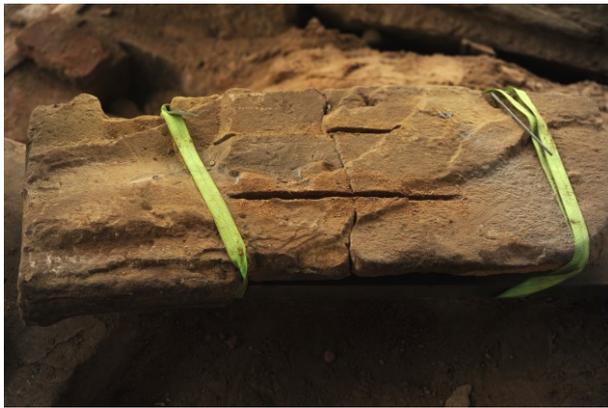
Fig. 26: Gluing of broken stone block, 2018

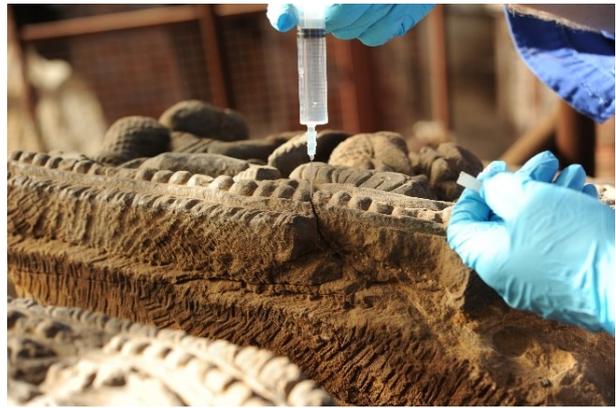
Fig. 27: Backfilling of small cracks, 2018

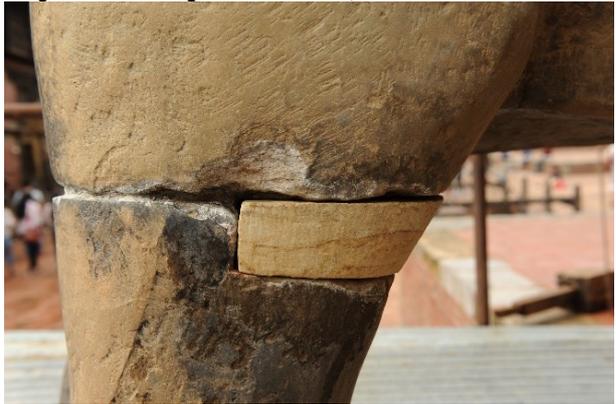
Fig. 29: Elephant: stone indent

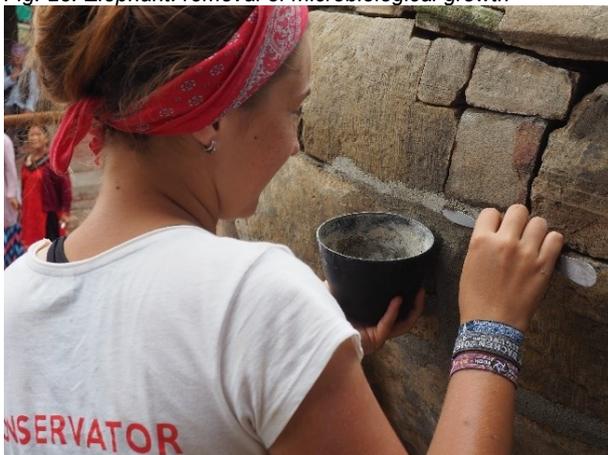
Fig. 30: Elephant: repointing

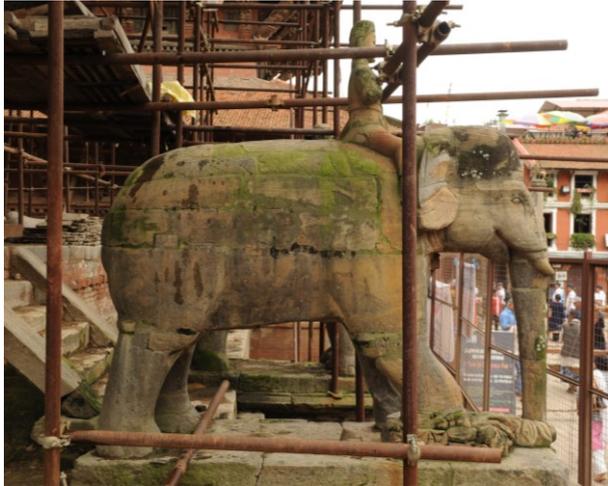
Fig. 32: Right elephant before conservation, 2018

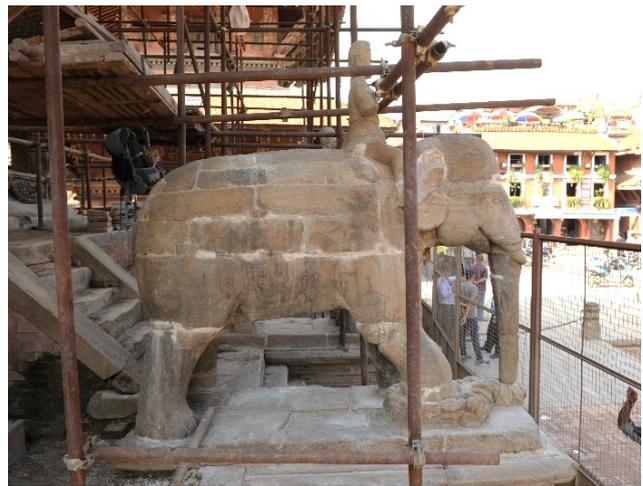
Fig. 33: Right elephant after conservation, 2018

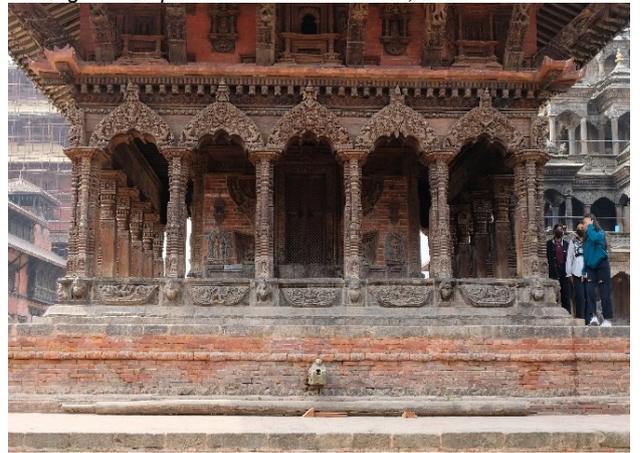
Fig. 37: Stone base after conservation, 2022

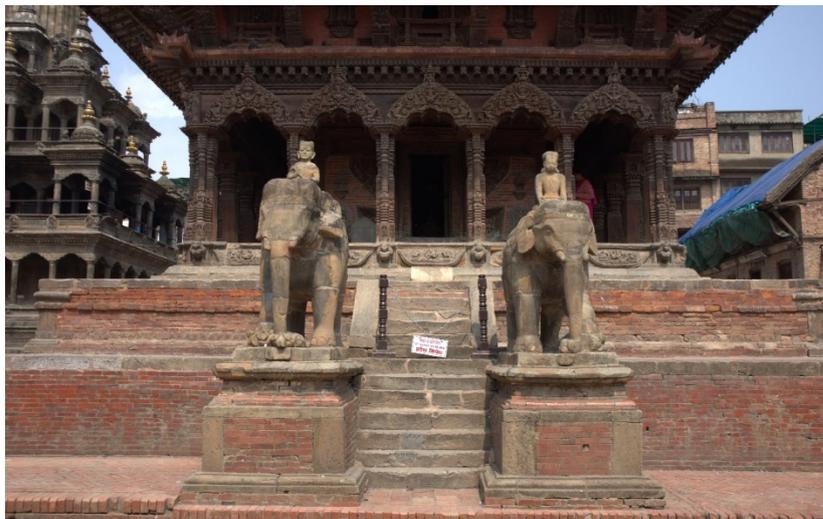
Figure 1: Both elephants from the front.

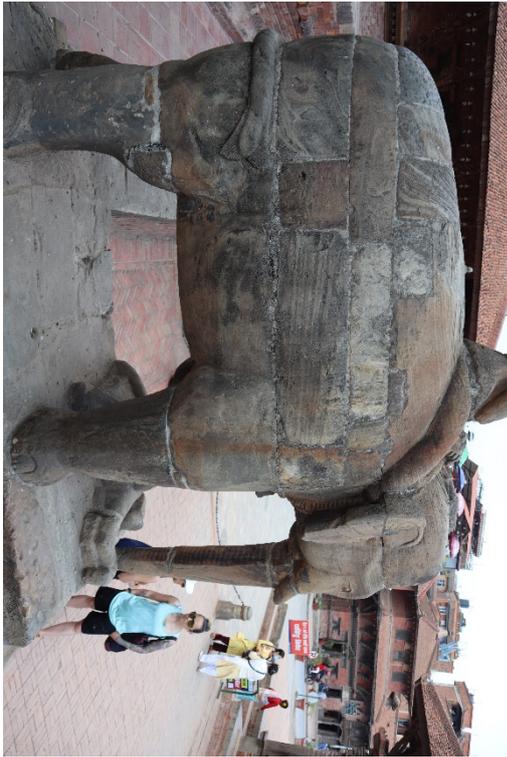
Figure 3: Right elephant (North), inside.

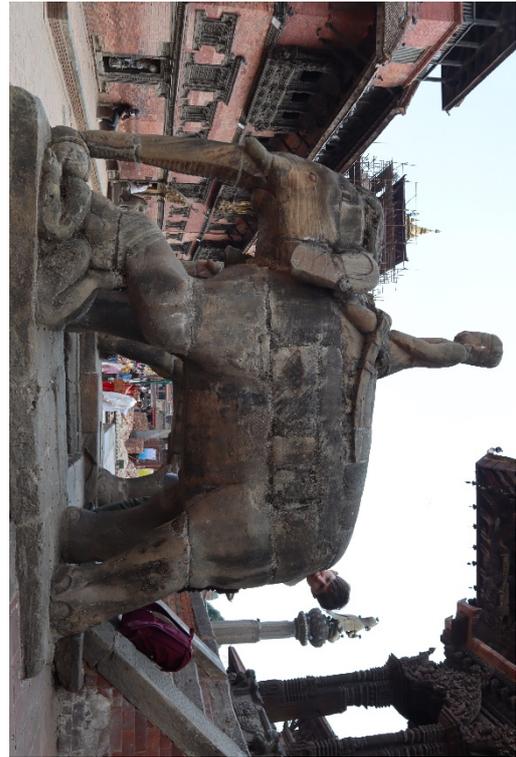
Figure 2: Right elephant (North), Outside.

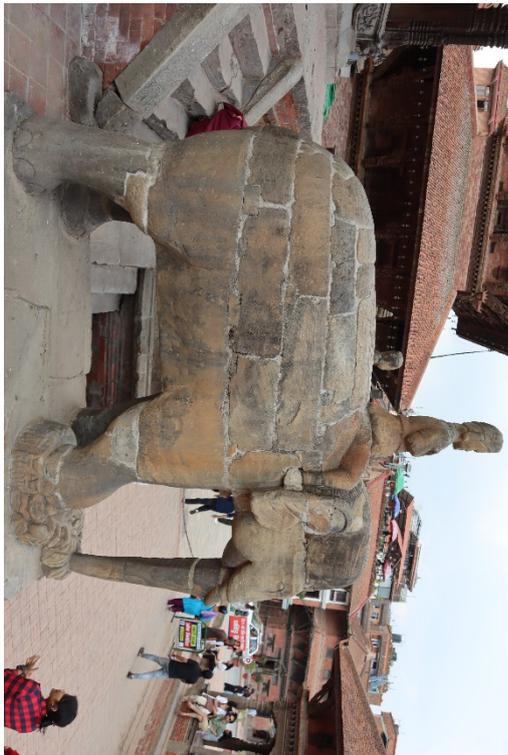
Figure 4: Left elephant (South), outside.

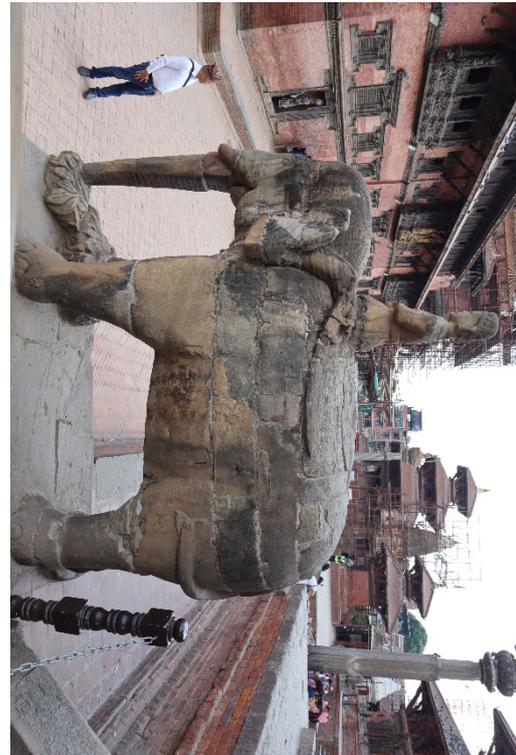
Figure 5: Left elephant (South), inside.

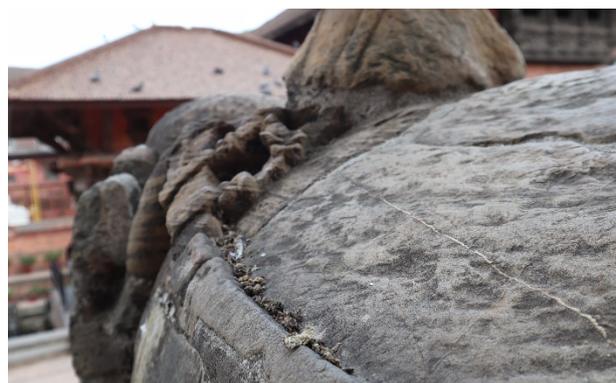
<input checked="" type="checkbox"/> Soiling	<input type="checkbox"/> Heavy	Mostly on the top of the elephants and at the feet in depths of carvings (Fig.17)
<input type="checkbox"/> Not detected	<input checked="" type="checkbox"/> Medium	
	<input type="checkbox"/> Light	
Comment:		
<input type="checkbox"/> Other	Comment:

Figure 17: Soiling.
