## PILLAR OF YOGANARENDRA MALLA

Report of the Institute of Conservation (IoC), University of Applied Arts Vienna

**GENERAL INFORMATION**

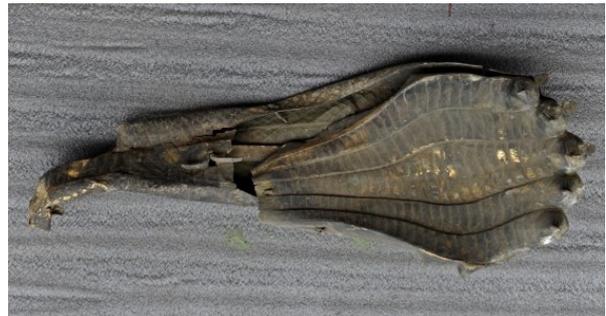
- Heavy deformations on all metal elements due to falling of the pillar during the earthquake 2015;
- Assembly connections partly loose or lost
- Voids and cracks due to falling during the earthquake
- Iron rods of the substructure connecting the sculpture with the stone pillar are highly corroded and deformed due to the earthquake
- Missing of original supporting construction
- Soiling (thick layers of dirt, dust and deposits)
- Partial corrosion
- Large areas without original fire-gilding (weathered) but only soiled copper

Fig. 21: Deformed nagas and soiled surface, 2016

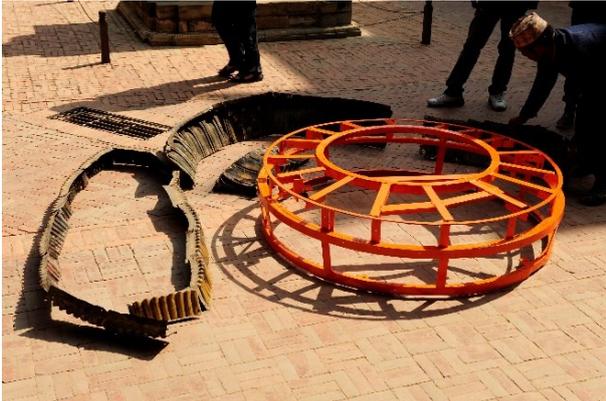
Fig. 42: Deformed ornate frame, new substructure, 2017

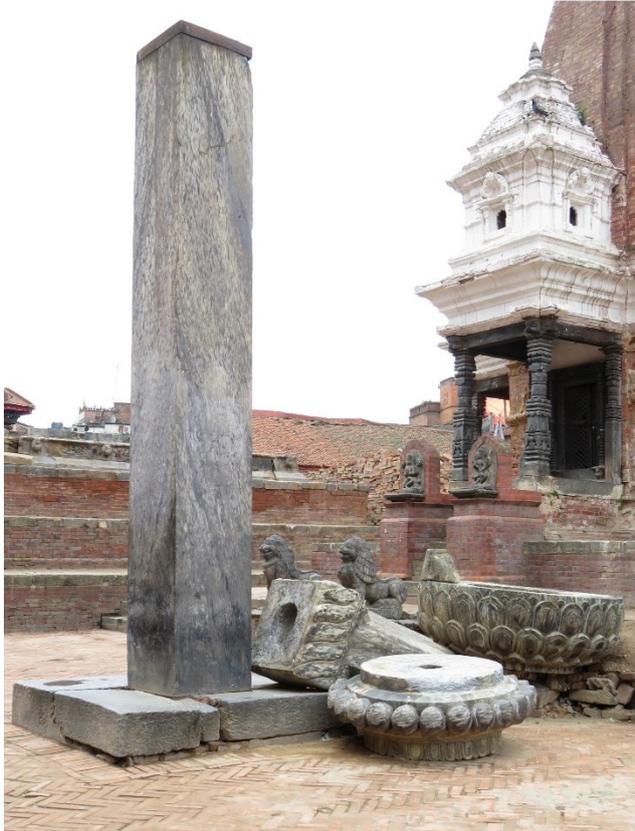
Fig. 48: Before Conservation, 2016

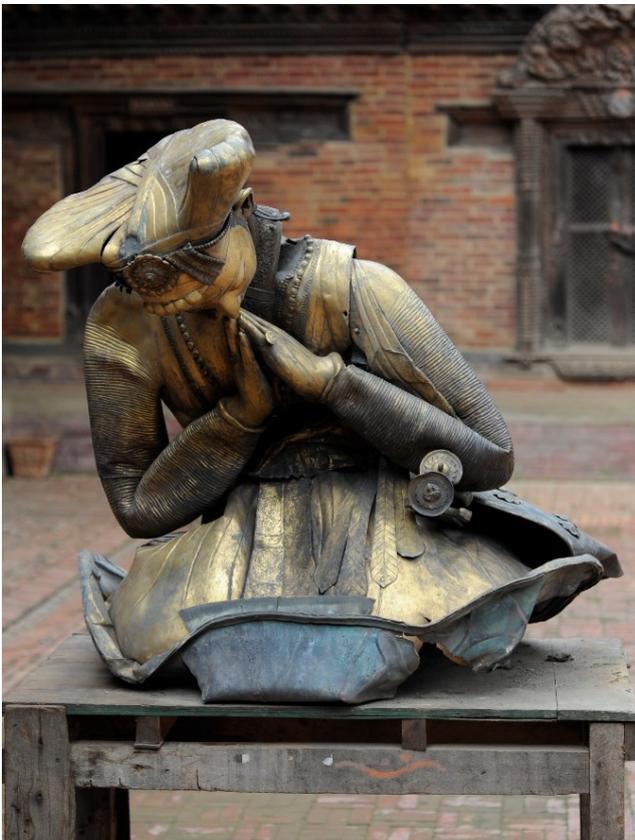
Fig. 50: King before conservation, 2016

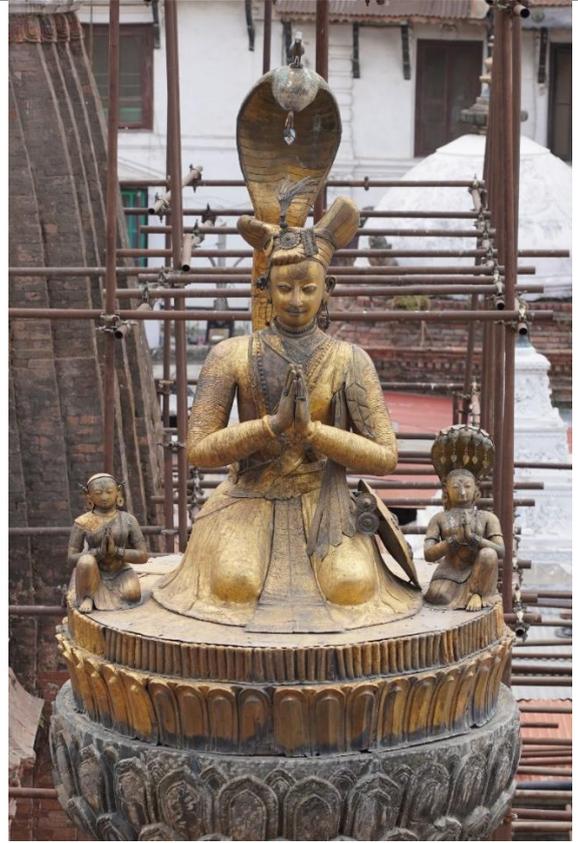
In general, the condition of the sculpture was judged as satisfactory. Due to inaccessibility, details of conservation work could only be assessed using binoculars. The technical interventions on the objects (e.g. repair of deformations, welding), carried out mainly by local craftsmen, have proved to be stable to date. Unfortunately, due to the lack of direct access, it has not been possible to assess the adhesive securing (e.g. closing cracks) with epoxy resin.

The surface treatments have also proven to be stable over time. In principle, the overall appearance of the sculpture blends in well with the surroundings of Darbar Square. However, the object appears blotchy today, as the areas with (retouched) gold leaf and the worn areas of the original fire gilding show different degrees of ageing (areas of the oil gilding are much lighter in colour).

The sculpture also has a matt appearance due to the dust deposits. Deposits (soiling and especially bird droppings) can be found on the surface and are a major cause of corrosive reactions. In this respect, maintenance is the key to the long-term preservation of the sculpture. Regular cleaning and removal of bird droppings must be considered by the local community as the most important factor in long-term conservation. Where citric acid is used to chemically reduce corrosion, it is essential that the surface is thoroughly rinsed after cleaning, as acidic residues accelerate corrosive reactions.

Fig. 2: Yoganarendra sculpture in May 2024

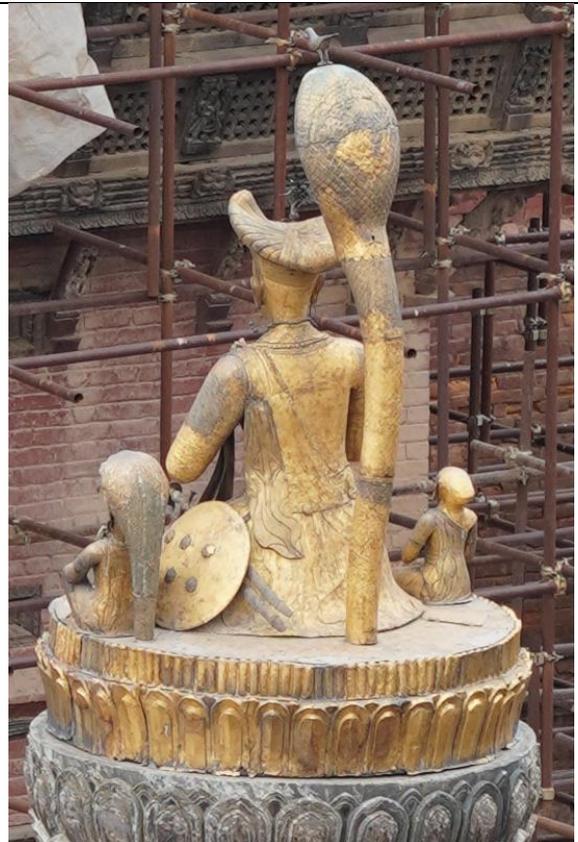
Fig. 4: Yoganarendra sculpture in May 2024

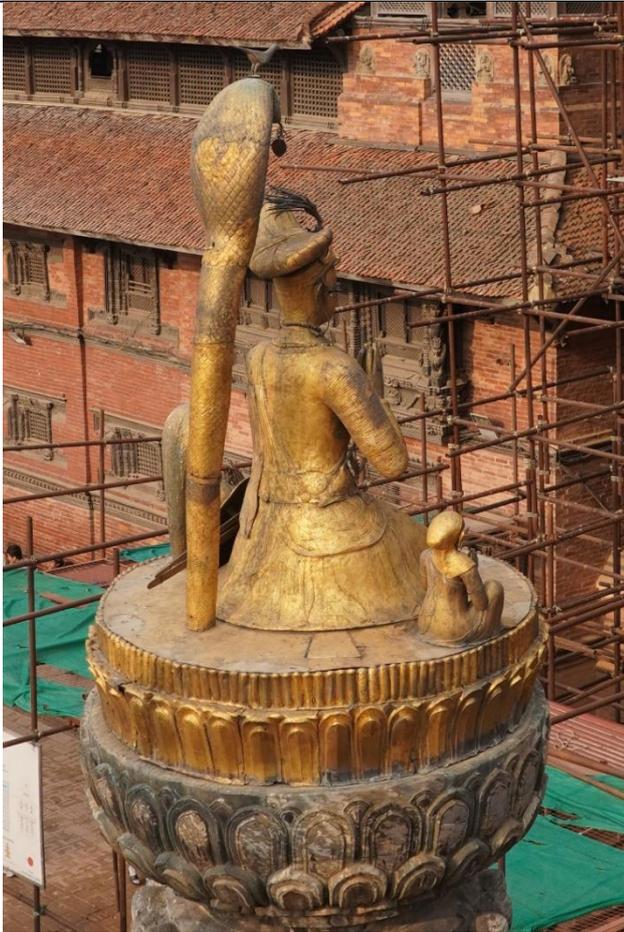
Fig. 5: Yoganarendra sculpture in May 2024
